HISTORIC STRUCTURE REPORT

CROW ISLAND SCHOOL

WINNETKA,
ILLINOIS

2017

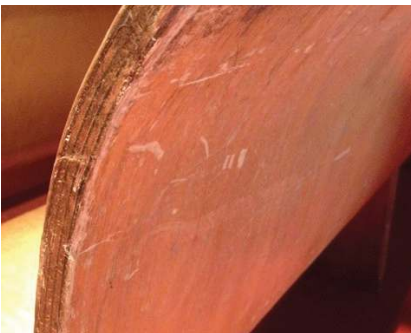
Plywood damage at the edge of the bench back, 2016 (BHC)

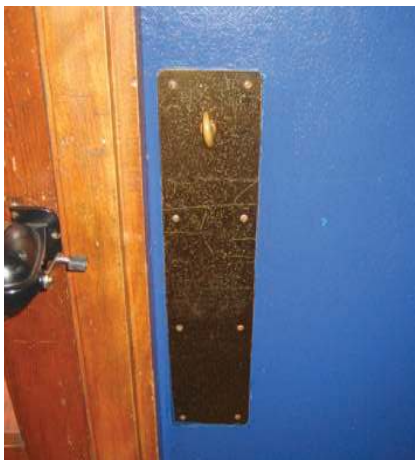
Pitted and scratched finish at 1954 classroom door push plate (BHC)

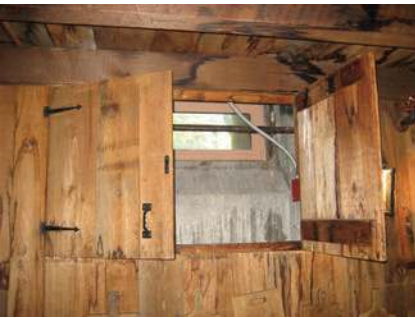
Water damage at pioneer room windows and walls.(BHC)

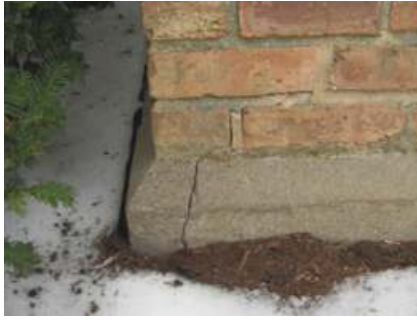
Concrete foundation crack (BHC)

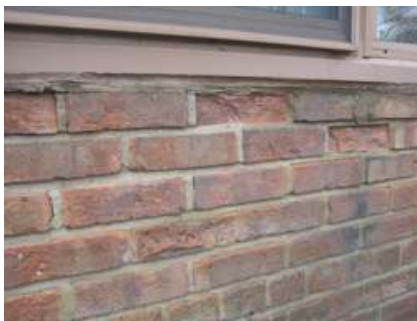
Spalled brick face (BHC)

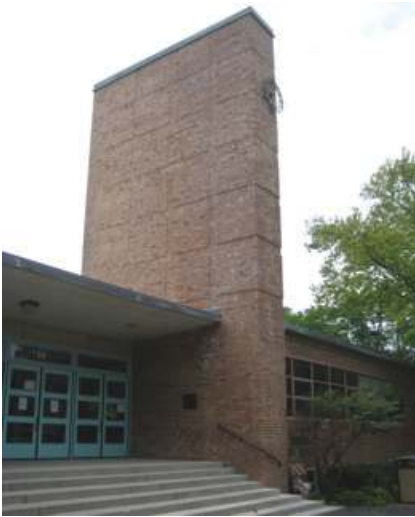
Clock Tower efflorescence (BHC)

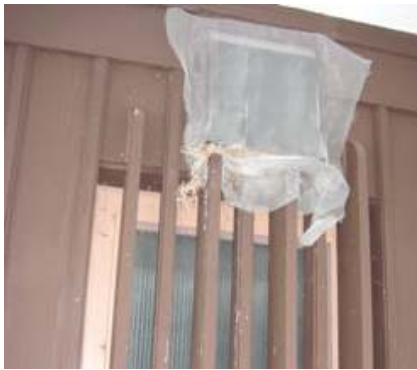
Board and batten walls and birdproofing at vent above windows at northeast wing entrance (BHC)

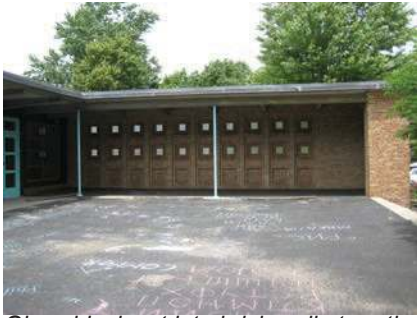
Glass block set into brick wall at north end of play terrace. Bottom row is infilled. (BHC)

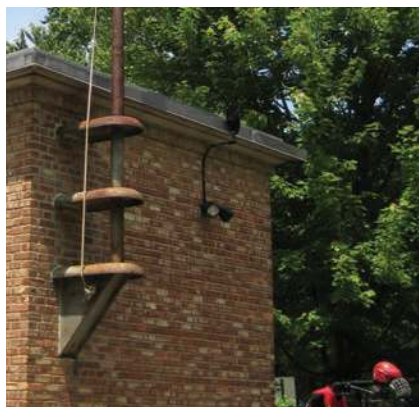
Flagpole structure on east wall of northwest wing has paint failure and rust that is staining adjacent concrete (BHC)

The flagpole structure should be repaired. See "Exterior Material Repair Recommendations" in the *General Guidelines for Maintenance and Future Work* section for details (p. 4-25).

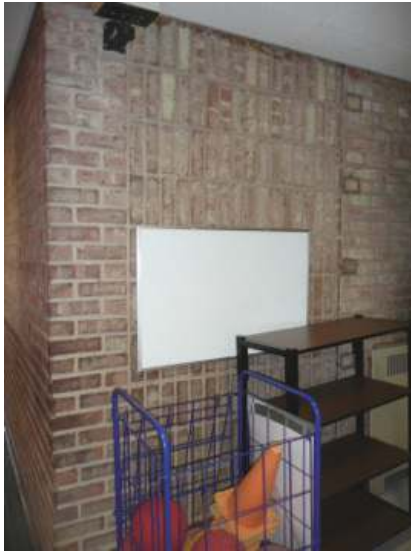
Brick wall at lobby has staining and non-matching mortar at repair locations (BHC)

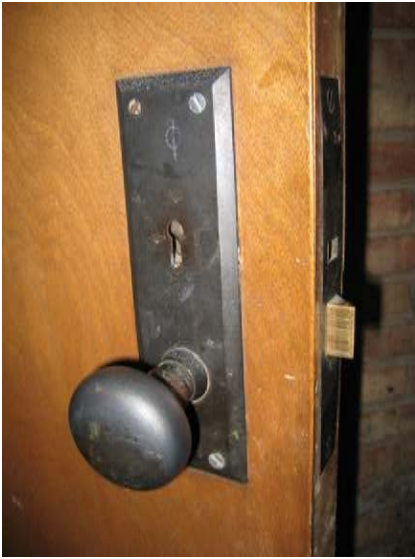
Bower-Barff iron hardware. Incompatible screws are corroding and false keyhole is visible. (BHC)

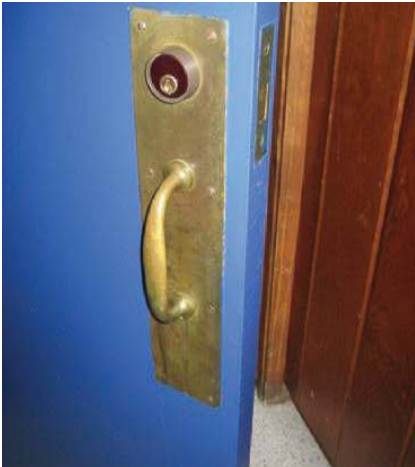
Pitted and worn interior hardware located in the 1954 southwest wing addition (BHC)

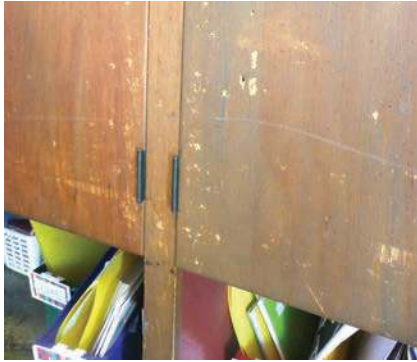
Wood cabinet with pin hole damage (BHC)
