HISTORIC STRUCTURE REPORT

CROW ISLAND SCHOOL

WINNETKA,
ILLINOIS

2017

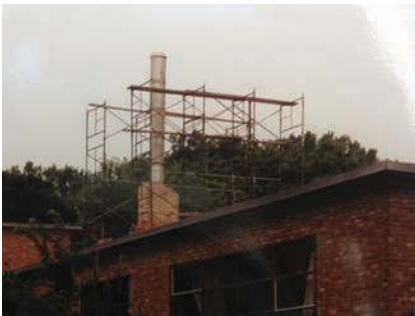
Reconstruction of the Clock Tower, 1993 (Winnetka Public Schools Archives)

- Repair the clock at the clock tower so it is a correct replication of the original clock components (pp. 3-151, 4-35).
- Inspect tower ladder rungs and repair as needed (pp. 4-27, 4-28, 4-34).

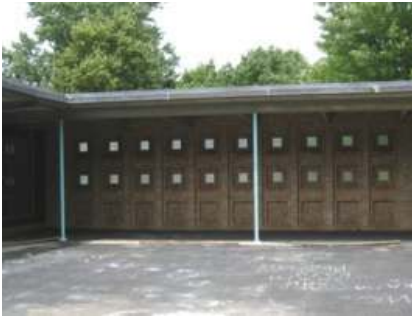
Glass block set in the south-facing brick screen wall of the play terrace, northwest wing (BHC)

The redwood boards are weathered and discolored due to water splashing up from the pavement.

- Glass block set in brick screens. Inspect joint sealant and provide necessary repairs. Replace any broken or damaged block units (p. 4-32).
- Signage - maintain bronze lettering and check anchoring (p. 4-34).
- Conduct repairs to flagpole structure, including rust removal and repainting (pp. 3-152, 4-35).

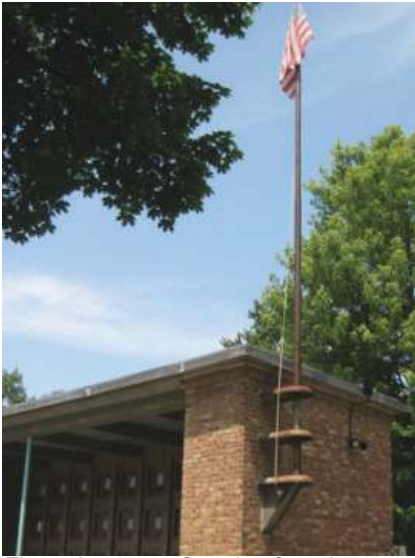
Flagpole at east façade of northwest wing (BHC)

This façade consists of a simple flat brick end wall. On the south end there are three cantilevered semicircular supports and a substantial metal base bracket that encloses and supports a metal flagpole that extends approximately 24-feet high. The metal supports and the pole have lost their protective paint coating and rust has stained the concrete steps below. The brick wall is in good condition, but shows signs of repaired brick and mortar joints that may have cracked due to stress from the weight of the flagpole structure attached to the brick wall. Another consideration is that there could be rusted metal reinforcing components within the wall that will continue to cause oxide jacking and cracking at the wall. See “Flagpole” in the *Artwork* section (p. 3-152) and *Exterior Material Repair Recommendations* (p. 4-35) for a detailed description of the flagpole and work recommendations.

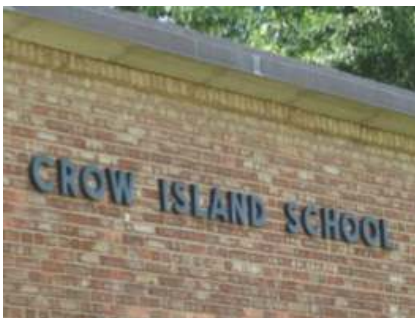
Contributing 1980 bronze signage on the north façade of the northwest wing (BHC)

This façade faces Willow Road and includes the school signage “CROW ISLAND SCHOOL” in block letters. The bronze lettering was a commemorative gift in 1980, from alumni, for the 40th anniversary.¹ The signage is not historic, but is considered a contributing feature on the façade. To the west of the signage is the backside of the brick screen wall mentioned at the south façade where there are two rows of ten small square openings that have glass block inset into them. Beneath them is a third row of square openings that have been infilled with brick. Originally all three rows had glass block.

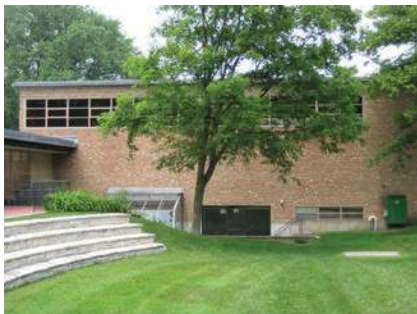
South Façade of Central Core (BHC)

This south-facing brick façade has a horizontal band of clerestory windows at the west end that allow light into the gymnasium. The steel windows have three rows of 15 rectangular sash (45 lites) with seven awning windows in the center row that are operable. On the east end at the lower level are two sets of rectangular window openings with two rows of three sash (6-lites). The lower level has an exit door from the resource center (door W11) with two, single sash sidelights and a single

steel door is located at the east end and is an auditorium exit. A concrete stair with two simple pipe railings is located adjacent to the building and runs east from the Resource Center exit door up to the central courtyard. A small, 25' x 4' glass greenhouse is located to the west of the resource center exit. The greenhouse and the doorway openings were added in 1974 as part of the Resource Center build out. A simple, metal electrical box is attached to the brick wall between the lower level windows. Other mechanical equipment is located along the east end of the façade on the roof of the publication office (room 19). Some brick spalls were observed on the façade and there are several locations where obsolete metal attachments are embedded in the wall.

- Repair concrete spalls at window ledges that were cut in 1974 to accommodate rear exit from Resource Center (p. 4-26).
- Repair concrete foundation crack at metal grille on west end of south façade (p. 4-26).
- Review 12" long structural crack at south façade west of greenhouse (p. 4-27).
- Repair brick spalls and remove and repair holes where four metal anchors are embedded in wall, at east end of south façade (p. 4-27).
- Review top of exterior stairs where there are hazardous conditions and a clay pipe drain (p. 4-26).

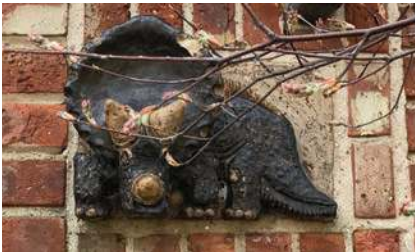
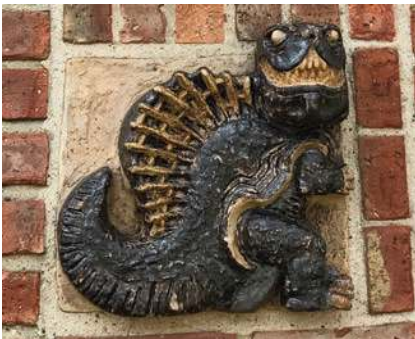
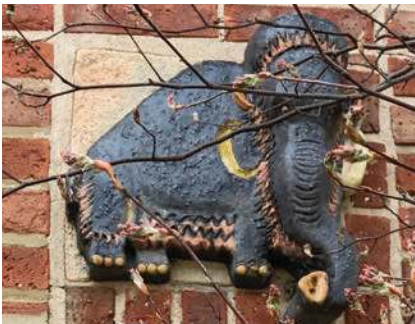
Terra cotta sculptures designed by Lily Swann Saarinen at classroom 106 courtyard (Winnetka Public Schools Archives)

Brick failure was observed at the base of the doors and each bathroom screen has had repeated rebuilding often not matching the original design. Damaged brick was observed at outside corners of each classroom wall. The north wall of classroom 102 has traces of graffiti visible. There is some corrosion at the metal supports at the sculpture pedestal and canopy.

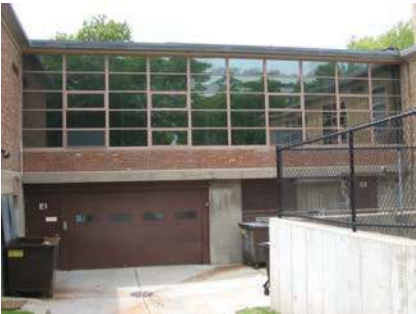
Loading dock and driveway at lower level and lobby windows above, southeast wing (BHC)

a concrete lower portion. The brick upper portion has a horizontal metal vent at the west end. The concrete portion has a single opening on the west end that is covered with metal panels except for a partially glazed metal panel with obscure glass. There is a small vent in the upper left corner. The brick wall is in poor condition due to surface delamination (face failure) of the brick. The concrete basement wall has visible reinforcing shadows and concrete spalling at the upper edge of the metal vent, reentrant cracks, and broken glass. Several metal anchors are also left exposed in various locations. Standing water was observed at door S1.

- Maintain the existing historic configuration and materials of the loading dock as desired, but rehabilitate as needed for functionality.
- At the opening that did not historically have a door, the non-historic doors may be replaced with new doors that do not detract from the historic appearance of the building and are compatible with it. Plain, flush doors, with or without glass panels, are recommended. Do not attempt to create historic-looking doors that did not exist here.

- At original openings that did have doors, any new doors should be based on original designs.

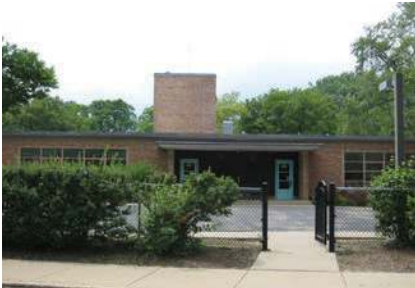
East façade of northeast wing (BHC)

12 horizontal windows in three vertical stacks; just east is a single door, door E3, with four glass panels and a transom. Concrete issues include: cracks due to reinforcing placed too close to the surface, reentrant cracks at opening corners, and concrete spalls at corners as a result of corroded reinforcing bars.

- Repair concrete spalls at lower level water table and entrance eave (p. 4-26).
- Repaint exposed metal pipes and grilles on south façade and electrical box on east façade (p. 4-34).
- Survey door hardware and provide consistent, matching sets of hardware for the two doors (door E4 and door E5) (p. 4-32).
- Repaint entrance doors (door E4 & door E5) and lower level door (door E6). Refinish or replace rusted hinges at door E6 (p. 4-34).
- Evaluate the vent covers at entrance and provide a better, low-profile, bird-proofing solution (p. 4-30).
- Replace or refinish electrical boxes that are rusted and where paint has failed (p. 4-34).

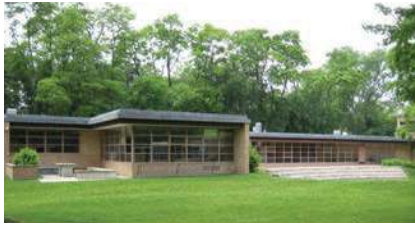
Southwest wing, view of east façade
(BHC)

The brick walls have spalls and detached conduit. Conduit was observed to be hanging without being properly attached to the walls. Door W9 and door W10 have paint failure. The door hardware has missing screws and an irregular finish on the kickplates, most likely from cleaning solution splashing onto their surfaces.

- Fill concrete structural crack at foundation on north façade (p 4-26).
- Repair brick spalls and reentrant cracks at west façades in courtyards (p. 4-26).

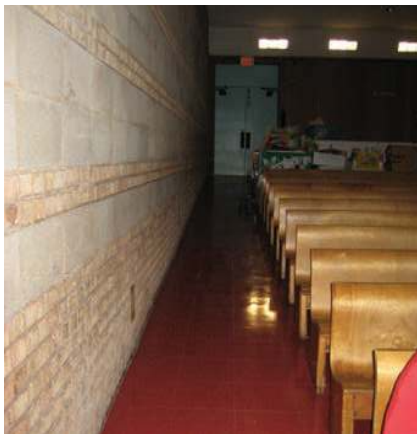
Side aisle with replaced flooring tiles, 2016 (BHC)

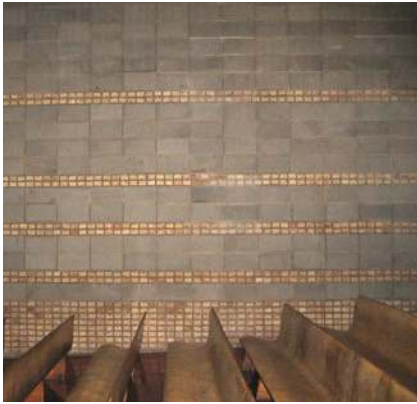
- Wood flooring has damage at the stage;
- Concrete block and brick units at the back stage walls have stress cracks;
- Concrete block and brick units at the walls have water staining
- Concrete block and brick units exhibit structural cracks at the midpoint of the room at the north wall;

Existing masonry wall, 2016 (BHC)

- Hire a wood conservator to conduct repairs to the oak veneer walls and molded plywood benches (pp. 4-40, 4-46).
- Train maintenance crews to use minimal water in mopping floors at the bases of the benches. Mops should not be saturated because the excess water will damage the plywood. If deterioration continues consider installation of protective material (p. 4-46).
- Monitor the progression of the structural crack at the midpoint of the north wall (p. 4-38).

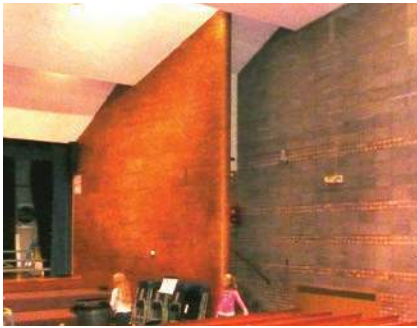
- Oak veneer plywood panels on both sides of the wing wall near the stage exhibit cracking, delamination, and are pulling away from the substrate;
- Molded plywood benches have delaminated wood, abrasions, failing finish, adhesive tape and paint on the surface, and missing material at the seatbacks;
- Molded plywood bench legs exhibit water stain marks due to water and waxes being used to clean and maintain the floor;
- Gypsum plaster exhibits water staining at the ceiling.

Existing molded plywood wing wall, 2016 (BHC)

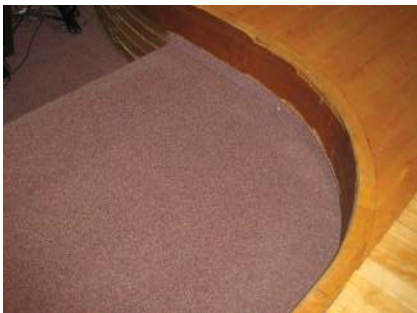
Existing forestage and flooring, 2016 (BHC)

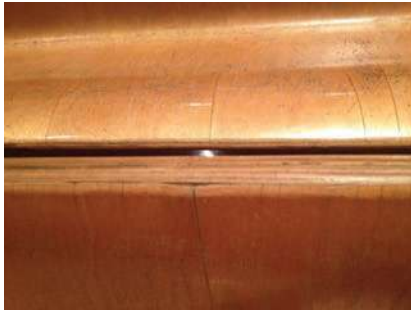
Bench back plywood damage, missing, cracked, and abraded wood, 2016 (BHC)

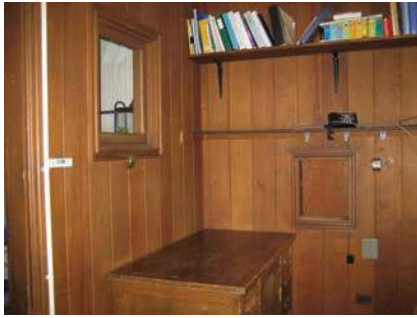
View of wood paneling, trim, and shelving at office 110 (BHC)

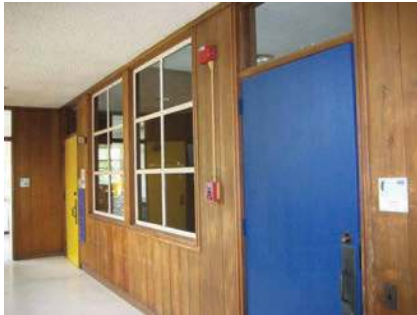
Corridor 152 at the northeast wing, the former kindergarten wing (BHC)

The two corridors remain unchanged in original layout. The material changes include replacement of the ceiling, floors, and lighting.

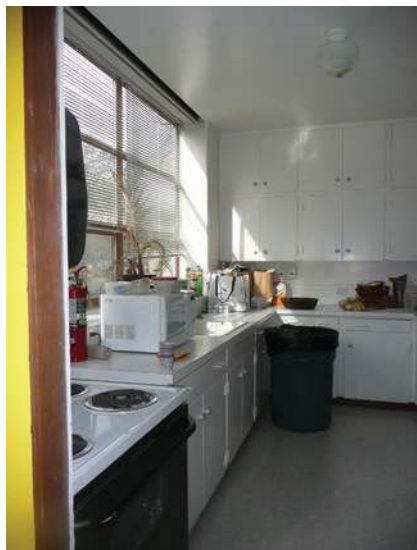
View of kitchen, room 153 (BHC)

because of its layout adjacent to the classroom that includes doors accessing the former milk bar. Appliances and countertops have been replaced, but all cabinetry is original.

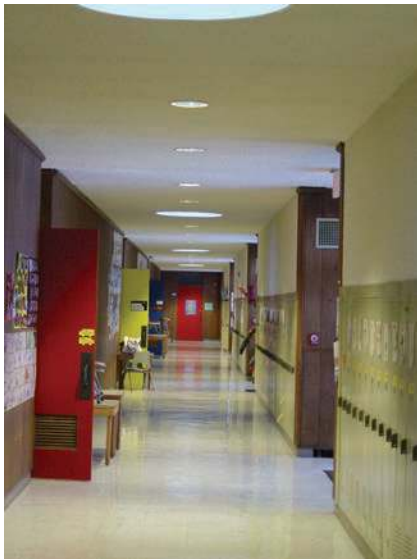
Northwest wing corridor, 133 (BHC)

The corridor remains unchanged in original layout. Material changes include the replacement of the ceiling and skylights, floors, lighting, and lockers. Stair B also is unaltered.

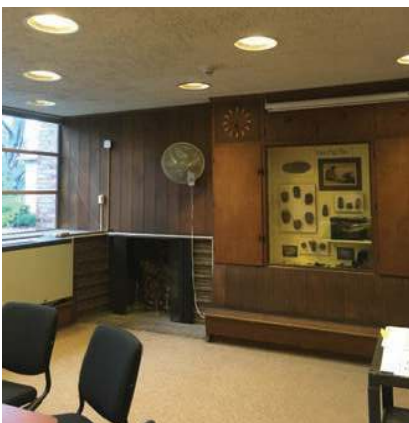
Room 146 converted into a conference room, 2017 (Winnetka Public Schools Archives)

The room does not continue to function as a library, but has retained much of its integrity due to the new uses having had a minimal effect on the layout and the original detailing of the space. Besides having the workroom reassigned to the principal's office, other changes include: installation of non-historic cabinet doors, alterations to shelving to create display spaces, replacement of a larger HVAC unit at the window, and installation of an interactive digital whiteboard on the south wall in 2015. The ceiling and recessed light fixtures have been replaced and carpeting has been installed, presumably over the original, elm, end-grain wood floor. The room retains the original clock built into the upper wood panels. The clock hands and tick marks have been replaced. Doors were added to convert open bookshelves to cabinets when the space was modified to accommodate the Children's Museum in 1974. Original hardware is missing or has been replaced on cabinets and doors.³

- Determine if original wood floor is intact and if it is, retain it and repair as needed.
- Repair clock to make it functional and restore its appearance.
- Maintain layout and character-defining features whenever new uses occur.
- The room is currently listed as "preserve" but can be restored if the project team wishes to focus on restoring missing or lost features.

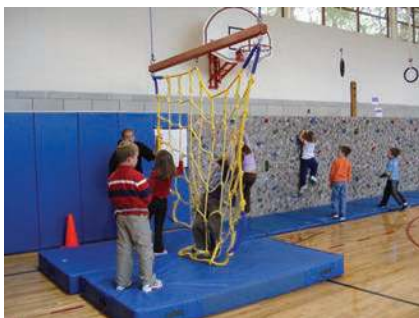
View of gymnasium with added wall pads and climbing equipment, 2016 (Winnetka Public Schools Archives)

The gymnasium, originally called the play room, is a large, open, rectangular space and is utilitarian in nature. Two sets of doors provide access from the main corridor (room 147). Clerestory windows at the north and south walls provide natural light. Maple tongue-and-groove flooring was the original floor surface and it was replaced in-kind in 2003. The lower wall is finished with glazed terra cotta units and the upper wall is finished with concrete masonry units. Various mats and climbing systems are attached to the walls. The gymnasium, overall, retains its original layout and materials. Changes are limited to new flooring, the addition of cushioned wall surfaces, and installation of new fitness equipment.

The treatment approach *Rehabilitate* is recommended for this utilitarian space. This treatment places an emphasis on the retention of the space and repair of historic materials, but more latitude is provided for replacement because the historic fabric is deteriorated or has been altered over time. Attention should be on preserving materials, features, spaces, and spatial relationships that together give the space its historic character.

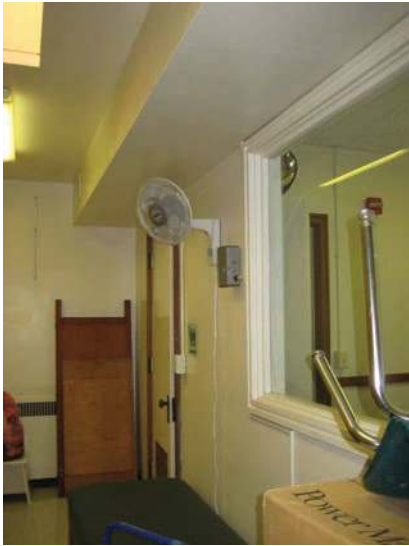
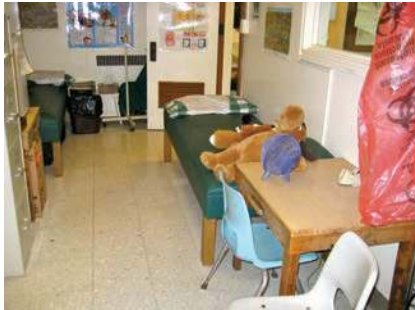
Nurse's resting room (room 126), 2016 (BHC)

This suite retains its original layout and most of the original materials including wood trim, doors, and partition wall. The physical education office was originally the nurse’s resting room (room 131), and the physical education director occupied what is now the resting room (room 126). Ceramic tile flooring remains at the toilet room, while the rest of the flooring has been replaced. The hanging fluorescent fixture in the small hall may be original. All features are in good condition except for some wood trim that is in fair condition. There are original cabinets. The radiators are original.

The treatment approach *Rehabilitate* is recommended for this space. This treatment places an emphasis on the retention of the space and repair of historic materials, but more latitude is provided for replacement because the historic fabric is deteriorated or has been altered over time. Attention should be on preserving materials, features, spaces, and spatial relationships that together give the space its historic character.

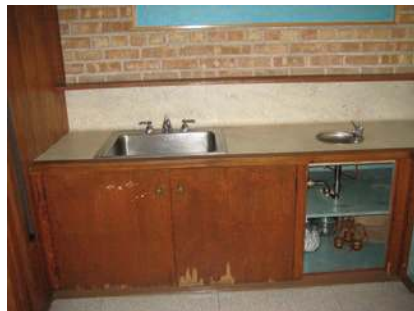
Wood laminate failure at cabinet in 1954 workroom (BHC)

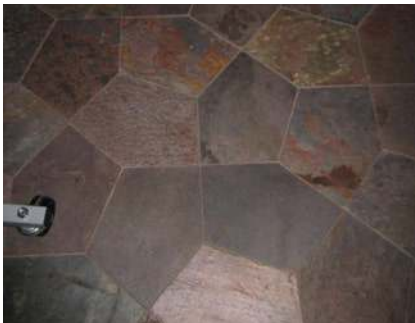
Slate tile flooring replaced resilient tiles in 2013 (BHC)

showing signs of wear. The original resilient tile floor was replaced with hexagonal slate tiles that are not a good match to the original material.

- Repair sources of water leaks that are causing water damage to wood walls and interior windows.
- Consult with a wood conservation specialist to determine appropriate repairs and scope of work for damaged veneer at the base of the main door.
- Retain historic painted, stained and raw finishes at historic doors and other wood surfaces.
- Maintain and repair existing light fixtures as needed.
- Any future floor replacement should be based on historic documentation and should match the appearance of the historic floor.

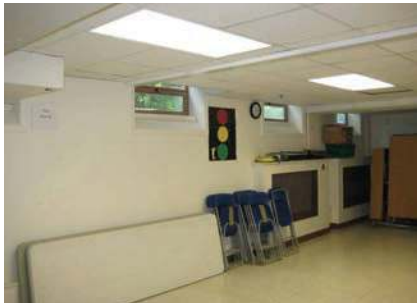
Room 13 was used as a workroom and lunchroom in 2016 (BHC)

The treatment approach *Treat with Care* is recommended for the work room (room 13), the storage room (room 17), and the publications room (room 19). *Treat with Care* designates that the space can be re-programmed to have sensitive alterations that incorporate new uses, equipment, methods and materials. It has been determined that the space or components of the space have had alterations so that their original use or configuration is no longer apparent, that there is no historic material remaining, or that the spaces or components were built out in years other than in 1940 and 1954, the periods of significance.

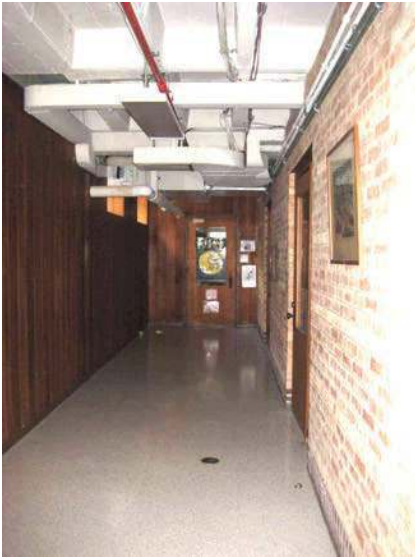
Corridor 31 on the lower level has vertical, wood plank walls on one side and brick on the other (BHC)

The treatment approach *Preserve* is recommended for corridor 31. This treatment places a high premium on the retention of the space and all historic fabric through conservation, maintenance, and repair. It reflects a space's continuum over time, through successive uses and occupancies. Attention should be on preserving materials, features, spaces, and spatial relationships that together give the space its historic character.

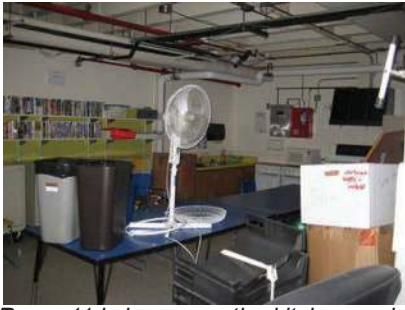
Room 11 is known as the kitchen and cooking barn (BHC)

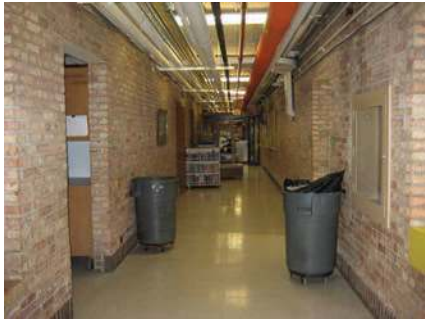
Corridor 32 has brick walls and base, identical to the main level (BHC)

The preservation treatment *Rehabilitation* is recommended for corridor 32. The brick and any original door materials should be maintained as they are original to the 1940 building and provide a link to corridor 31.

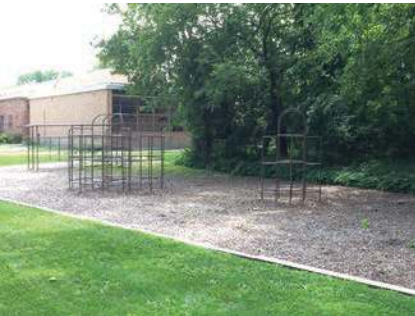
Play structures at west play area, 2017
(BHC)

with modern play equipment and scattered mature trees. The area just south is composed of a grass lawn, again with scattered mature trees. A second woodchip area is located at the south end of the grass lawn. Three historic jungle gyms, composed of connected iron pipe, are located within this wood chip area. The western edge of the property is bound by Crow Island Woods Park, owned by the park district.

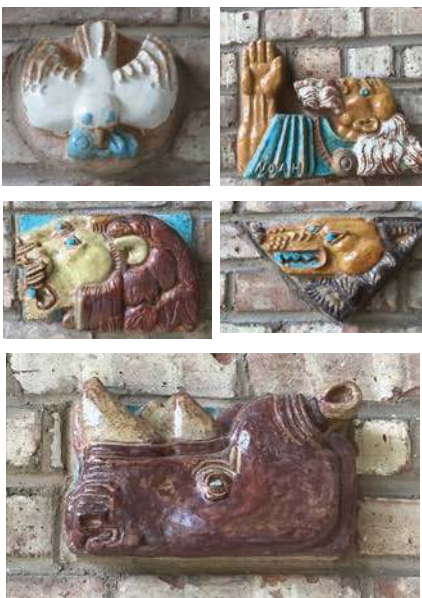
Five terra cotta sculptures are in the lobby/foyer (room 148). Clockwise from top left by survey numbers: 1. dove, 2. Noah, 3. wolves, 4. rhinos, 5. lions (Winnetka Public Schools Archives)

The clay-based ceramic sculptures, set within the building's brick masonry walls, depict stylized representations of various animals, Native Americans, and the biblical story of Noah's Ark. Five of the twenty-two pieces, those depicting the story of Noah's Ark, are located inside at the south wall of the first floor lobby. The sculptures are original to the 1940 sections of the building.

All sculptures should be monitored and any damaged pieces should be evaluated by a conservator and repaired.

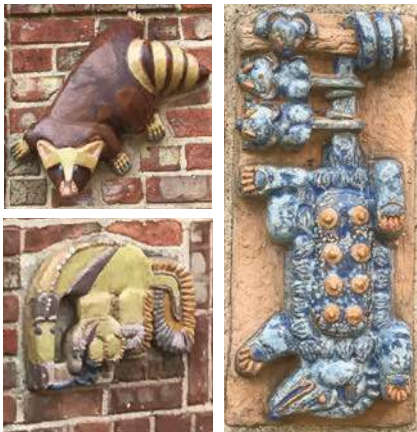
Exterior sculpture clockwise from top left by survey numbers: 6. raccoon, 7. blue opossum with babies, 8. anteater with baby (Winnetka Public Schools Archives)

The sculptures are typically in good condition, with limited glaze loss on some exterior units. The sculptures were restored in 1990 by art conservator Erin McNamara. According to McNamara, two methods of restoration were undertaken: cement and sand patching using a color matched breathable masonry coating applied on the surface to blend with the surrounding glaze, and an epoxy-based repair method covered by a compatible epoxy paint used to duplicate the glaze effect.⁵

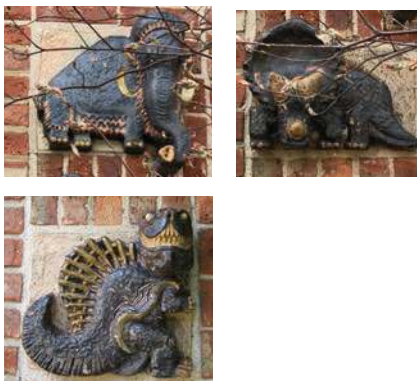
Dinosaur sculpture at room 106 courtyard wall clockwise from top left by survey numbers: 9. woolly mammoth, 10. triceratops, 11. Stegosaurus (9 and 10 Winnetka Public Schools Archives, 11 BHC)

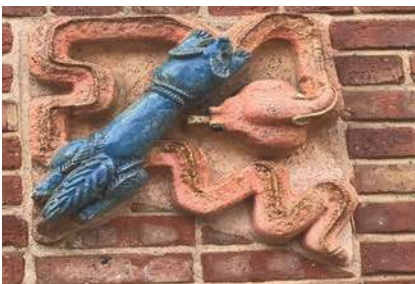
Sculpture at room 114 courtyard: survey number 22. blue mongoose and brown cobra (Winnetka Public Schools Archives)

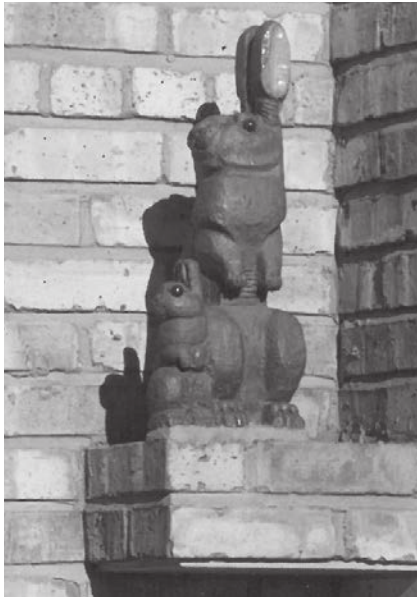
1. Empty brick shelf and canopy, room 105 courtyard, south wall
2. Rabbit and baby rabbit sculpture (now missing), was located on pedestal at classroom 112 courtyard, west wall.
3. Classroom 108 courtyard, south wall, the brick is treated differently and was constructed to receive sculpture

Rabbit and baby rabbit sculpture in 1940, room 112 courtyard, 1940, now missing (Hedrich Blessing)

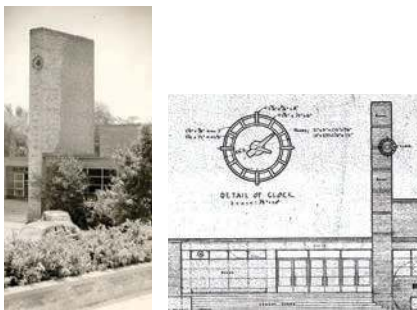
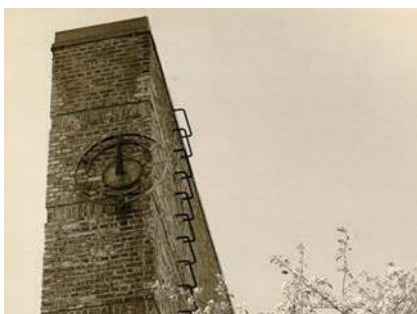
Rebuilding of the brick tower occurred in 1993 and during that time the original clock was removed. The clock mechanism was restored and automated, and the original parts were cleaned and reinstalled in 1995.⁶ The original bronze hands, the back plate dial, and associated mechanism were again removed in 2015. The original hands and base plate dial were replaced in 2016. The base plate does not match the original in design or thickness and the minute ticks were not replicated. The current finish is a high polish but initially was called to be unlacquered so a natural patina would occur. Even though the tower and clock had major intervention in 1995 and 2015, it somewhat resembles the original appearance from 1940.

Clock tower, ca. 1950s and 1939 detail (Winnetka Public Schools Archives)

Clock on clock tower (Winnetka Public Schools Archives)

- Determine which original components are still intact or can be recovered, if in storage. Original components should be retained and reinstalled if found.
- Existing replacement components that do not match the appearance of the original should be modified or replaced with replicas of the original. Match the original finish, color, texture, and details such as the 3, 6, 9, 12, marks on the dial.
- Oxidize the repaired or replaced components to match the weathered patina on the existing concentric rings.

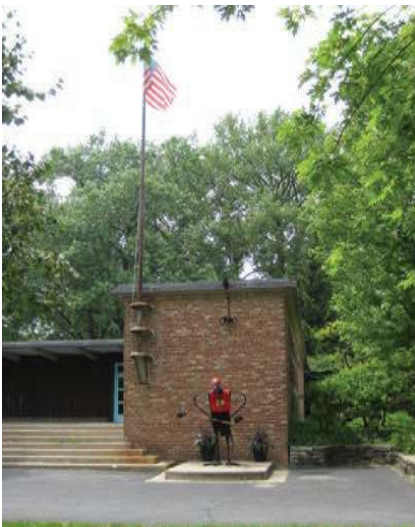
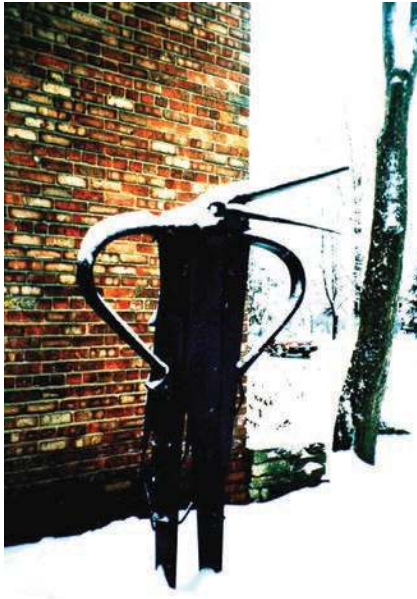
*View of flagpole and crow sculpture
(BHC)*

A steel, Art Moderne-style flagpole is located at the front, east façade of the northwest wing of the building and is mounted to the east façade of the end wall that encloses the raised play terrace. Extending approximately 25' above the building's cornice line, the flagpole is original to the building and continues to function as designed. The flagpole structure projects from the wall and is composed of a tapered steel pole that is supported by streamlined elements that extend from the building - three horizontal, metal extensions with curved edges and a single metal bracket at the base. The flagpole is in fair condition overall, with paint failure and significant corrosion observed. Historically the pole was painted white and the bracket appeared a darker color.

The flagpole structure should be repaired. See "Exterior Material Repair Recommendations" in the *General Guidelines for Maintenance and Future Work* section for details (p. 4-25).

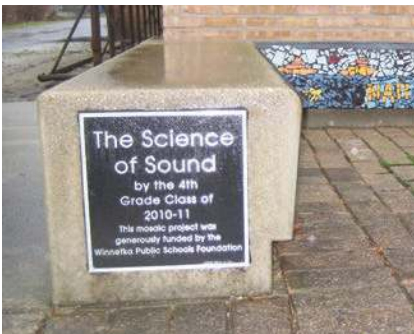
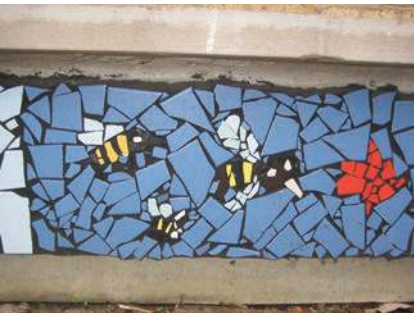
Bench mosaics were designed by students (BHC)

Mosaic tile murals were designed by students and funded by the Winnetka Public Schools Foundation. They were installed at the face of the concrete benches located within selected classroom courtyards at the southwest wing. The murals are composed of polychrome, ceramic tile pieces set in mortar. Each mural has a plaque identifying the mural title and the class responsible for its design and installation. The murals are in good to fair condition overall.

Detail of mosaic in courtyard of room 120 (BHC)

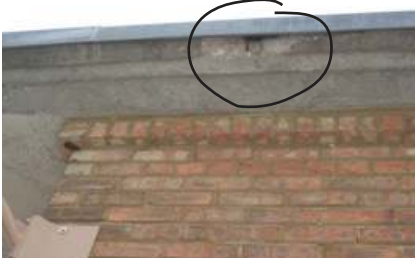
Concrete spill at eave (BHC)

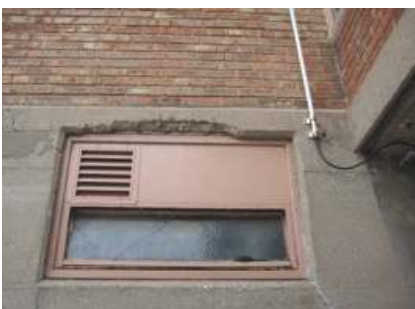
Concrete spill at window head (BHC)

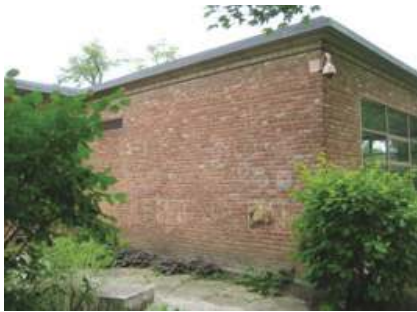
Graffiti on brick wall (BHC)

- Do not clean the brick until consultation with a preservation architect. If cleaned in the future, always use the gentlest means possible. Use only chemicals recommended

for cleaning brick. Protect adjacent materials. Any pressure washing should be done at the lowest effective pressure and from an appropriate distance to avoid etching or damaging the brick. Do not sandblast brick.

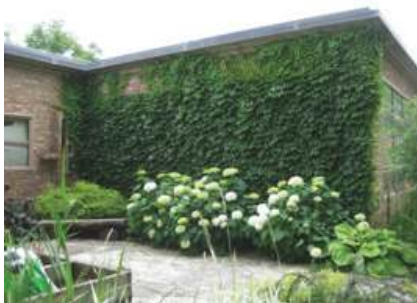
Climbing ivy on brick façade (BHC)

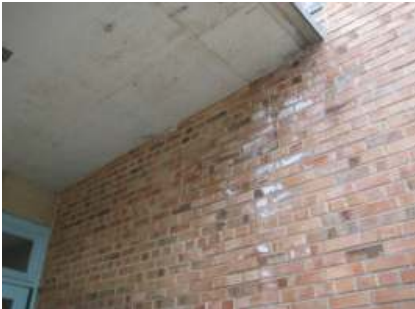
Efflorescence along bottom of Tower (BHC)

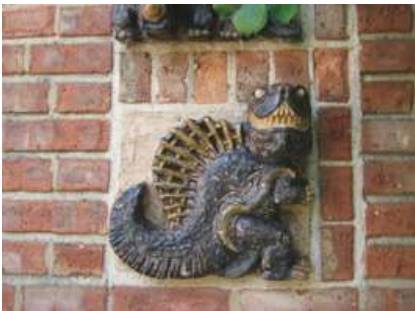
Repaired terra cotta sculpture (BHC)

- Continue to maintain sculptures. Consult with a qualified conservator for any repairs that may be needed.
- Conduct further research to determine if empty pedestals and wall spaces originally held sculptures. If so, provide updated documentation to be placed in the archives.
- Research to find information about the missing rabbit and baby rabbit sculpture. Consult with the Cranbrook Academy of Art archivist for records that will detail the missing sculpture dimensions and appearance.

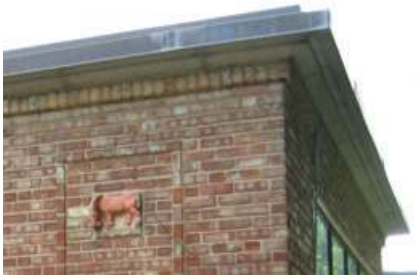
Lead coated copper sheet metal coping and fascia originally existed at all roof edges. Sheet metal is also used as coping for the chimney. A replacement project was completed by Green Associates in the Summer of 2017.

Lead coated copper sheet metal coping, 2015, prior to replacement (BHC)

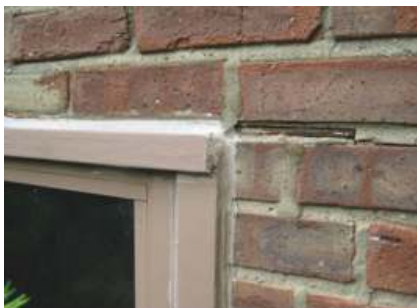
Exposed steel window lintels need repairs (BHC)

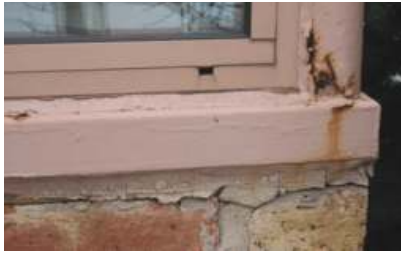
Typical steel window frame corrosion (BHC)

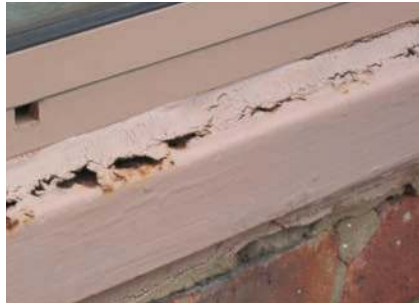
Replaced steel window sash (top), 2002, within original, 1939, rusted steel frame and sill (below). (BHC)

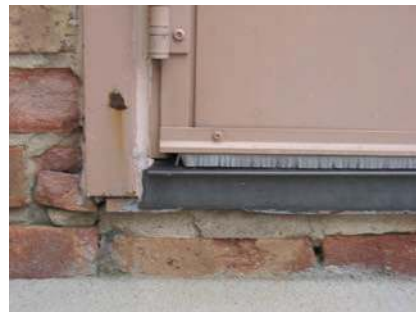
Classroom courtyard door with replaced door (2002) and original frame with finish failure (BHC)

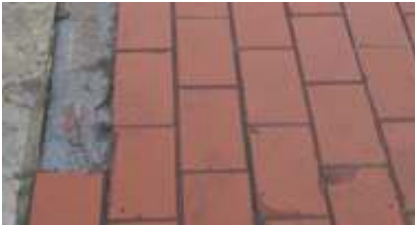
Failed quarry tile where dissimilar materials meet at joint. Area has since been repaired in 2017 (BHC)

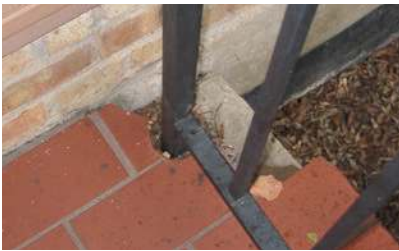
Quarry tile failure at embedded railing, repaired 2017 (BHC)

Quarry tile is used as paving at the terrace located on the east façade of the southwest wing, adjacent to the amphitheater. The tile was found to be in poor condition, with significant cracking, spalls, efflorescence and areas of missing material observed. It was replaced with matching tile in the Summer of 2017.

- Repair any cracked or damaged quarry tile. Investigate if 2017 project replaced 100% of tile or if any original tile remains. If any original tile exists, retain and repair, if possible. Materials that are beyond repair should be replaced in-kind, matching the size, color, composition, texture and profiles of the original.
- Maintain joint sealants at embedded metal railings and at expansion joints.
- Repair any expansion joint failures between the quarry tile terrace and the amphitheater seating.

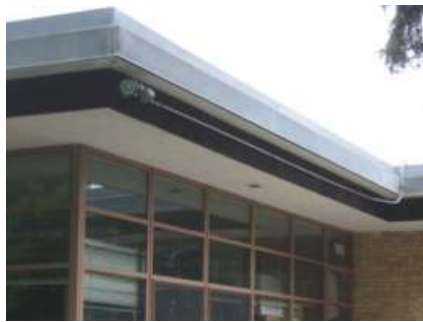
Stucco eave at 1954 southwest wing (BHC)

Painted stucco is located at the eaves of the 1954 southwest wing. It was generally found to be in good condition.

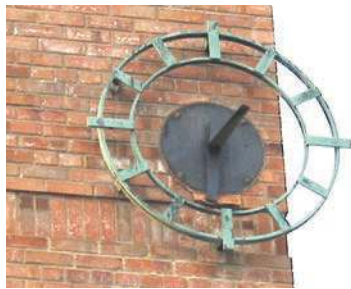
View of clock with original bronze ring, backplate, hour tickmarks, and hands, ca. 1985 (Whitcomb)

The clock had not kept time accurately since early in the building's history and several repairs have been made to the clock and the clock tower over the years.⁶ In 1993 the clock was removed from the tower and in 1995 a two-speed electric clock was installed with original hands and base plate wired to a control box in the lower level.⁷ The clock then ceased to work for some time and another repair effort occurred in 2015-2016. The original hands and base plate are missing and were not reinstalled.

- Determine which original components are still intact or can be recovered. Contact people involved in the repair to see if objects were put into storage. Original components should be retained and reinstalled if found.
- Existing replacement components that do not match the appearance of the original should be modified or replaced with replicas of the original, if the originals cannot be found. Match the original finish, color, texture, and details such as the 3, 6, 9, 12, marks on the dial. Oxidize the repaired or replaced components to match the weathered patina on the existing concentric rings.

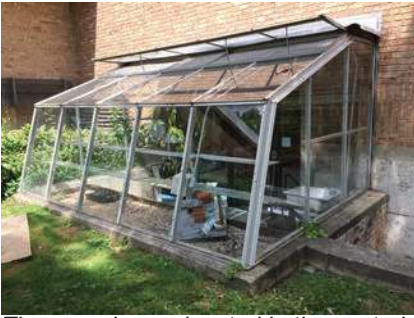
The greenhouse located in the central courtyard dates to 1974 (BHC)

An aluminum and glass greenhouse with concrete basin foundation was installed in 1974 as part of the Resource Center addition. The structure is not historic and is a non-contributing feature on the site. The greenhouse was found to be in fair condition, having displaced, broken and missing glass, cracks in the concrete flooring, and ventilation or heating equipment that was rusted and perhaps not operational.

- As a non-contributing feature, the greenhouse may be removed or altered in a design that is compatible with the building.
- If the greenhouse will be retained, repair existing aluminum framing and replace broken glass. Repair concrete base. Seal joints between dissimilar materials.

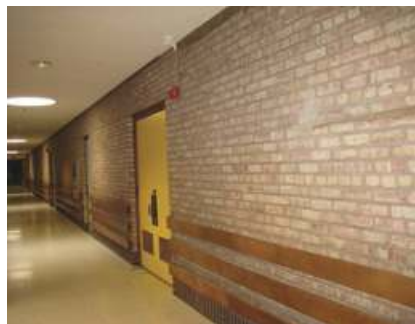
Illinois common brick walls and red brickbase at corridor (BHC)

Exposed brick is used at walls throughout the interior. Overall, the brick was found to be in good condition, with localized areas of damaged brick, mortar loss and soiling.

- Provide selective repointing to repair areas of mortar loss and deterioration. New mortar should match the color, aggregate mix, aggregate exposure, and joint profile of the existing mortar. Compressive strength of new mortar should be less than that of the existing brick to avoid damaging the brick. Grinding of joints in preparation for repairs can only be approved by the preservation architect, after having done a mock up sample.

- Repair damaged brick by filling cracks with patching materials specifically designed for this purpose. Spalled or severely damaged or missing bricks should be replaced in kind, matching the color range, surface finish and size of the existing brick.

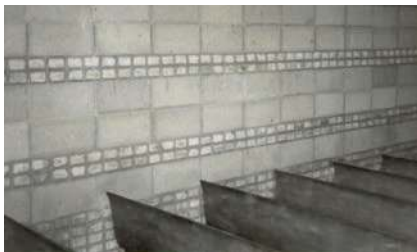
Concrete masonry units between rows of brick in the auditorium (Winnetka Public Schools Archives)

The auditorium and gymnasium were constructed with Waylite insulating concrete block from the Chicago Insulcrete Co. The bathroom walls in the 1954 southwest wing are painted concrete masonry units. Several other spaces have walls constructed with concrete block. Concrete masonry units throughout were found to be in good condition, with localized areas of cracking in the gymnasium.

- Repair cracks as needed using appropriate patching mortars.
- Maintain painted finishes.

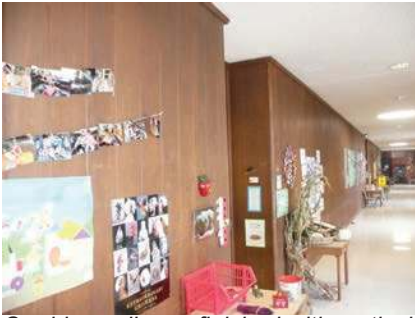
Corridor walls are finished with vertical pine planks with v-grooves (BHC)

Corridor and classroom walls have vertical Idaho white pine planks that are ingeniously designed as tack boards, a unique feature. They are dark and discolored from age and have tack holes throughout. The original finish was "natural with waxed finish." The wax was intended to sit on top of the wood and prevents it from oxidizing. The design intention was to provide a freshly cut, unfinished appearance. Localized areas of water damage were noted.

- Continue to allow walls to be used as tack boards, per the original design intent.
- Avoid using adhesives to attach items to the walls.
- Repair any holes exceeding 1/16" or defects that are a hazard. Patch using a filler of pine sawdust and wood glue.
- A clear wax finish should be maintained on the walls. If the finish is worn and missing, it should be applied and maintained as a standard form of general maintenance. A preservation specialist or wood conservator should determine the level of shine the finished product should reach: matte, dull sheen, or high shine. For any work, either small or large, a mock up and repair submittal should be required prior to any work commencing.
- Repair sources of water leaks that are causing water damage to wood walls. Consult with a conservation specialist to determine whether water damaged wood can be refinished.

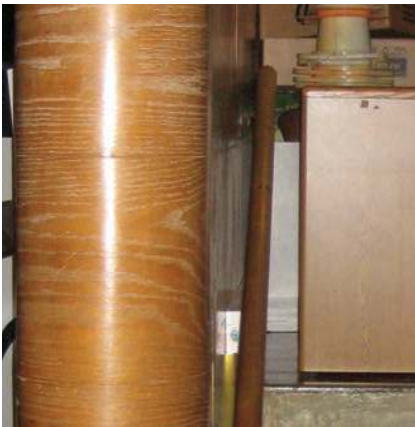
Molded plywood wing wall is delaminating at auditorium (BHC)

The auditorium has molded plywood panels at the curved wing wall flanking the stage. These plywood panels are oak veneer attached to a wood substrate. Specifications called for quartered white oak "Flexwood" as manufactured by the Flexwood Company of Chicago.¹ The finish was to be exact per the company's specifications of the time in 1939. The original finish of the oak is pickled, the act of treating light-colored wood to make it appear even lighter. The oak veneer is cracked and damaged and pulling away from the substrate.

- Retain and conserve the existing oak veneer plywood. Consult with a wood conservation specialist to determine appropriate repairs and scope of work. Research suggestion of reinstalling veneer with contact cement and refinishing surface as suggested in 1987 Building Audit by Perkins & Will.
- Retain pickled finish. Do not oil the wood, as it would irreversibly damage the pickled finish.
- Do not post flyers or attach anything to the oak veneer walls. If items must be attached to this location, consider a spline system or other hanging solution that would allow posters to be hung without damaging wood.

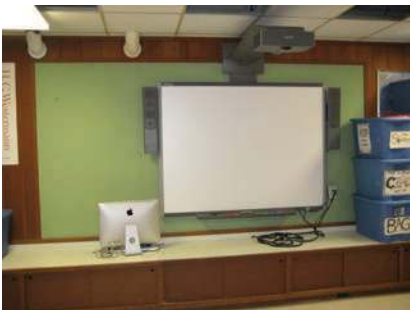
This addition of new technology is reversible, but could have been better designed as well as centered within the fibreboard frame.

- Survey all fibreboard locations and conditions. Determine if they are original by comparing to historic photographs, or drawings.
- Create an audio-visual plan to determine how best to integrate historic blackboards and fibreboards with new technology, such as interactive digital displays.

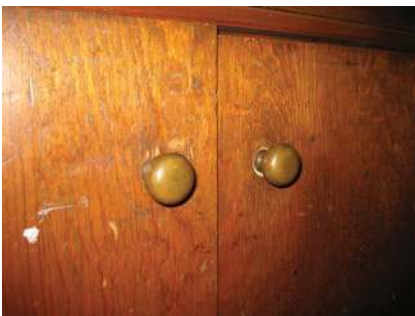
Cabinet knobs in classrooms are often inconsistent and unmatched (BHC)

- Retain existing original hardware and repair as needed to keep in working order. The maintenance staff should have a collection of hardware to be repaired and reinstalled.

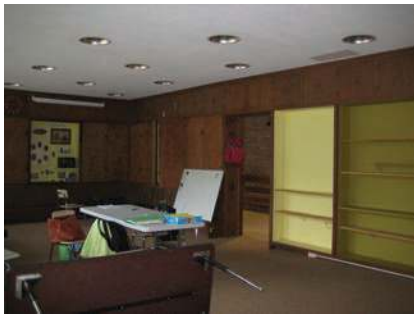
Room 146 with replaced, textured, acoustic ceiling tiles, 2015 (BHC)

- Reset displaced tiles.
- Replace damaged and poorly sized tiles. Any new tiles should match the texture and color of the existing, adjacent tiles.

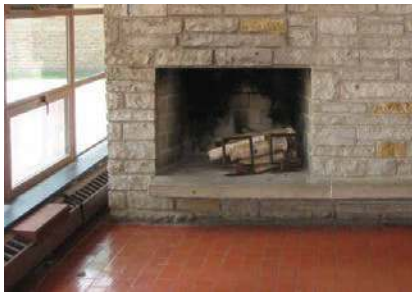
Quarry tile located in activities area (room 121) in southwest wing (BHC)

Quarry tile flooring is located at the interior near the fireplace in the activities area (room 121) in the southwest wing. The tile was found to be in fair condition. It has a waxed finish and areas of spalls and holes were noted. The quarry tile extends to the outside into the central courtyard terrace.

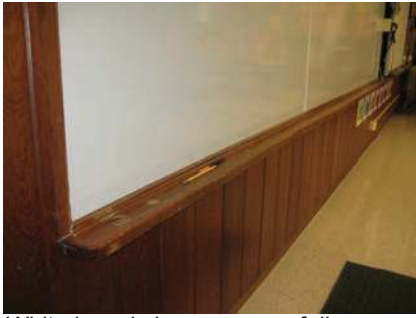
White boards have successfully replaced the slate at many classroom blackboards. This is a good example of rehabilitation of an historic feature. (BHC)

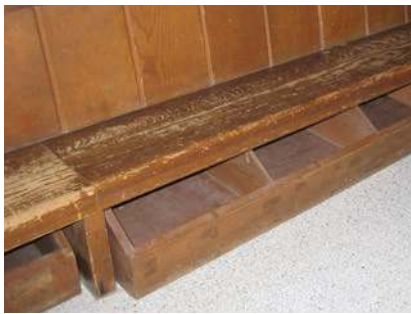
Wood benches with worn finish and wood storage bins beneath, 2015 (BHC)
