HISTORIC STRUCTURE REPORT

CROW ISLAND SCHOOL

WINNETKA,
ILLINOIS

2017

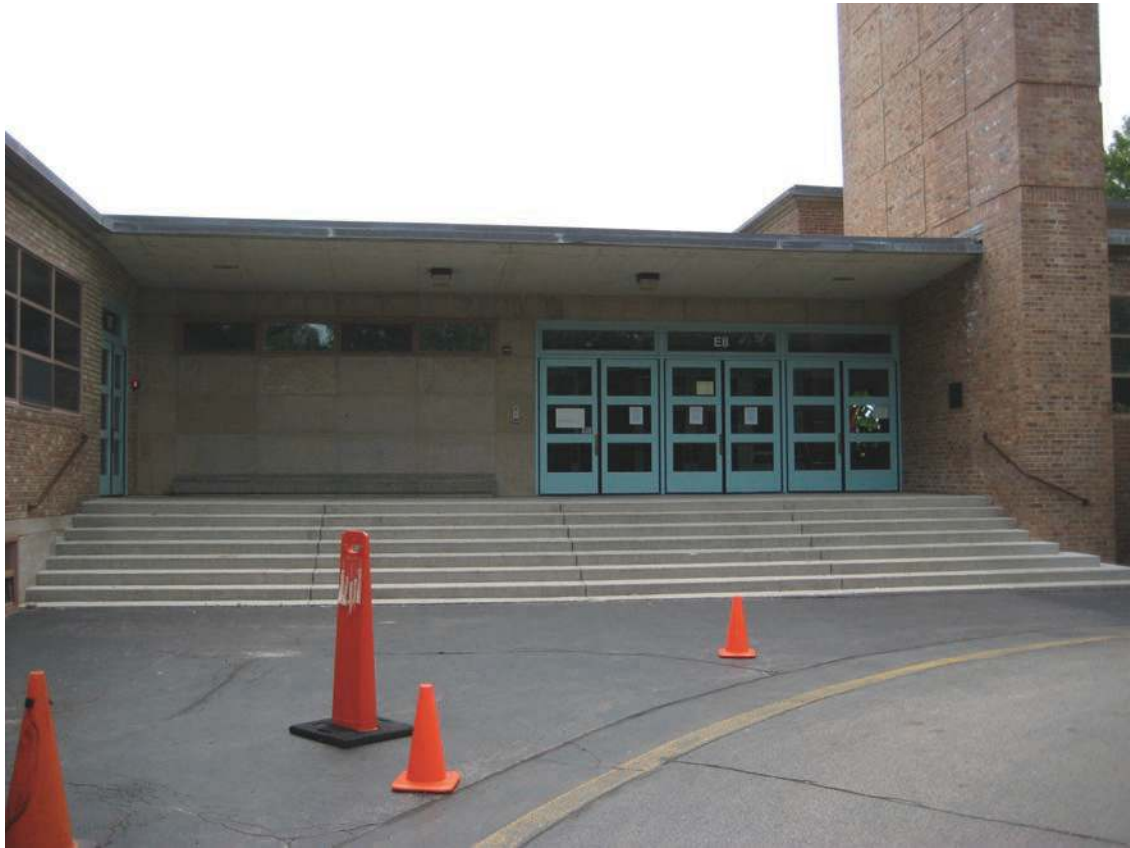
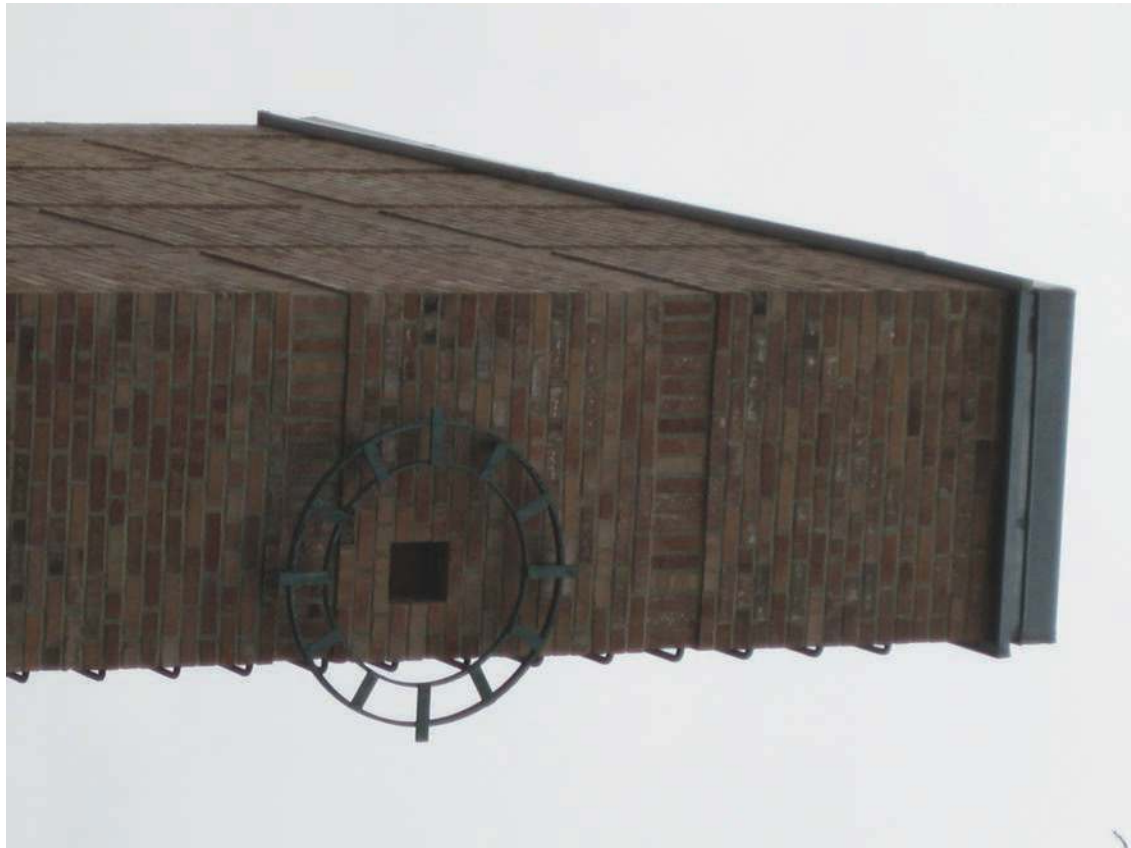
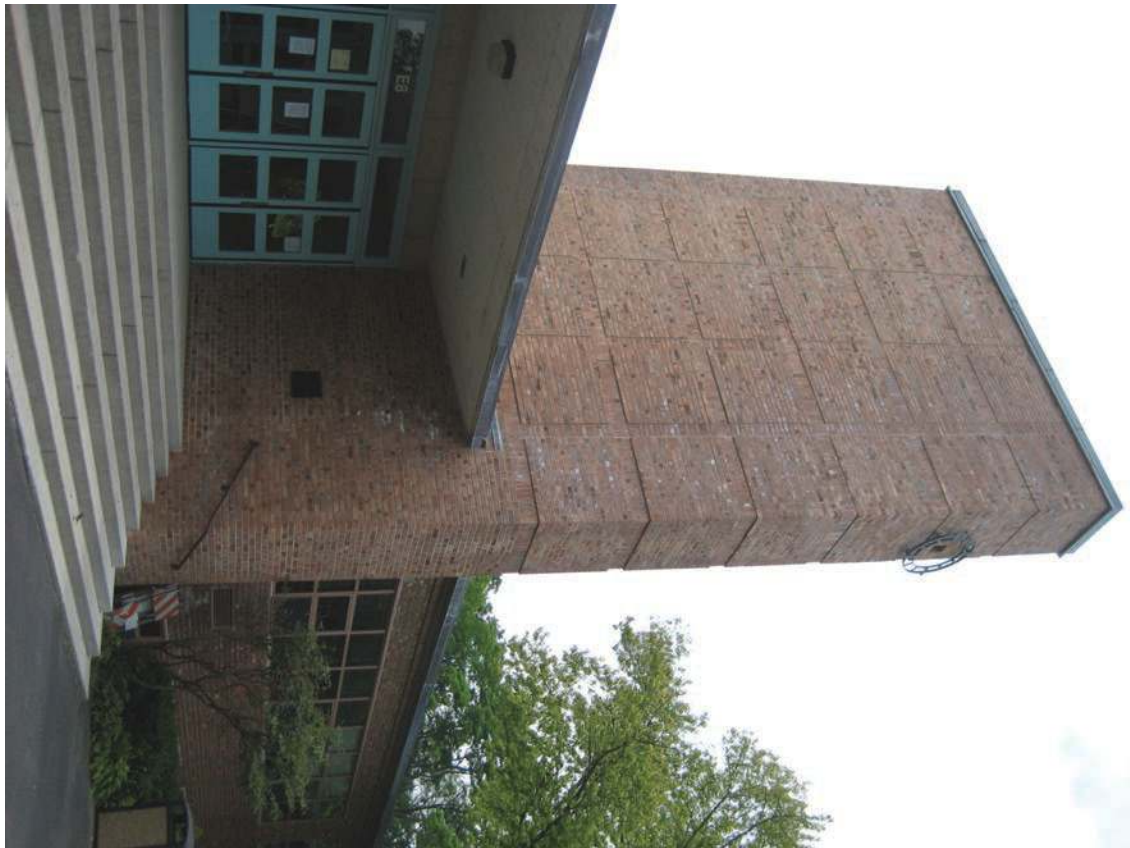
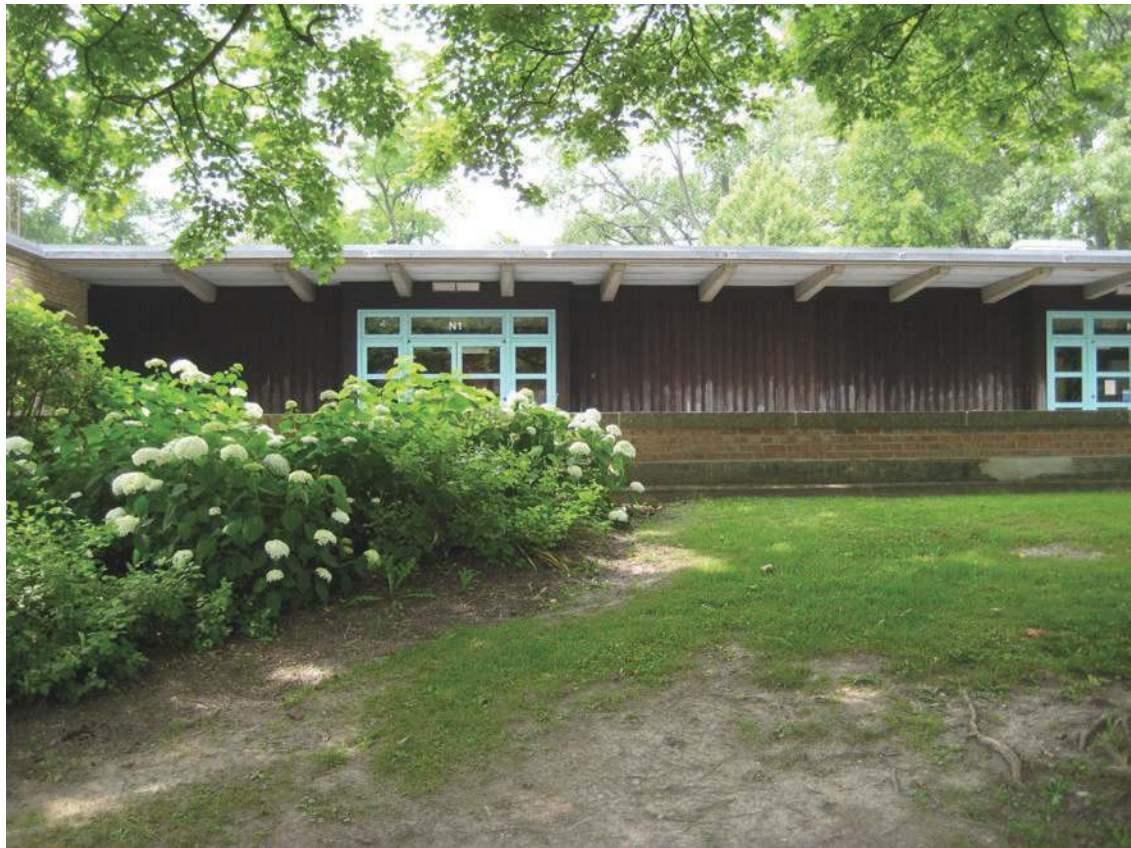
Main entrance, northeast wing and central core

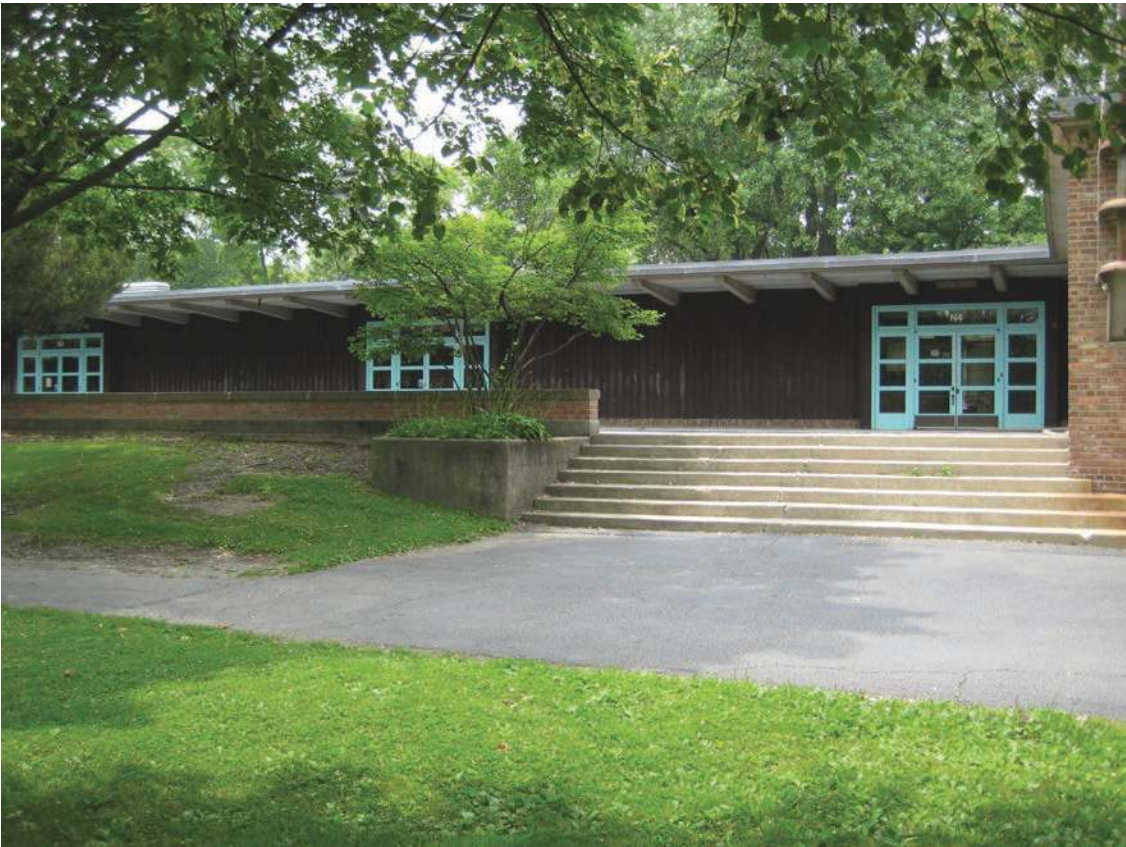
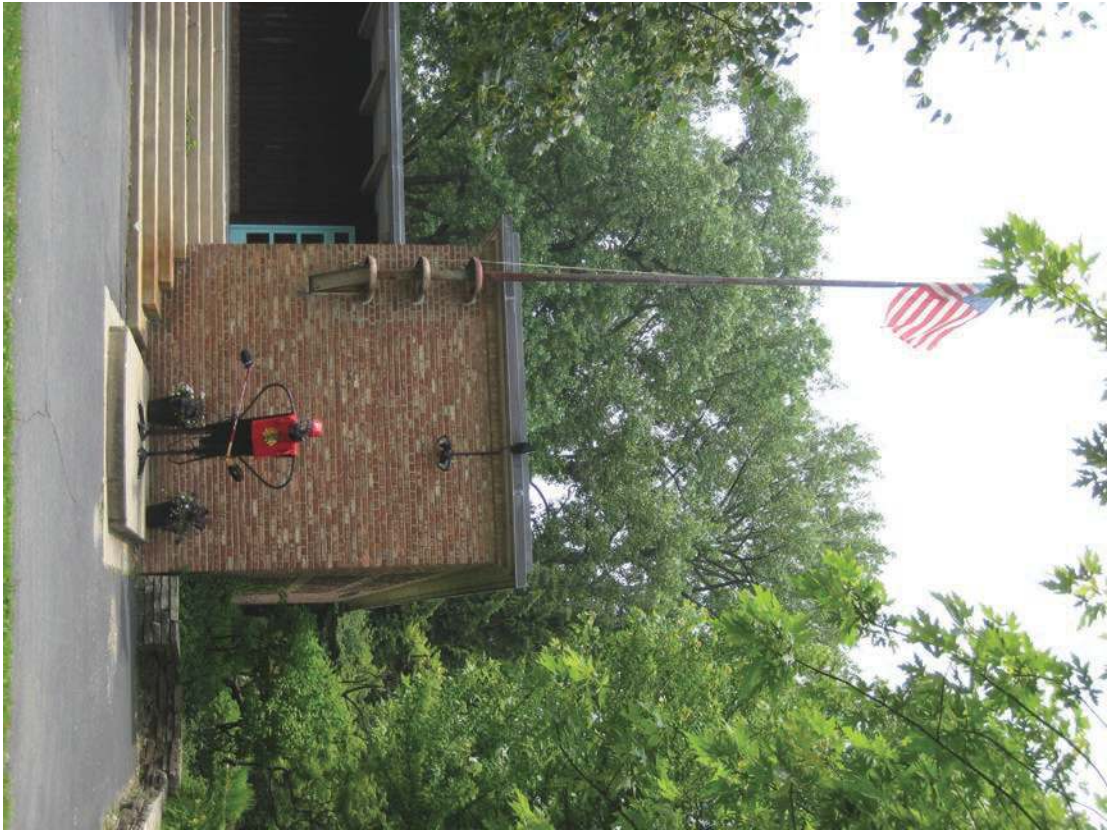
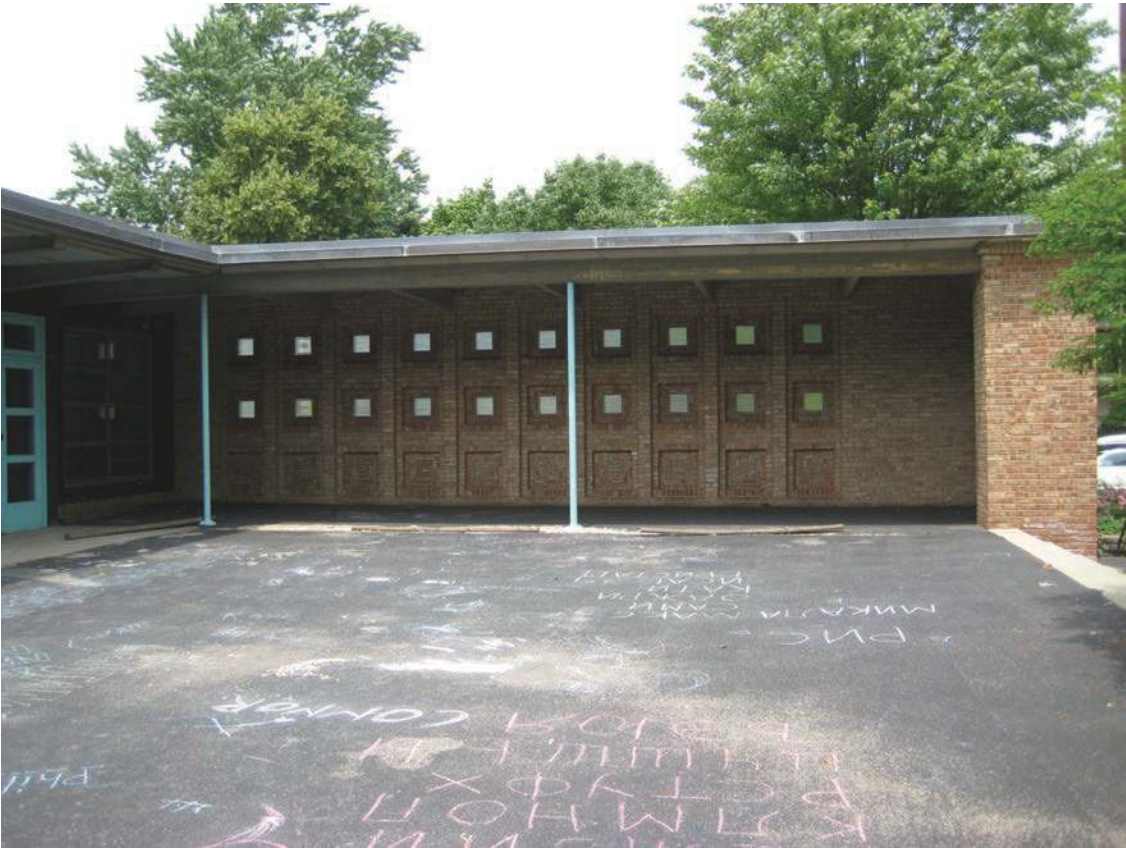
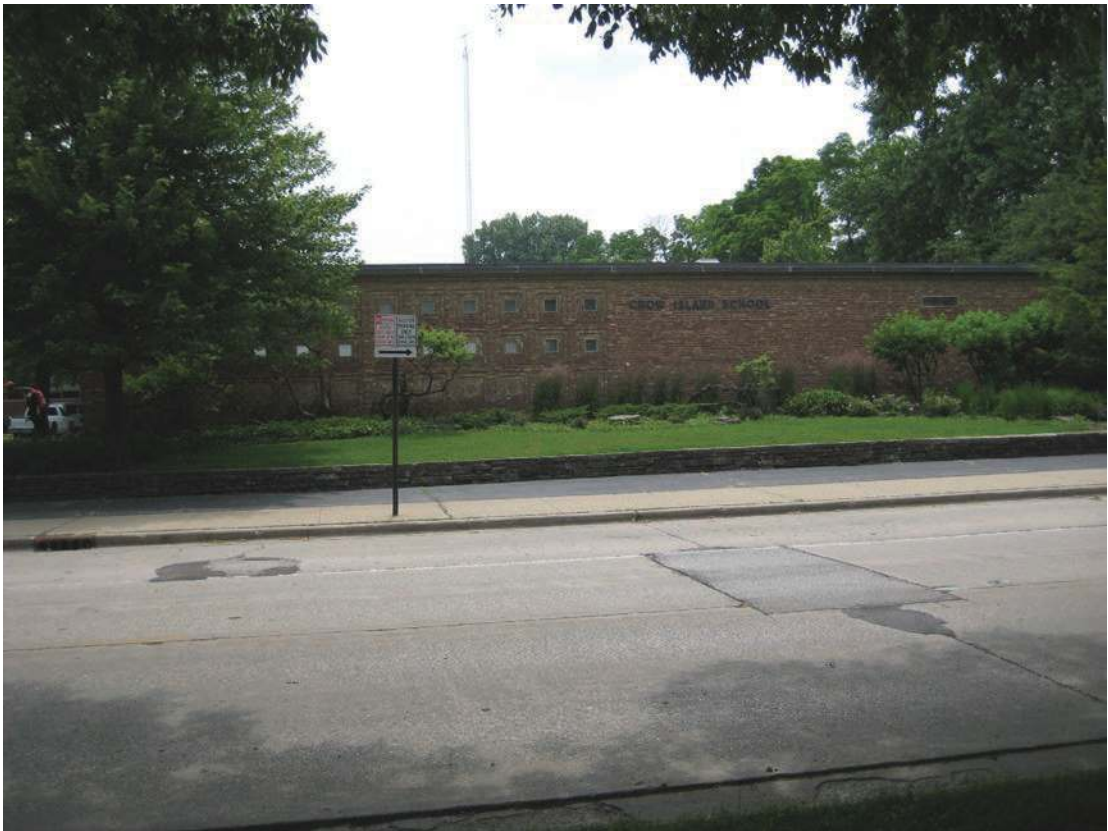
Main entrance, clock tower, central core

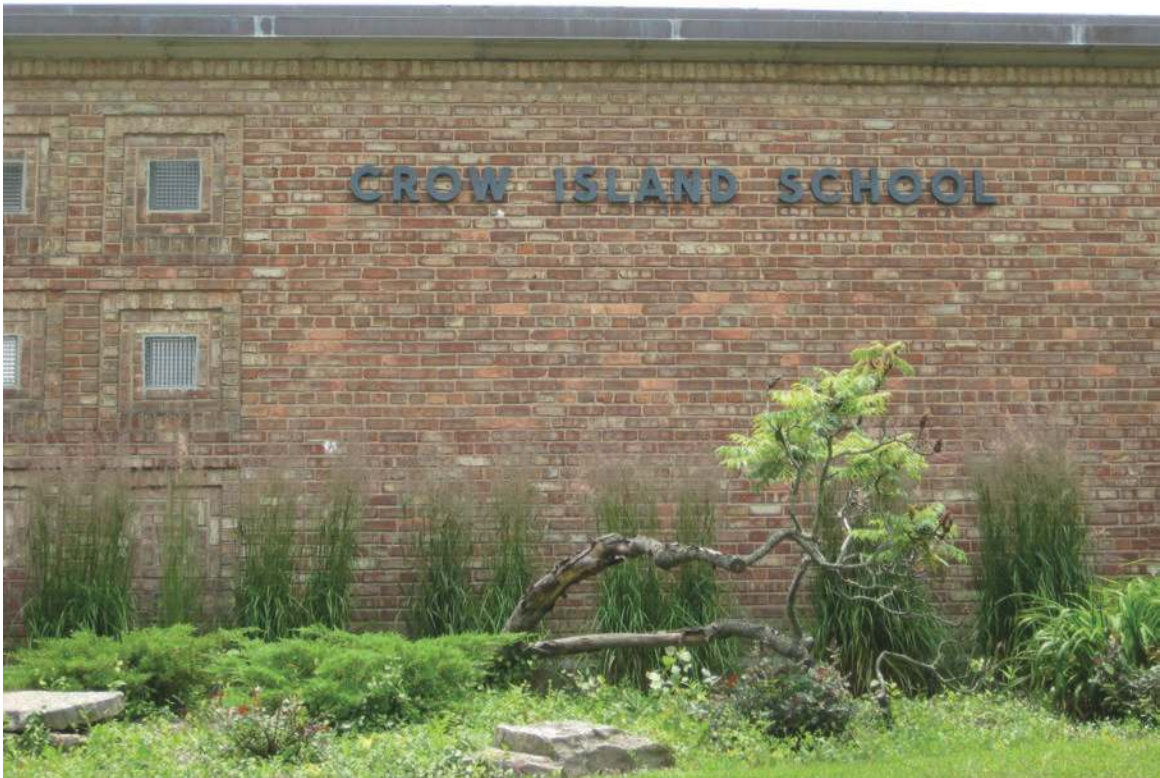
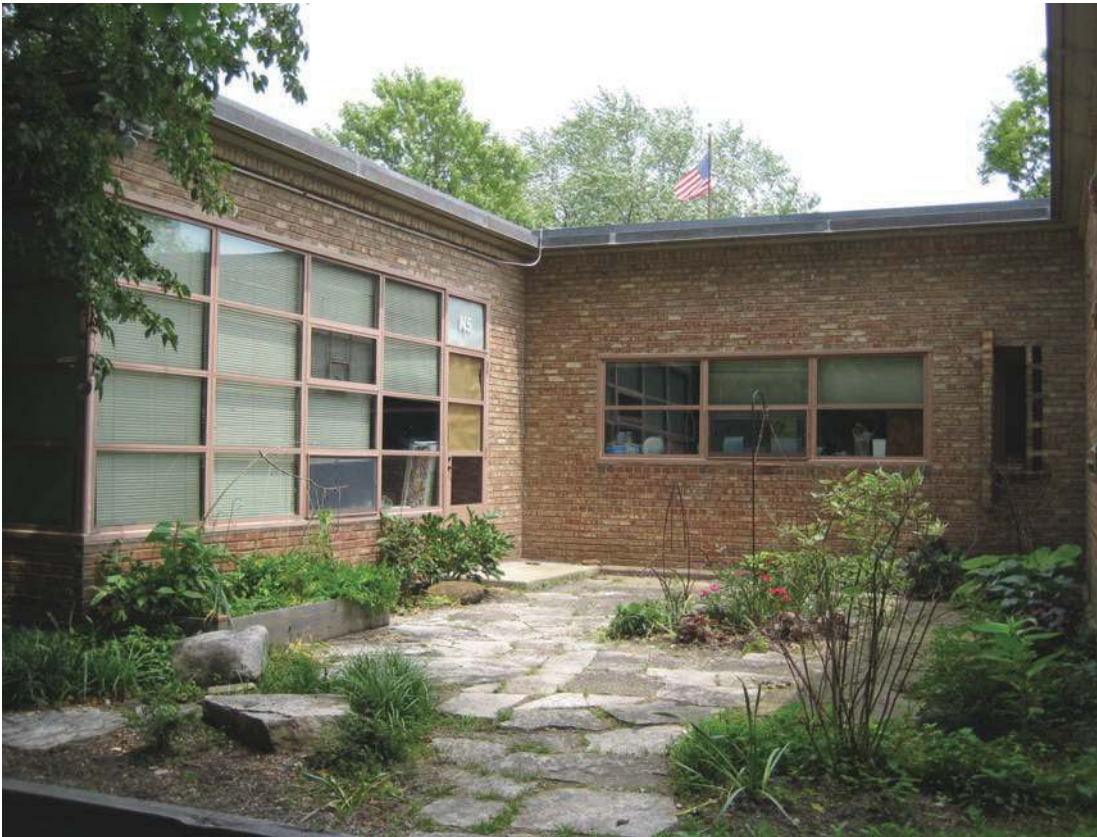
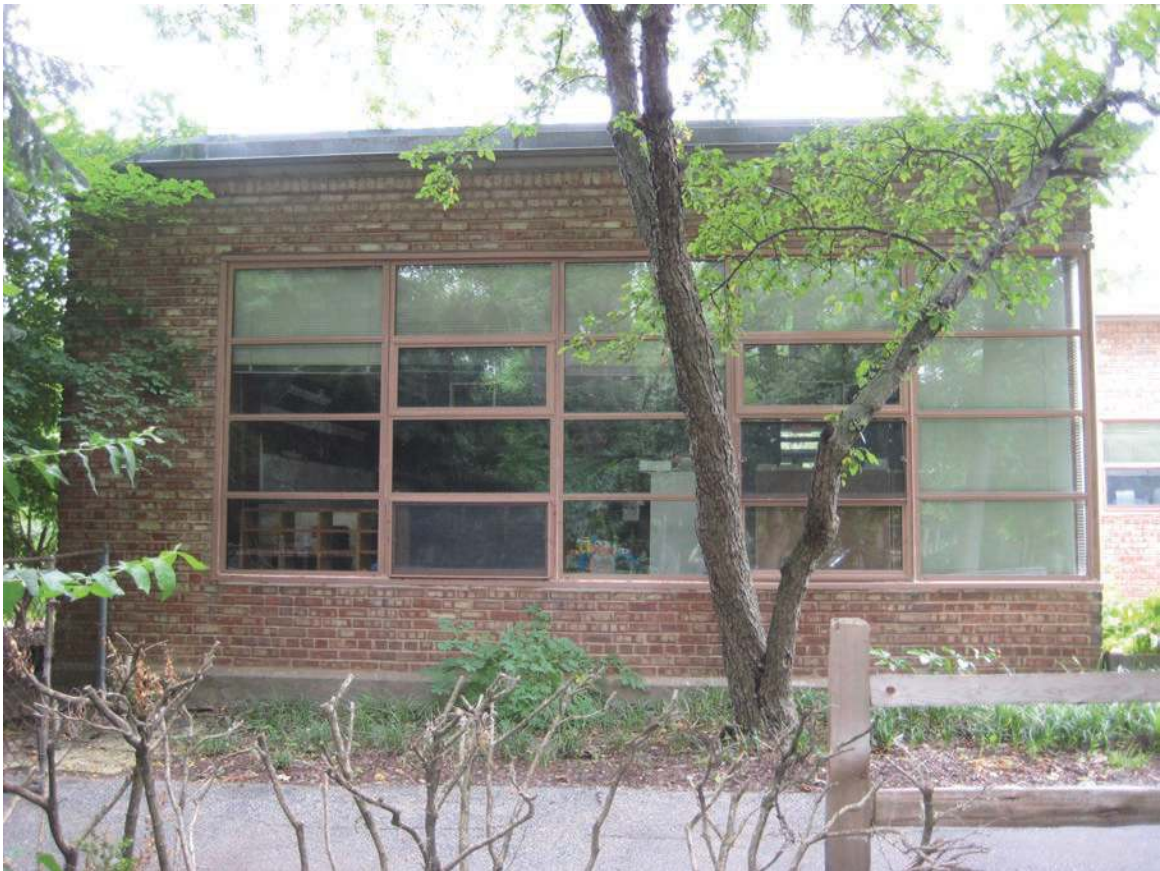
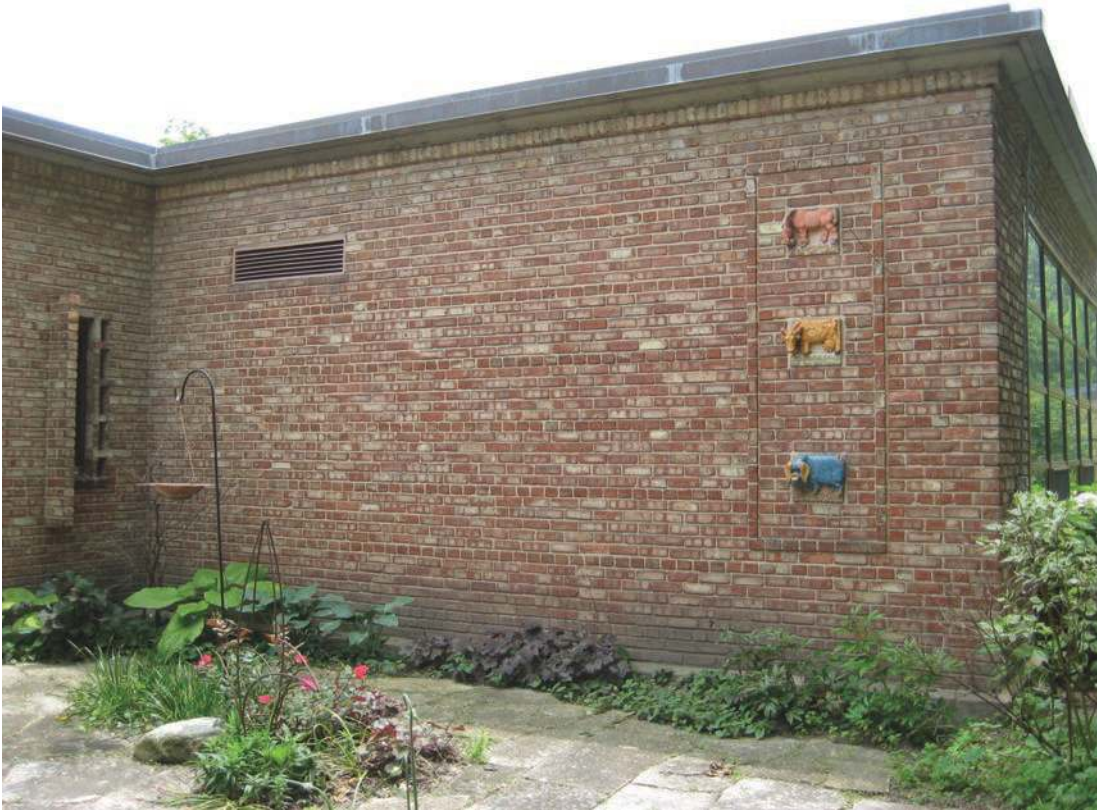
Northwest wing, raised play terrace

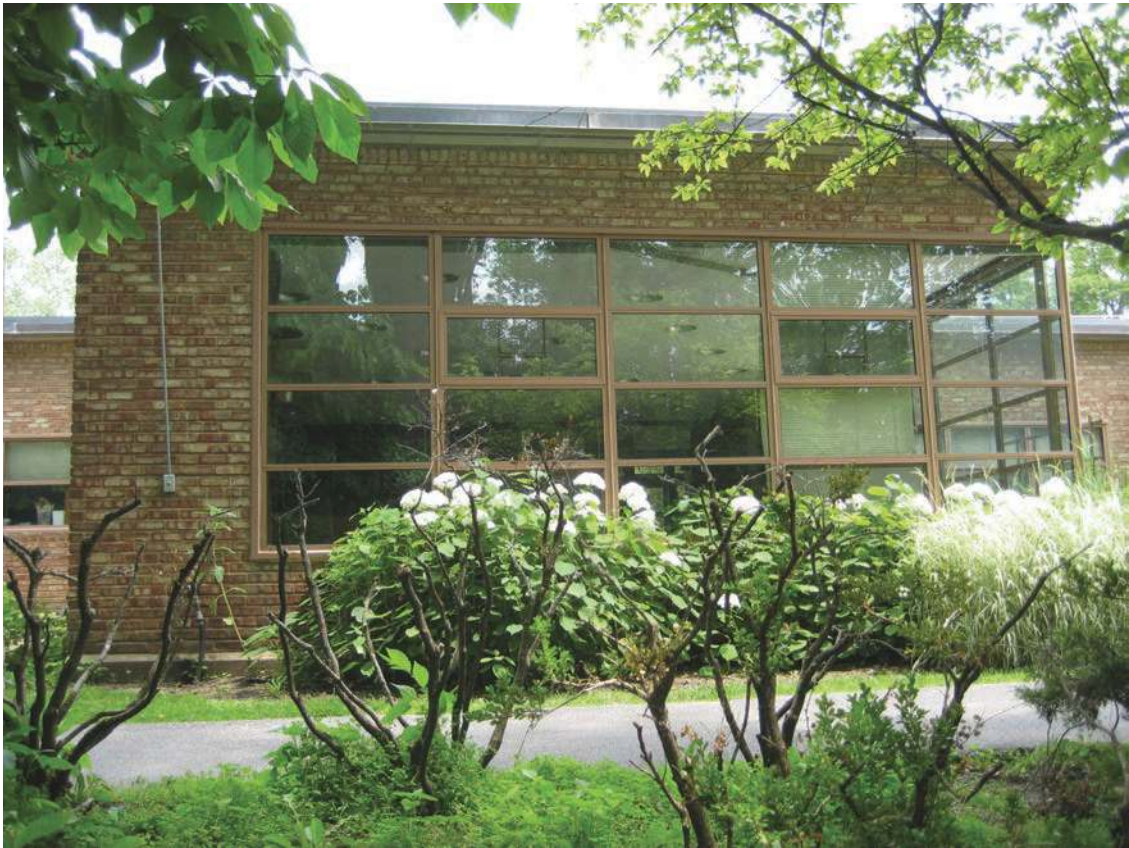
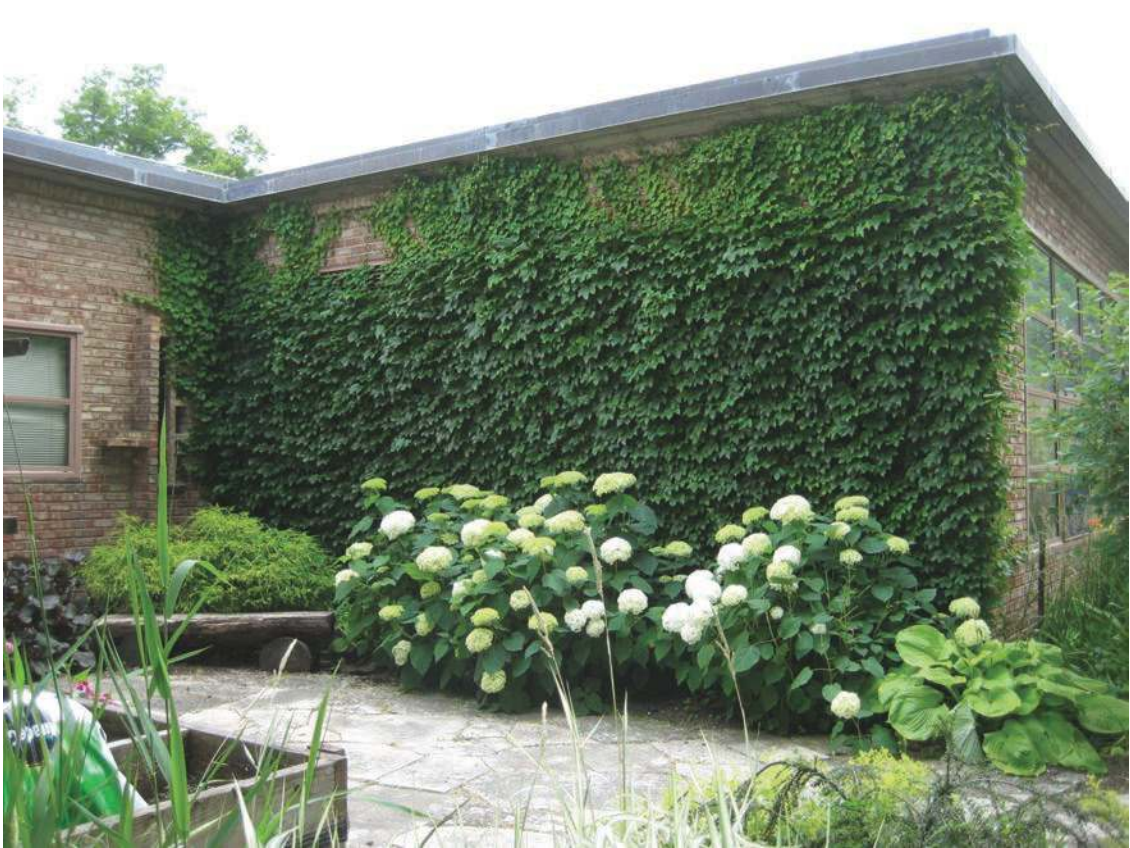
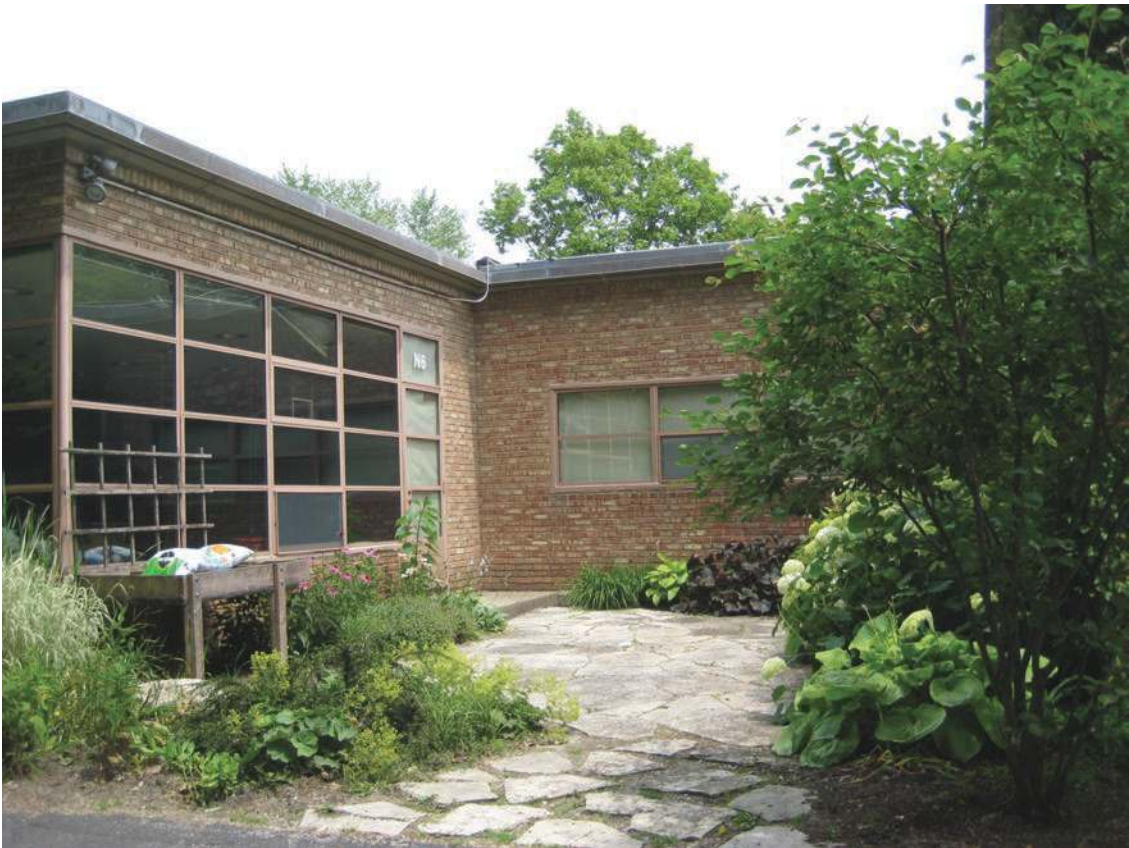
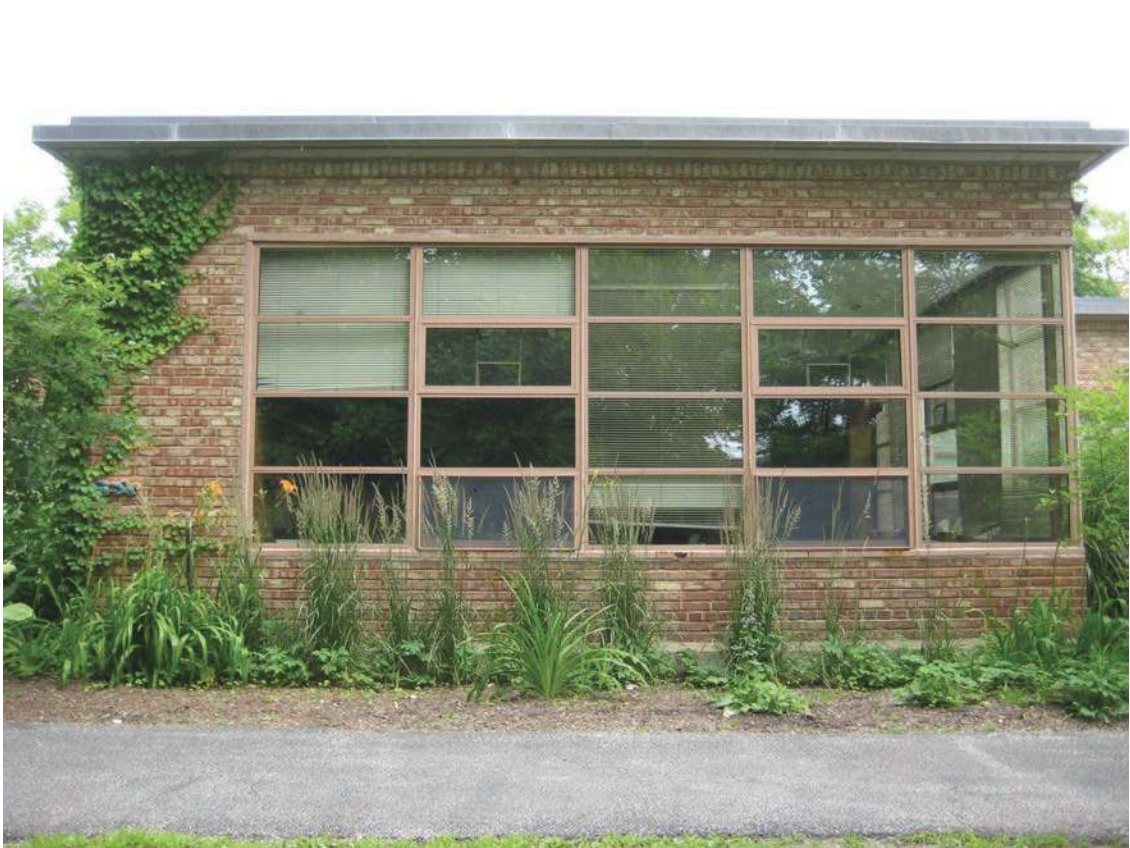
Northwest wing

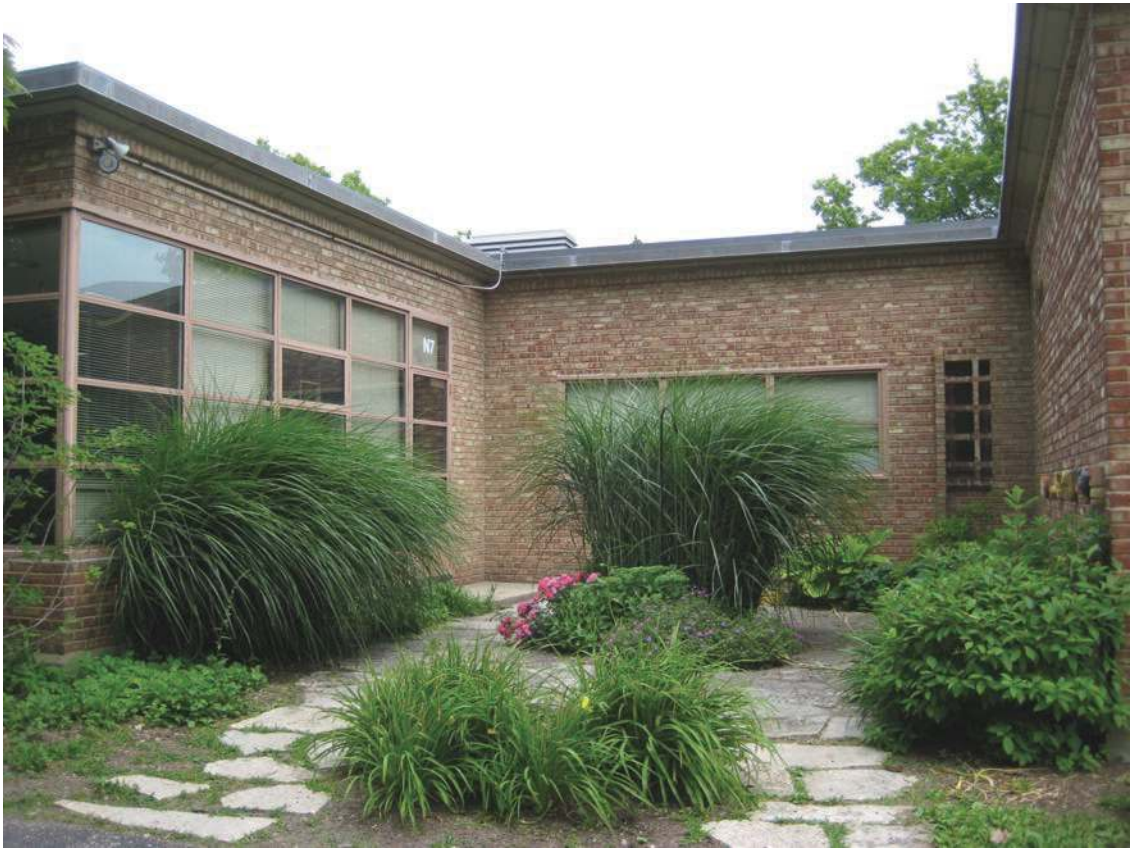
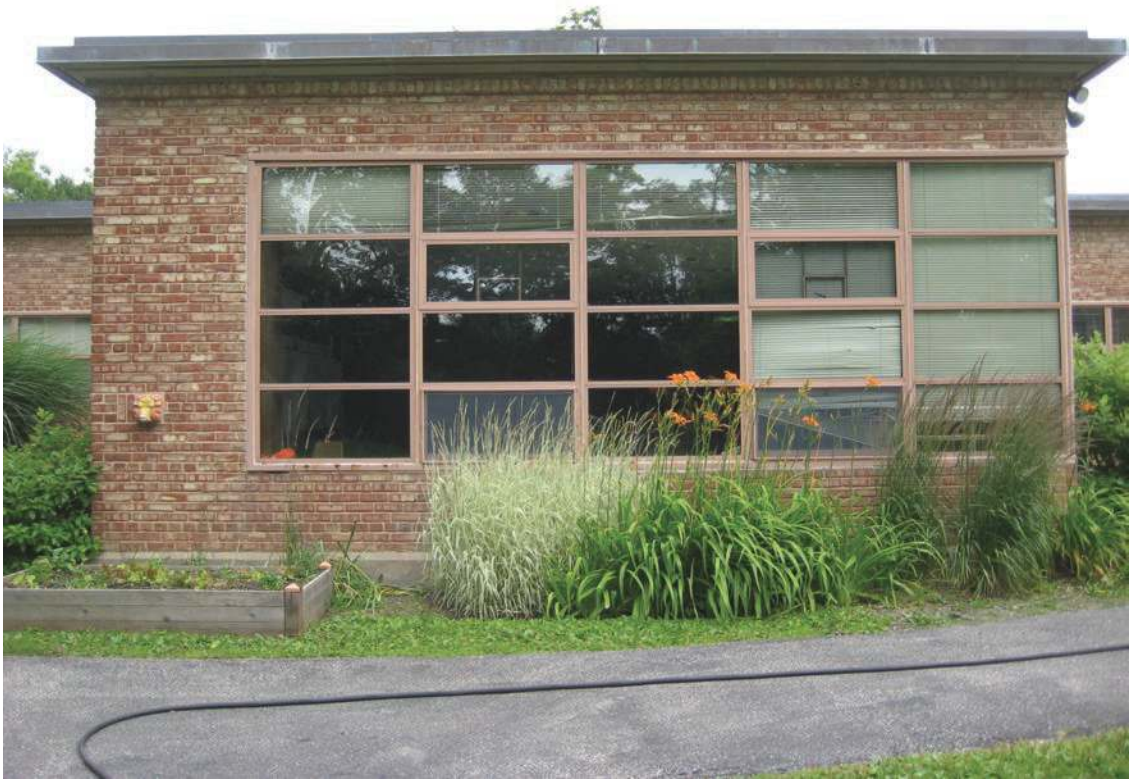
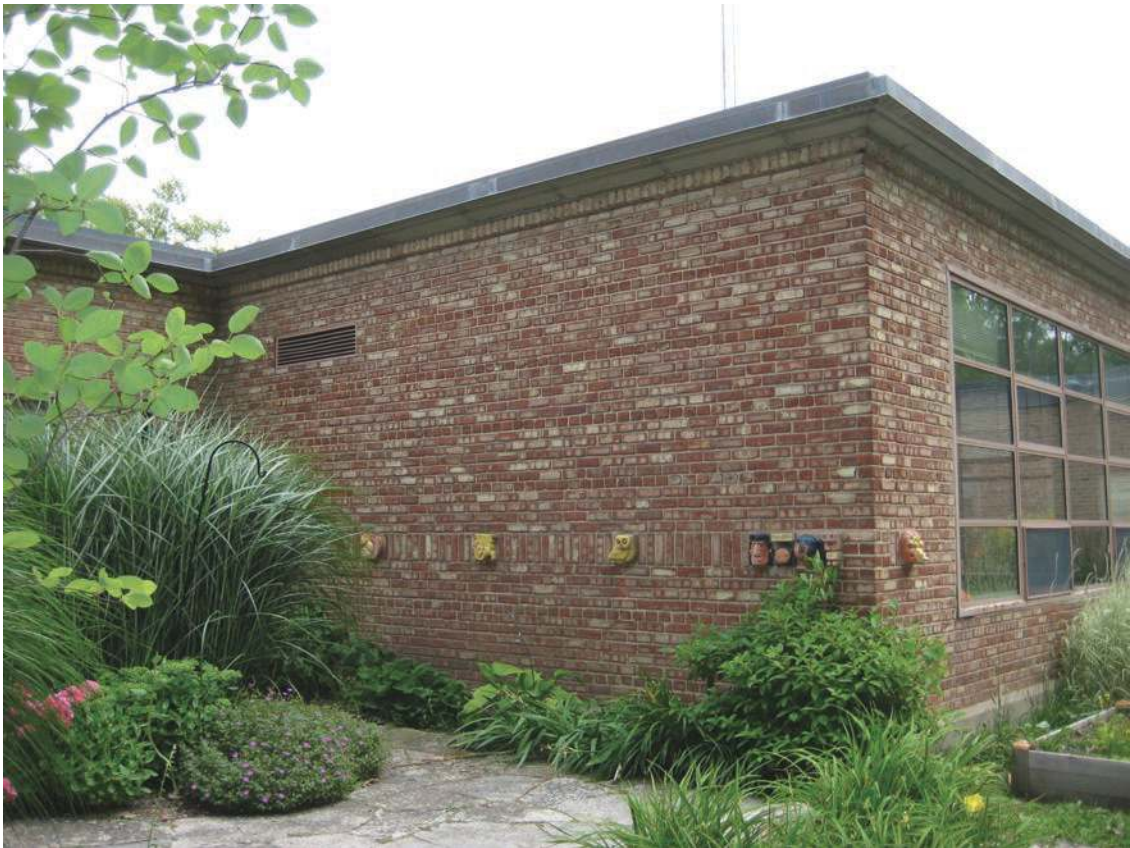
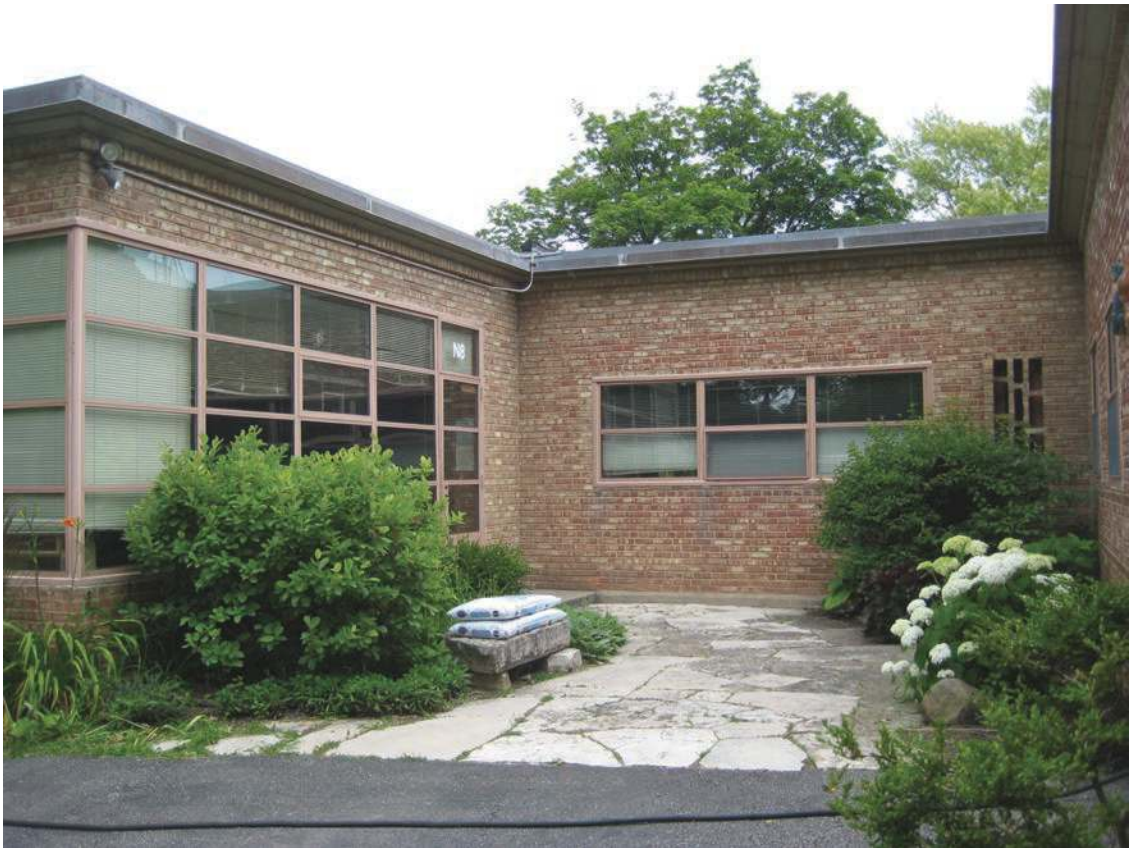
Northwest wing classroom courtyards

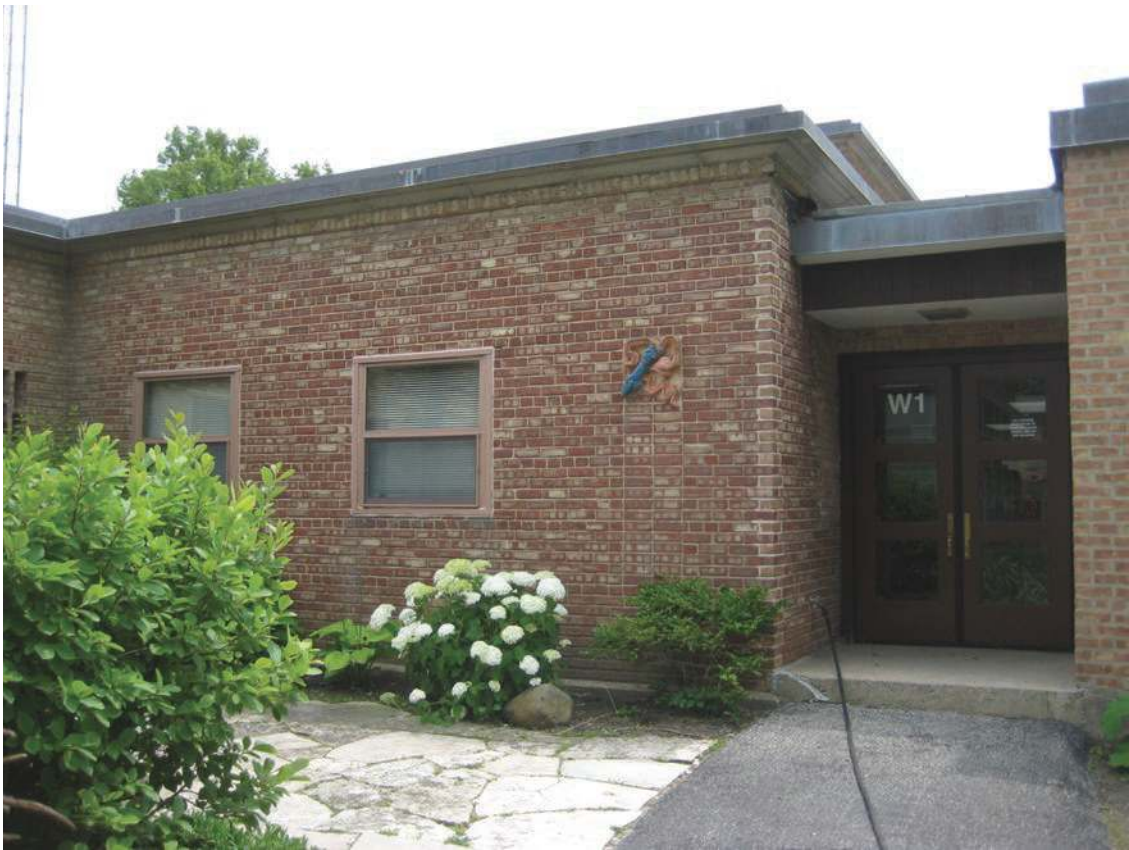
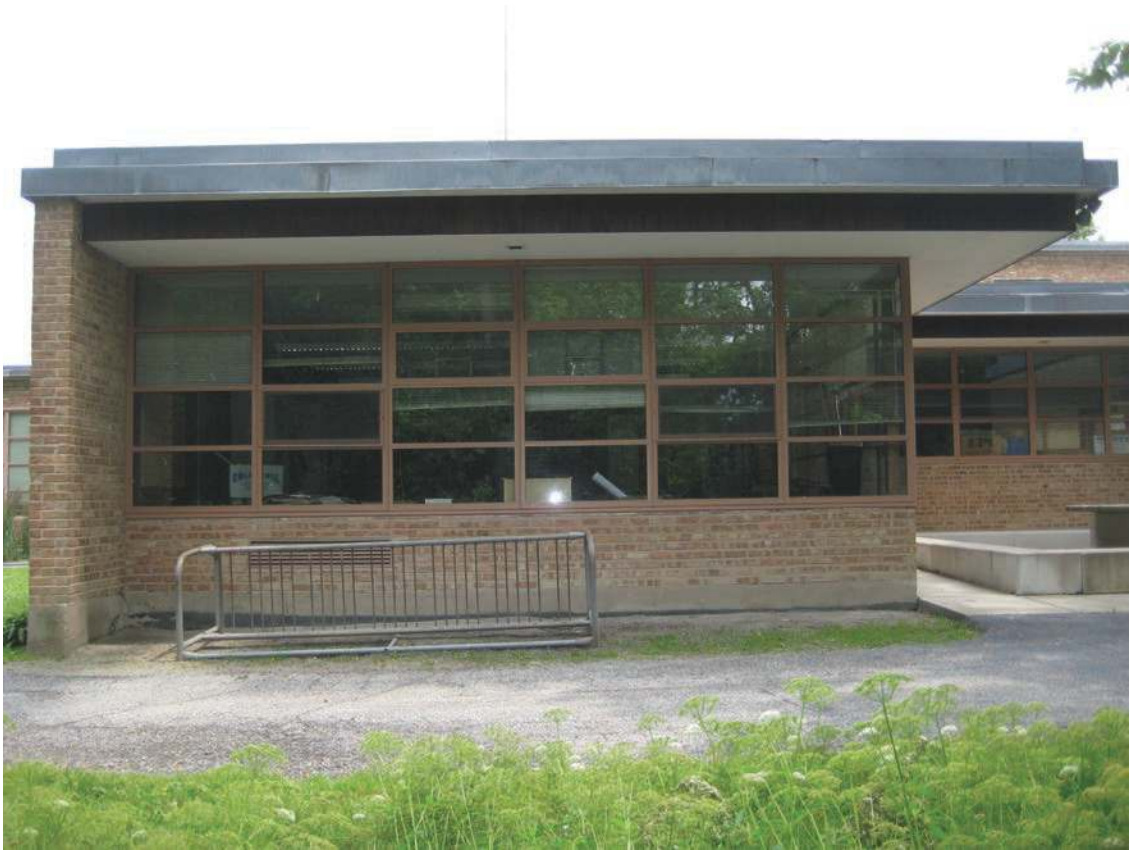
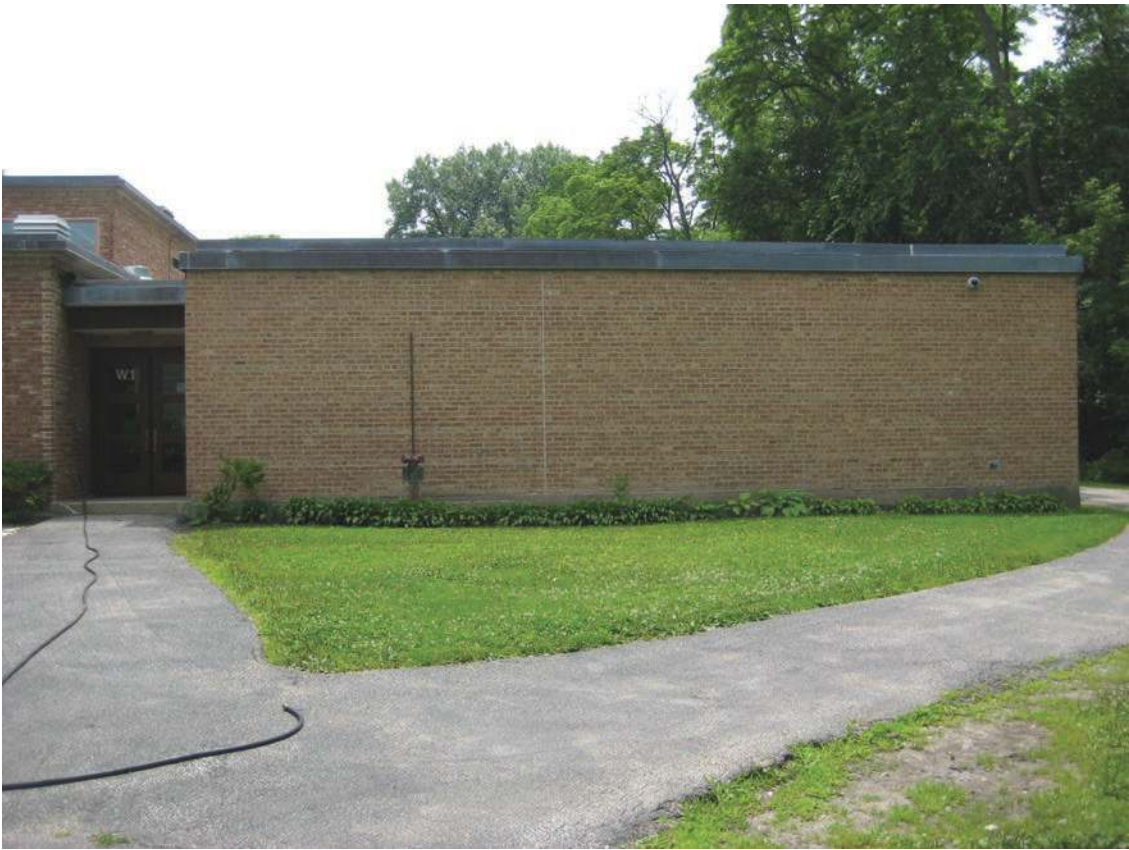
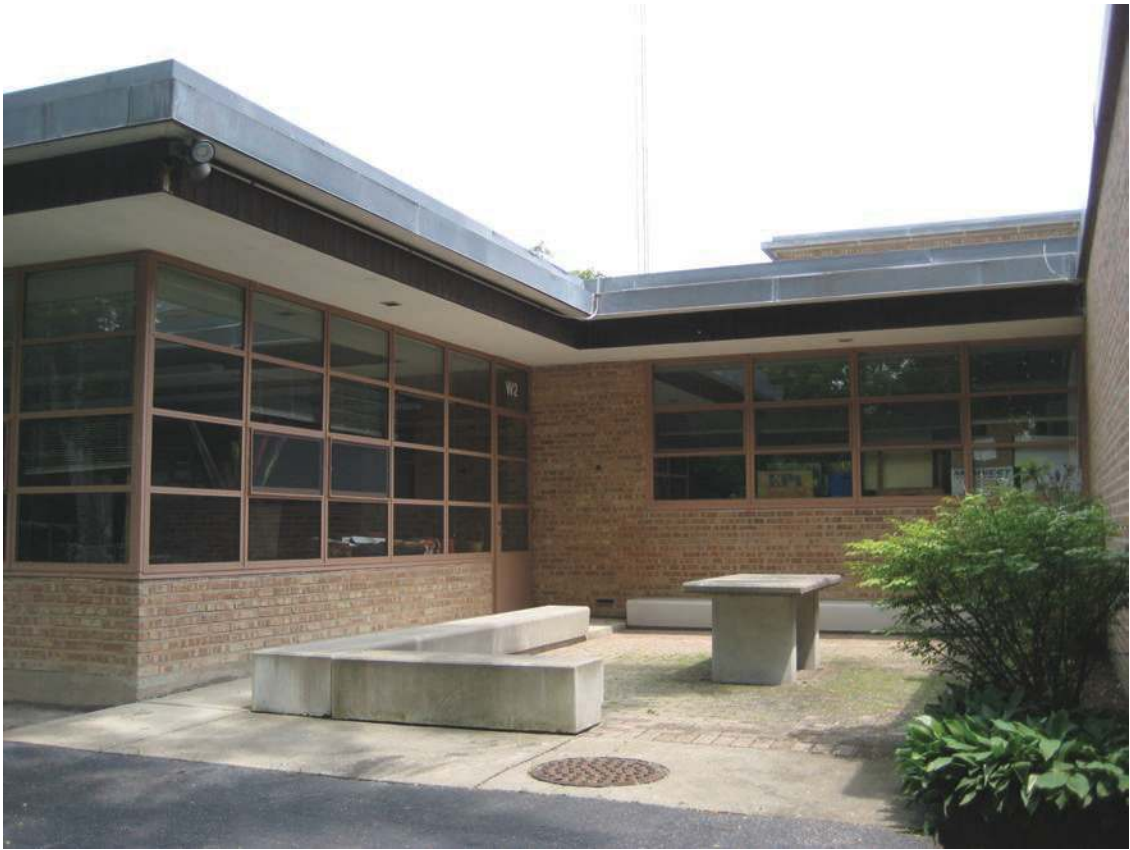
Northwest wing classroom courtyards
