HISTORIC STRUCTURE REPORT

CROW ISLAND SCHOOL

WINNETKA,
ILLINOIS

2017

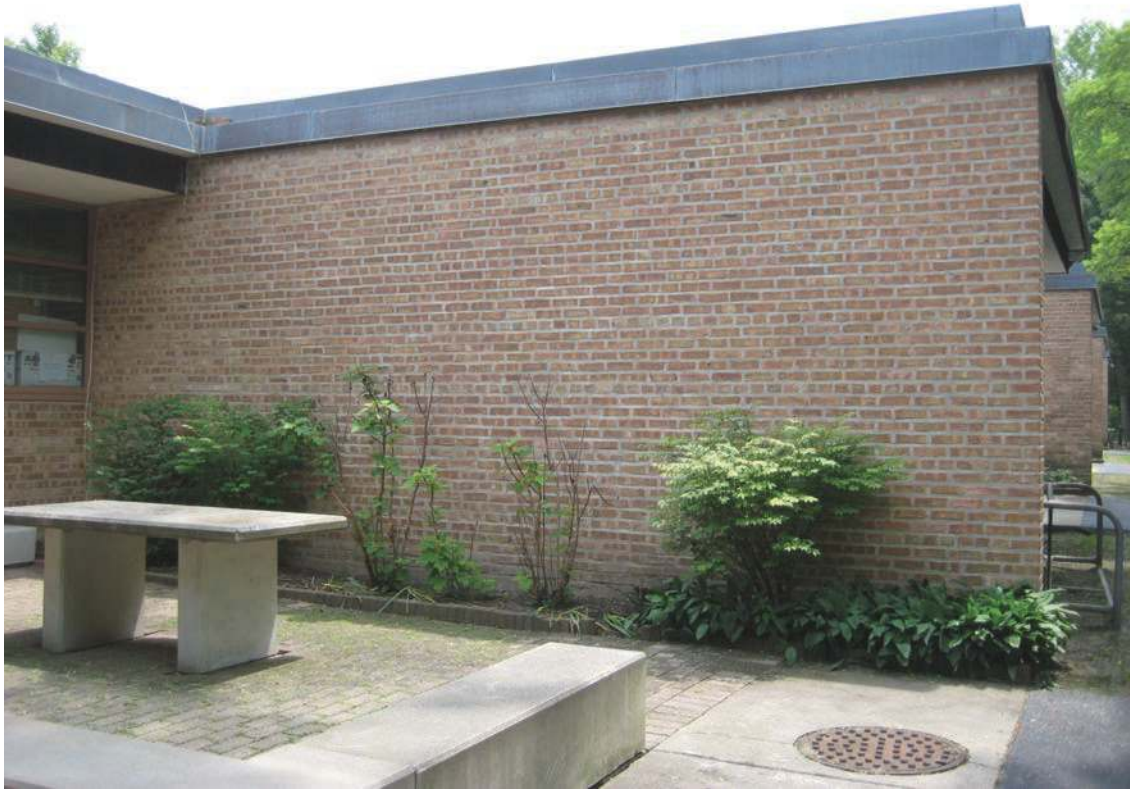
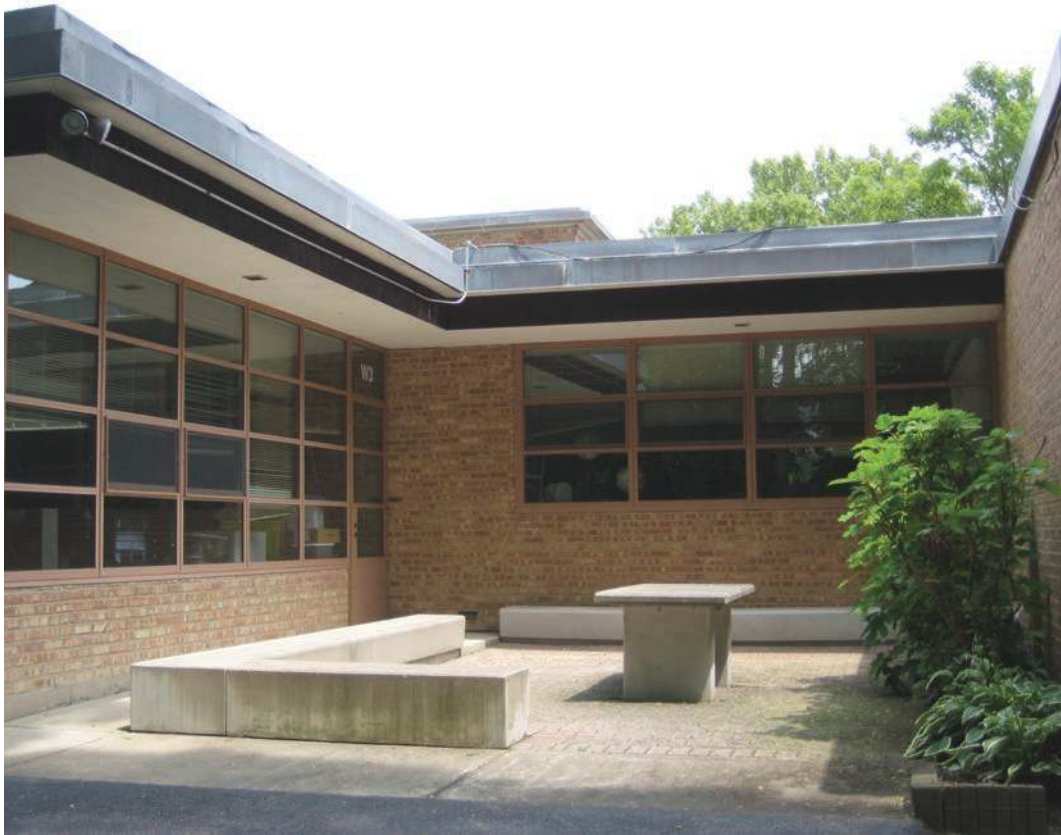
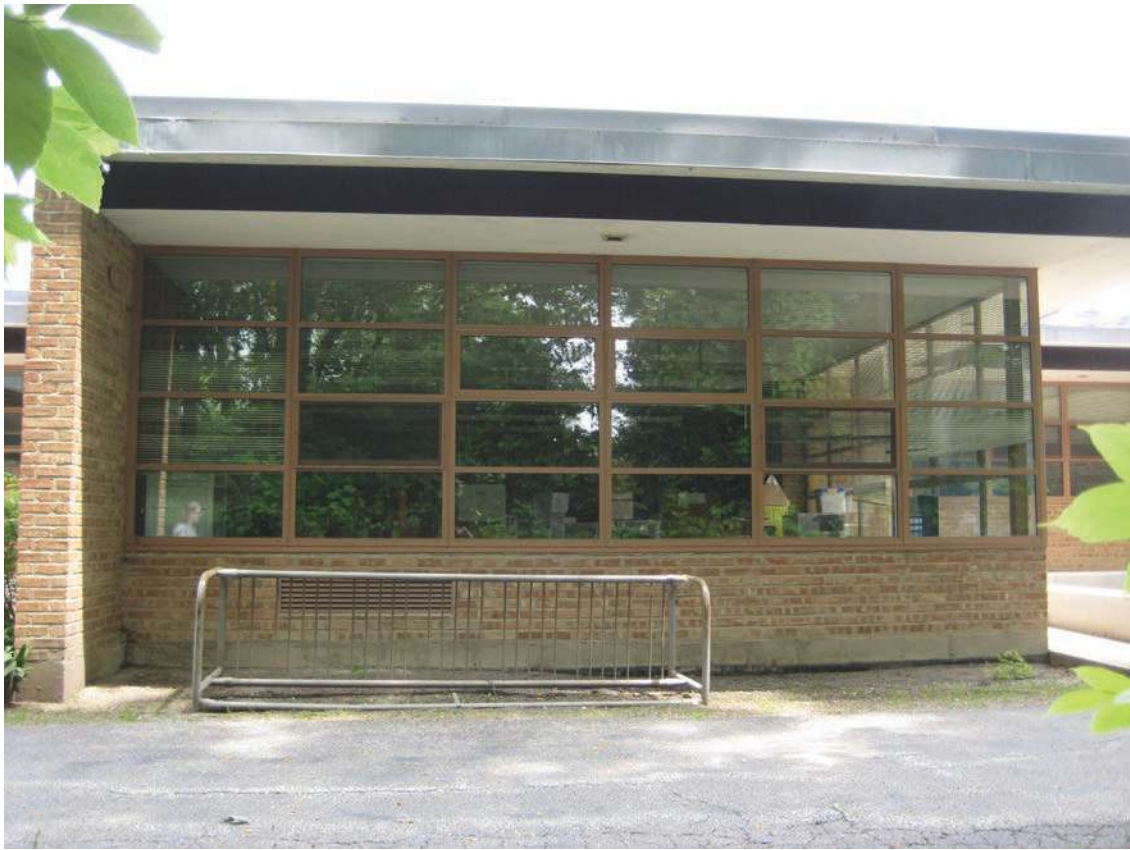
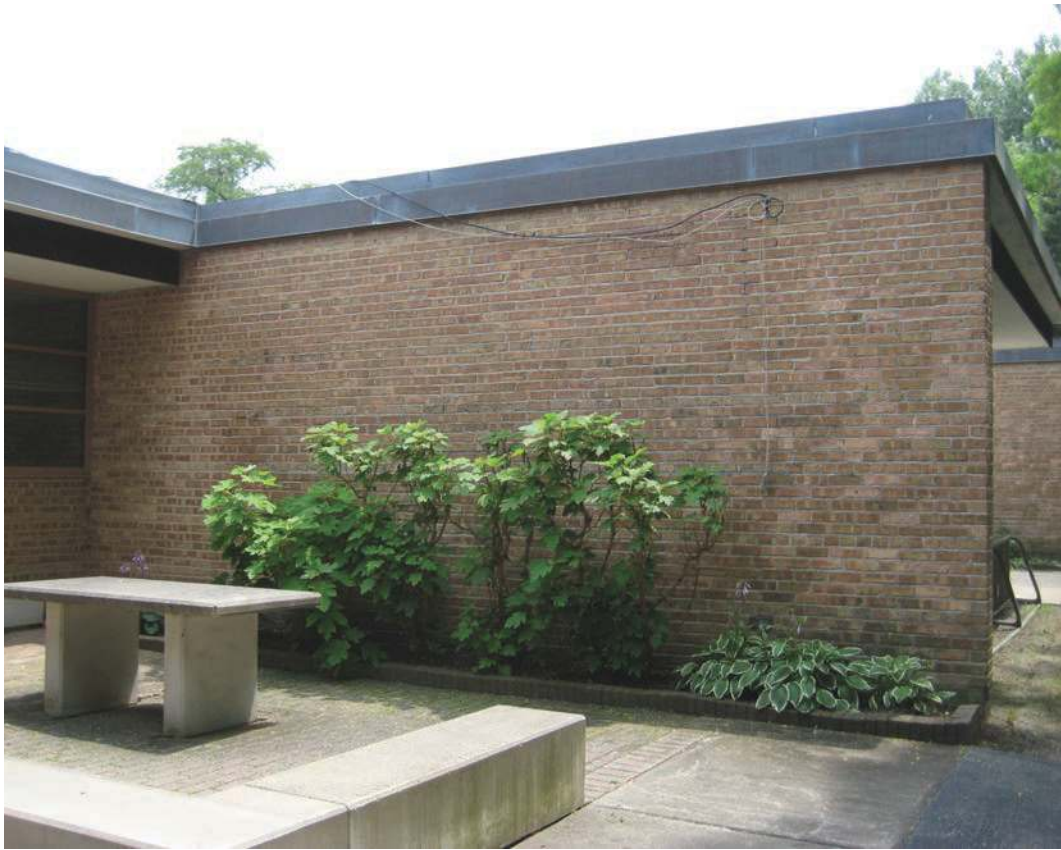
1940 wing and 1954 addition connection

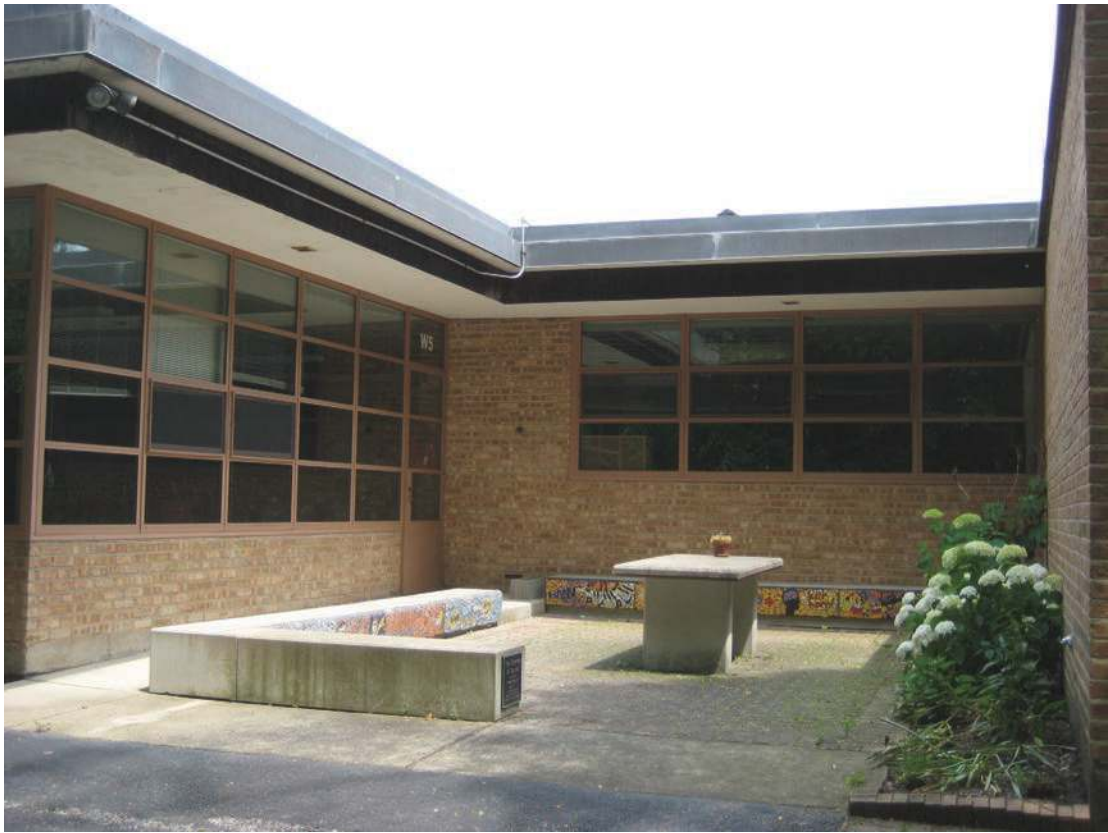
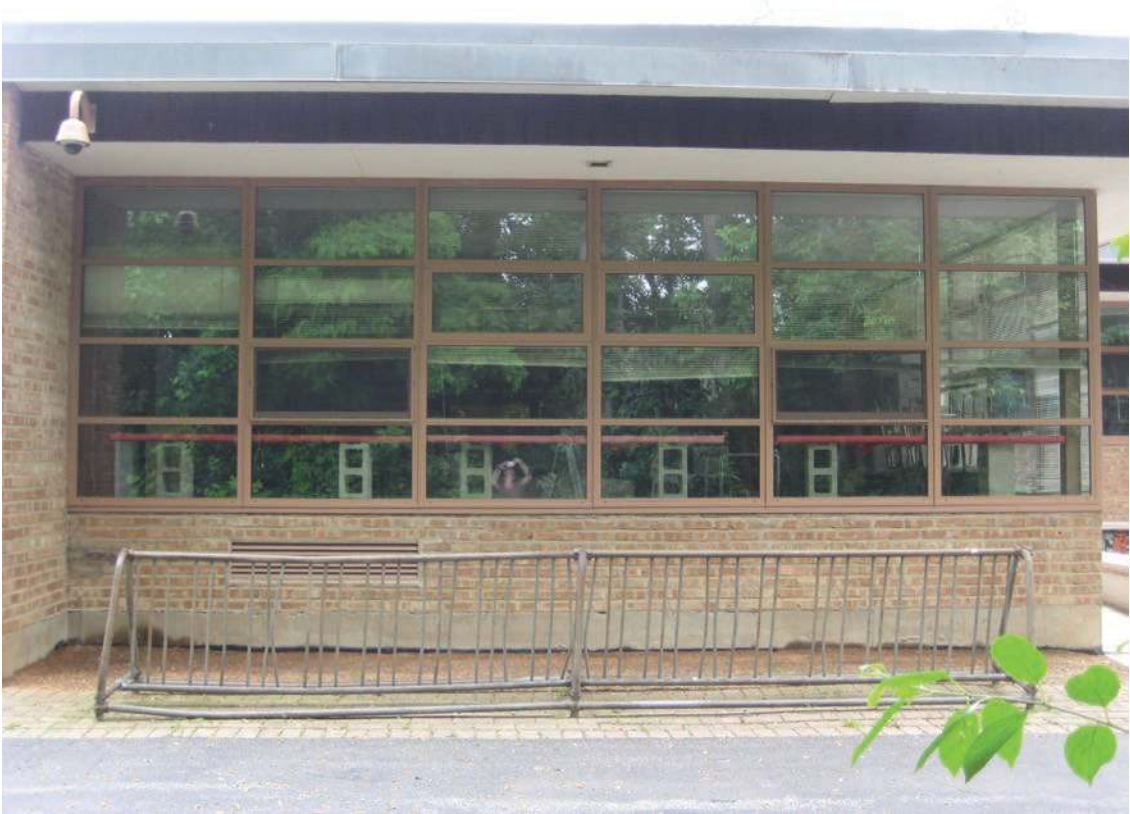
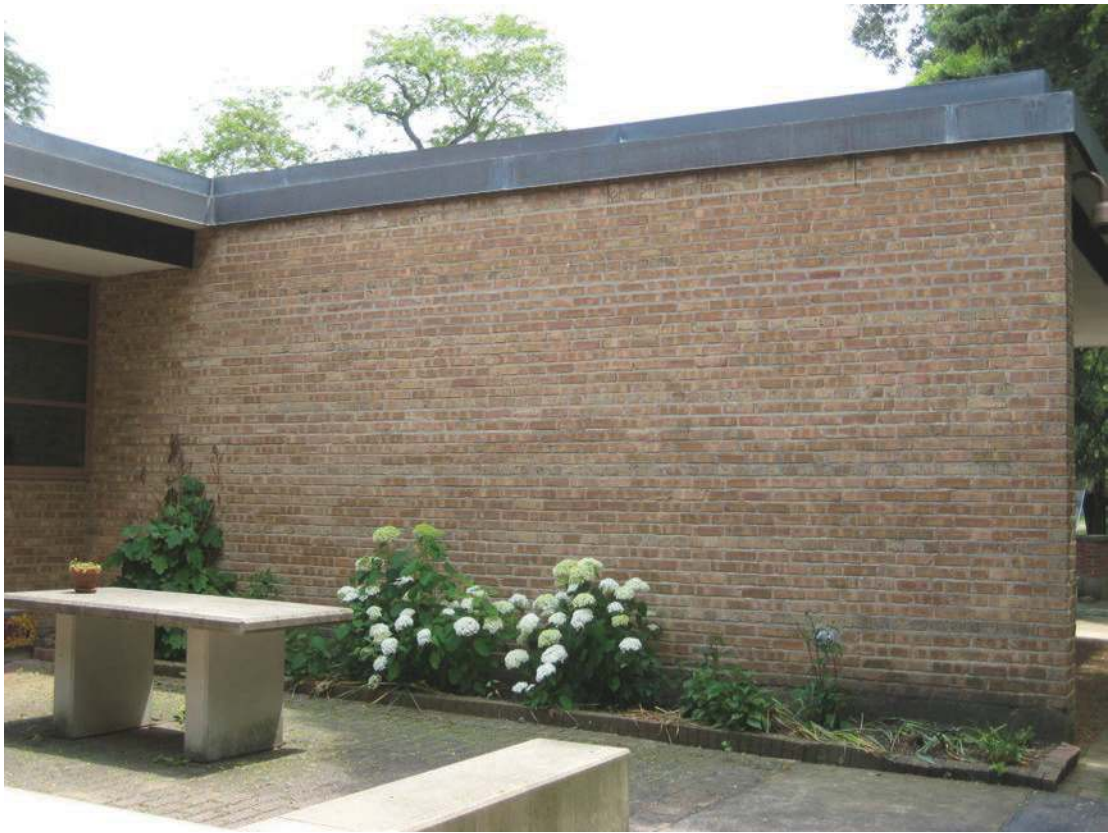
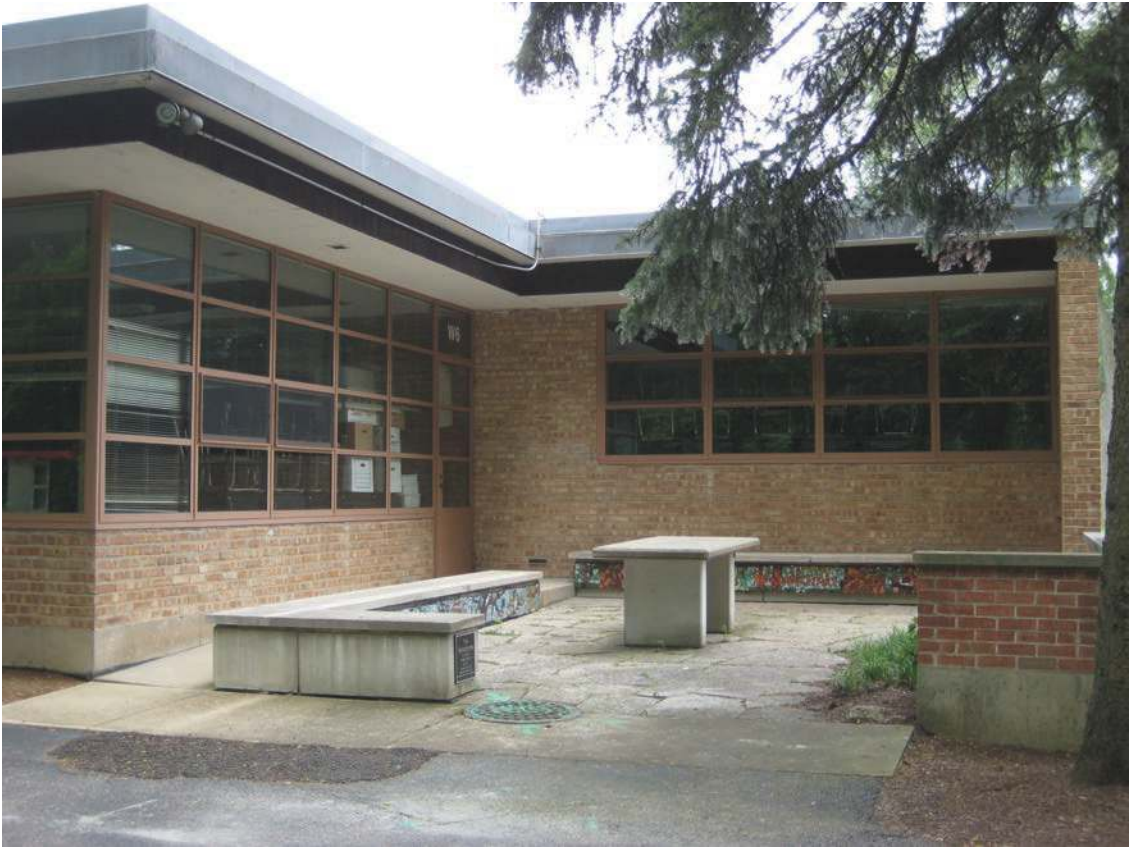
1954 addition, classroom courtyard

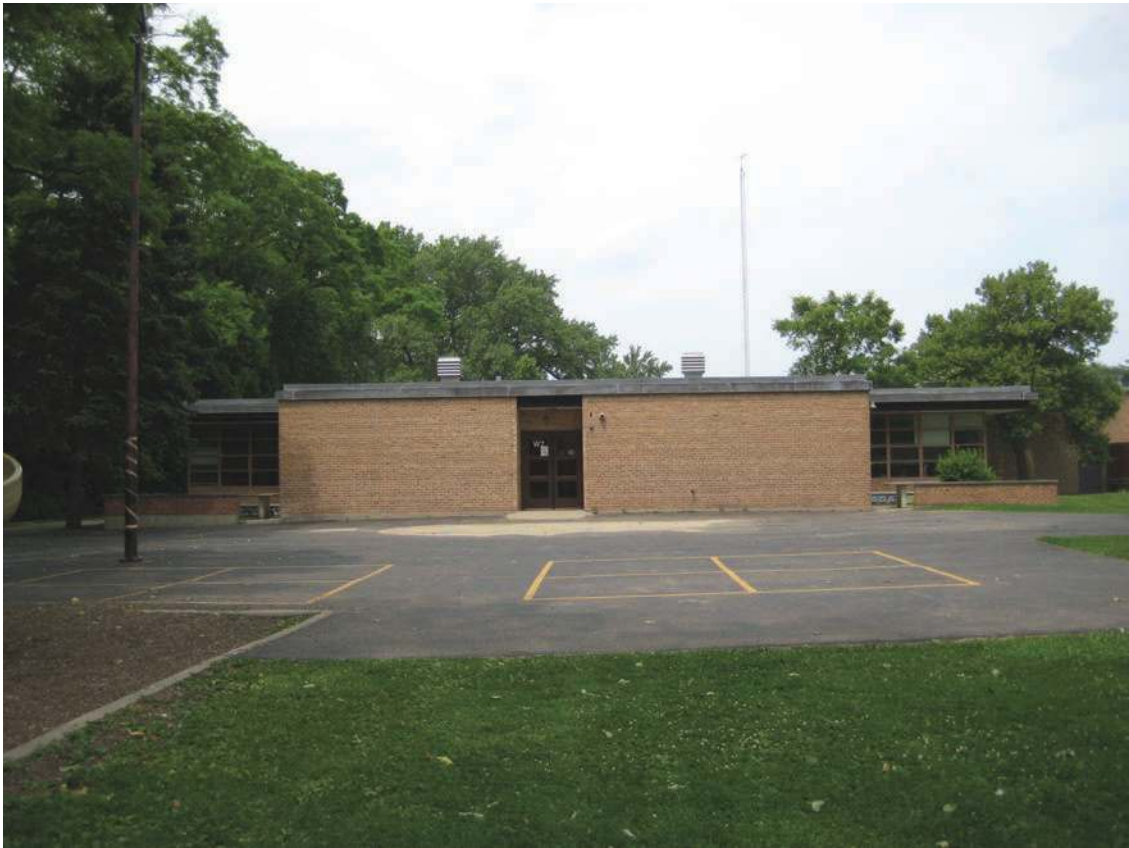
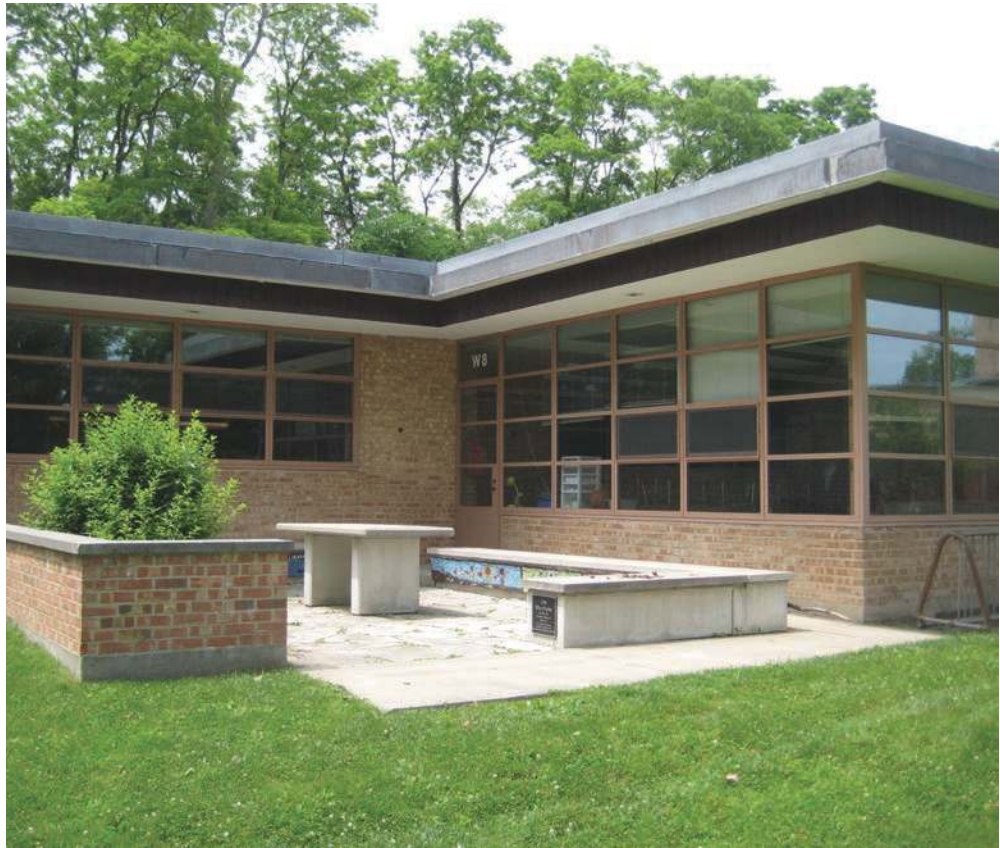
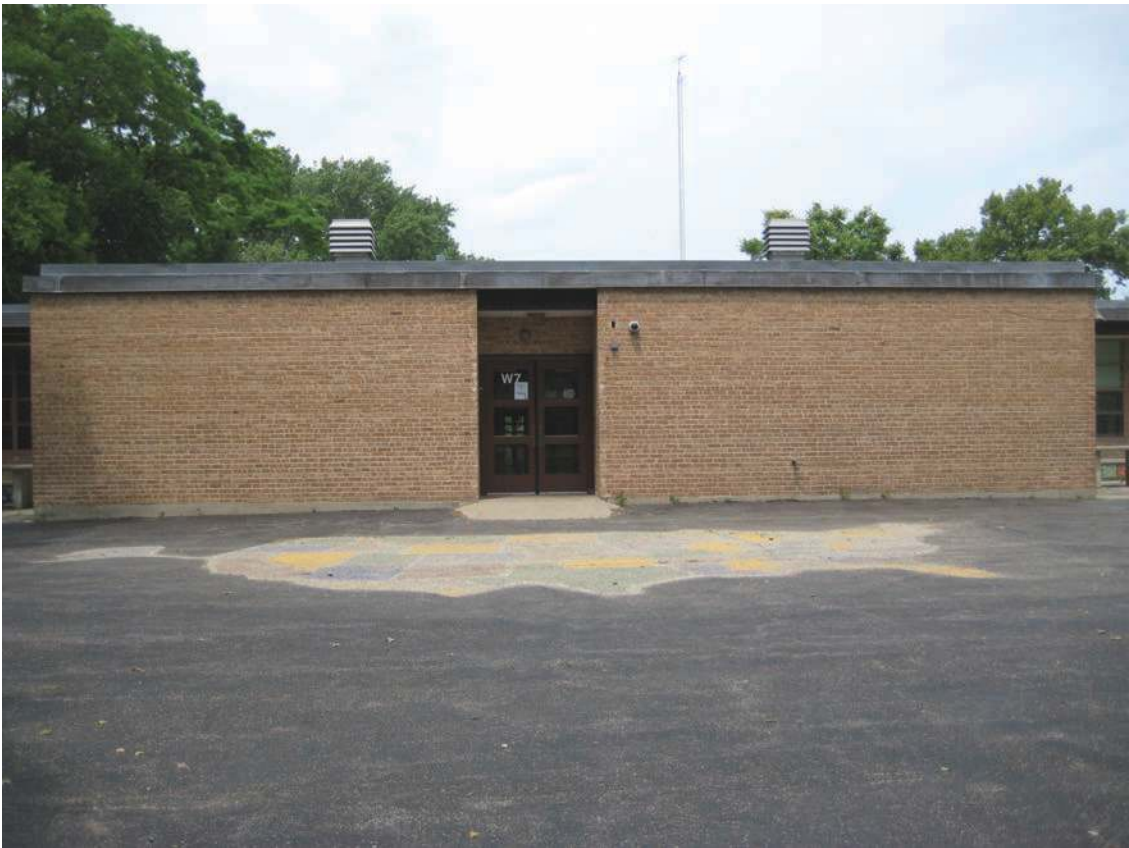
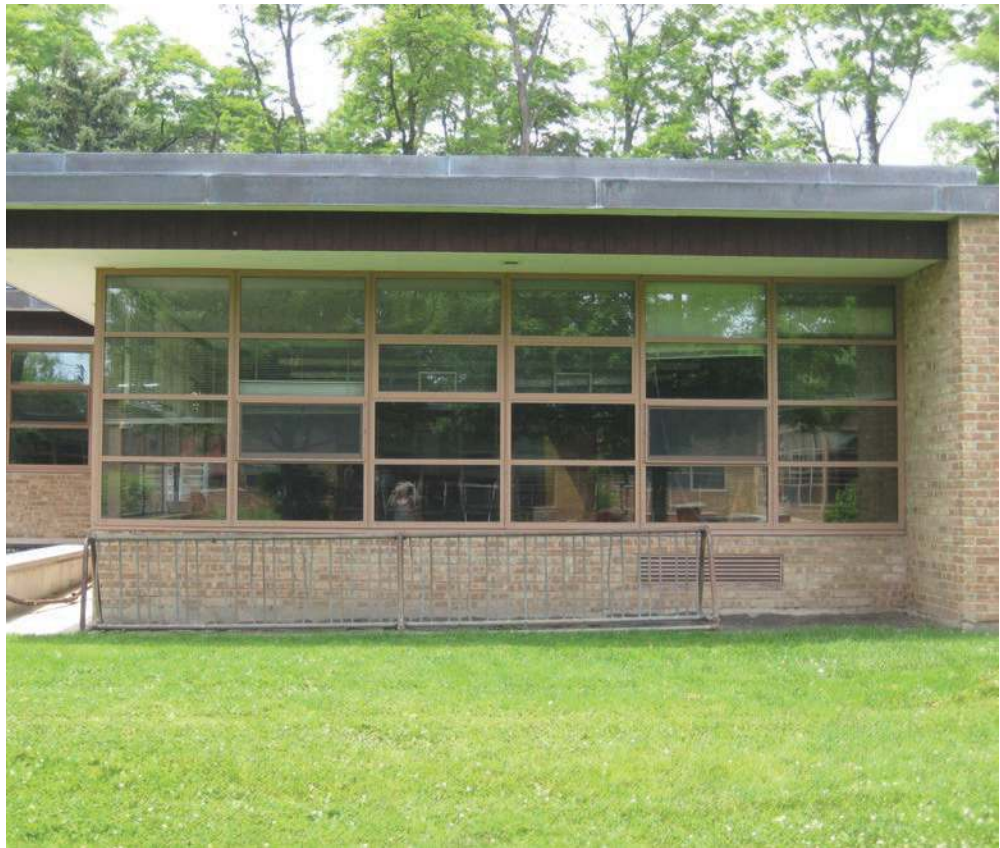
1954 addition, classroom courtyards

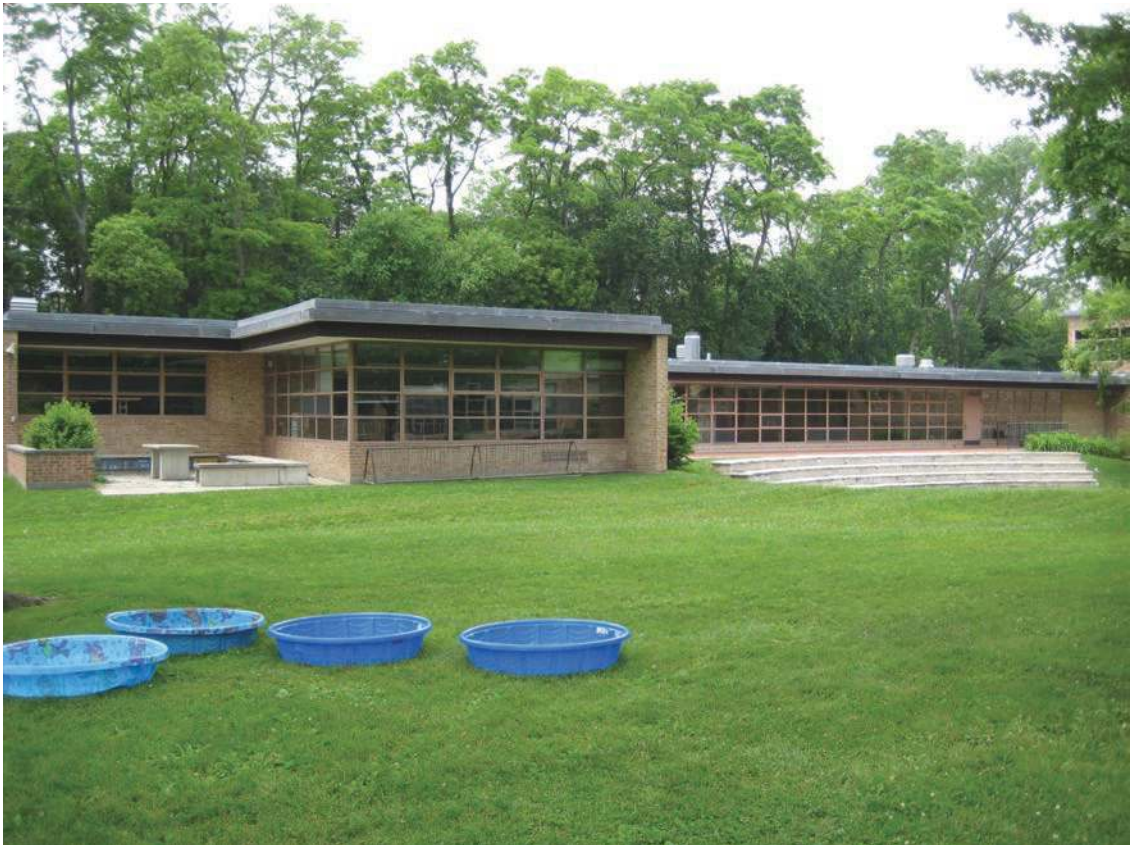
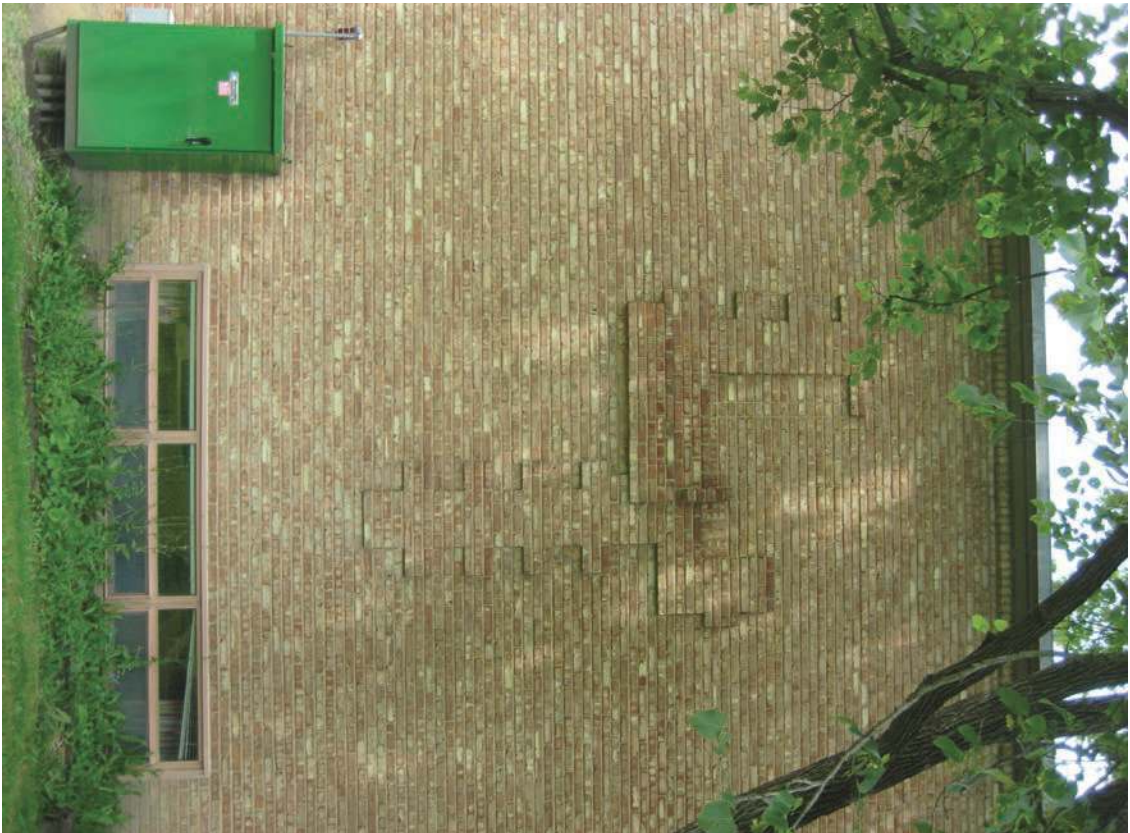
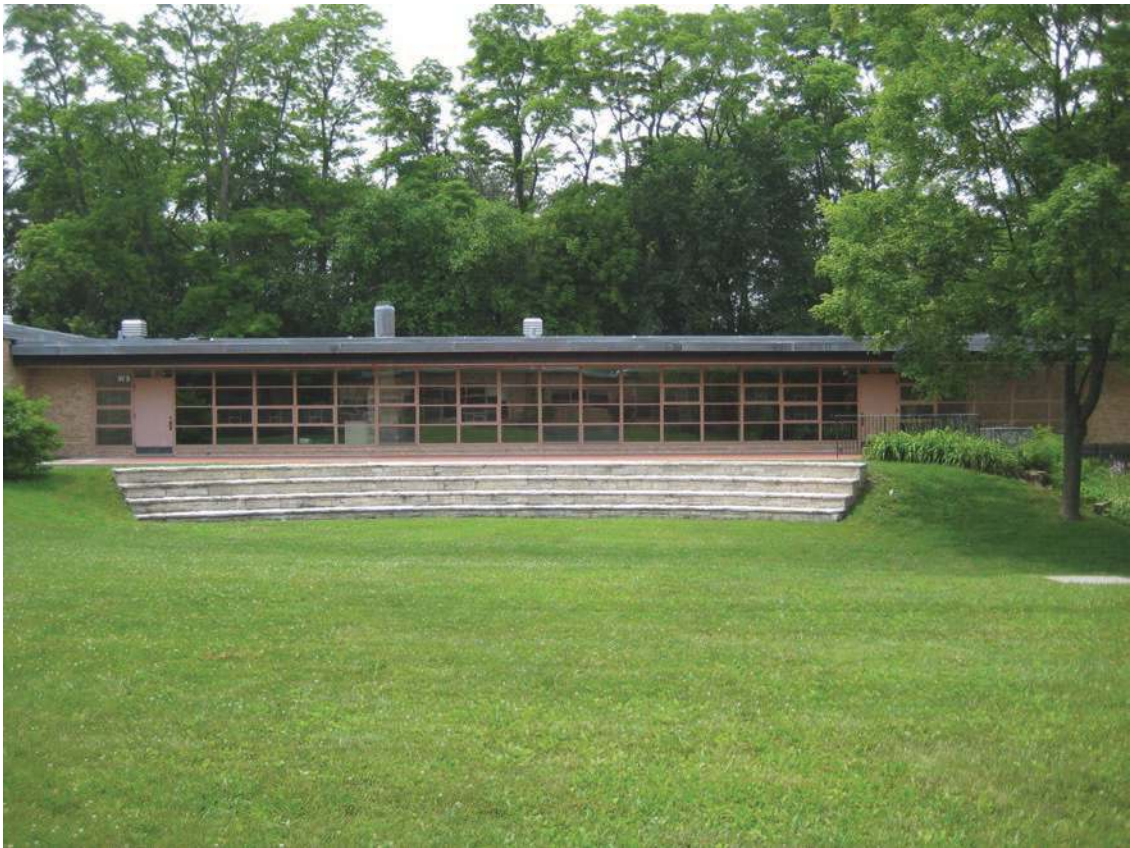
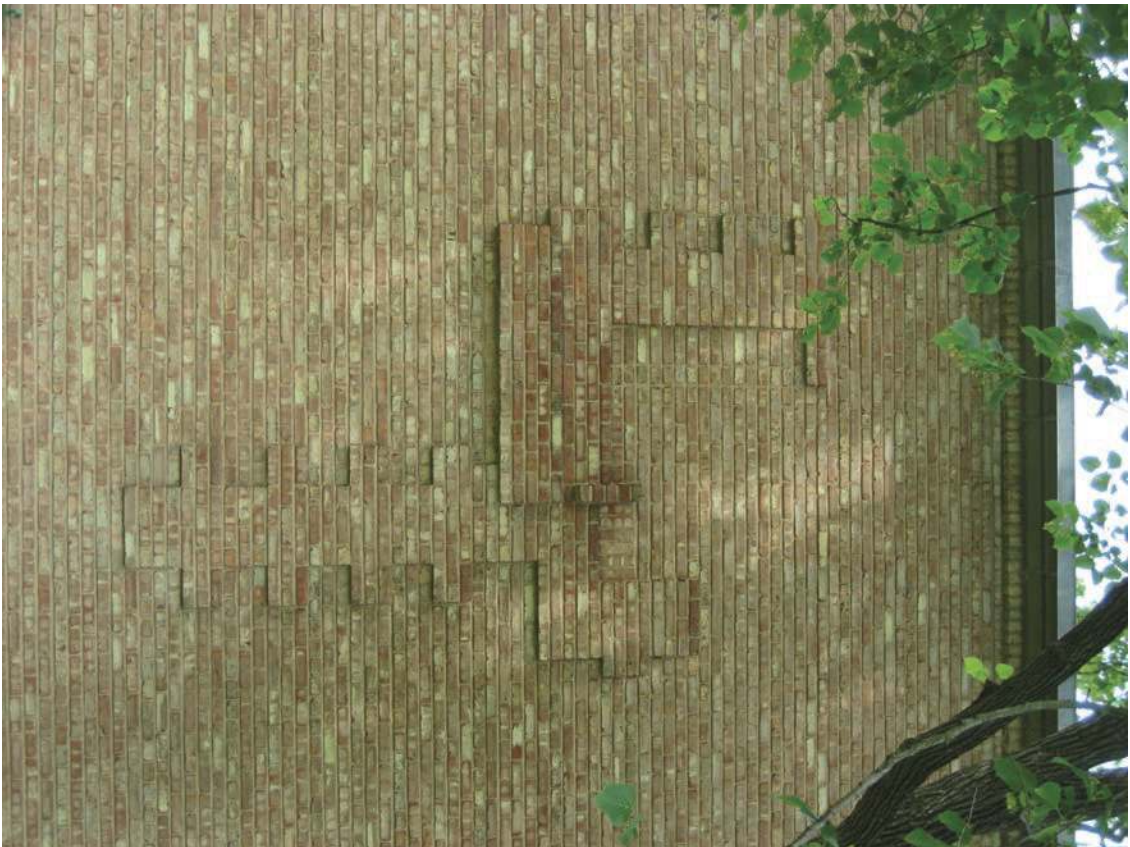
1954 addition, south façade and classroom courtyard

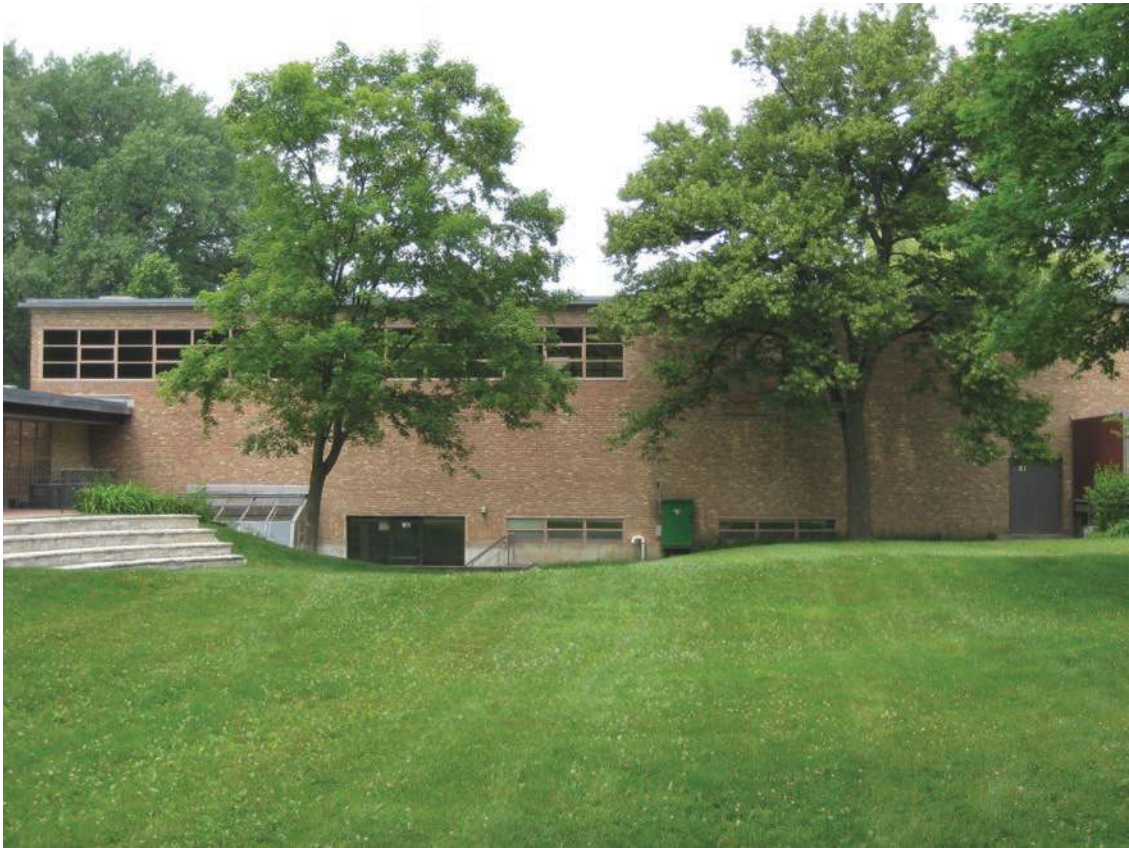
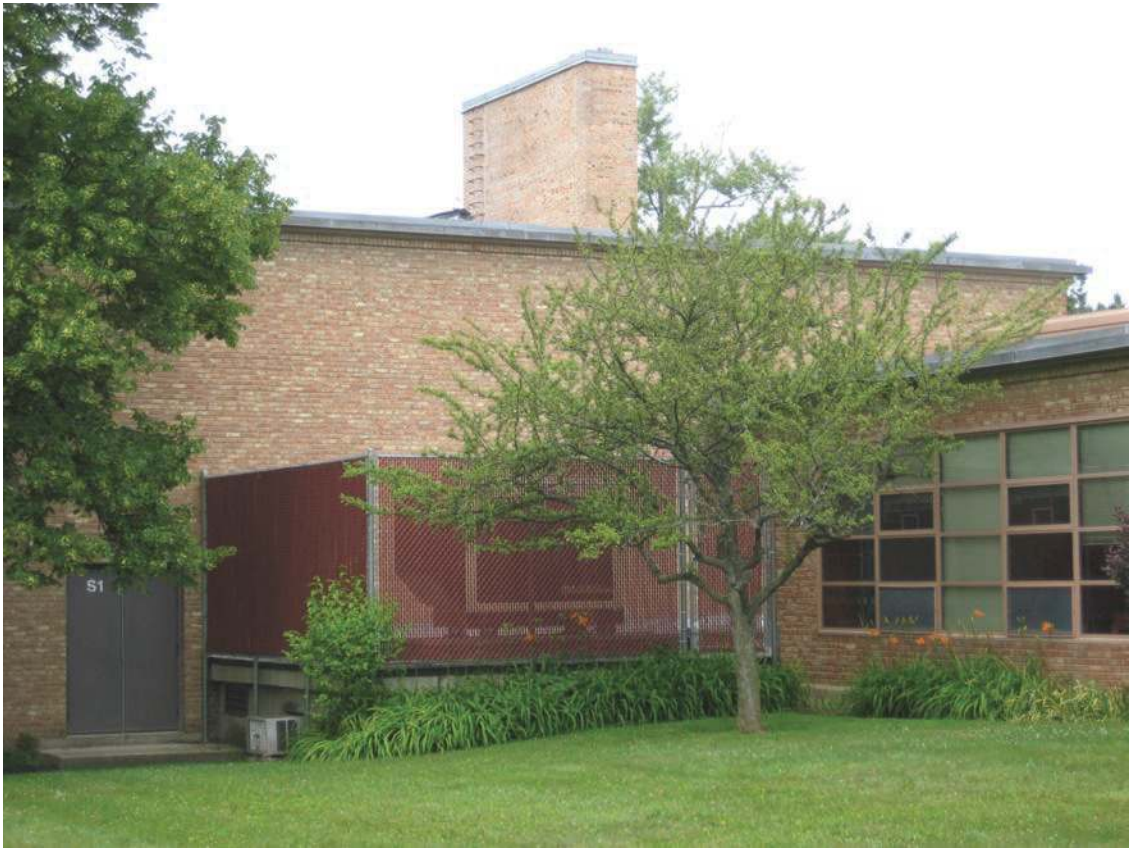
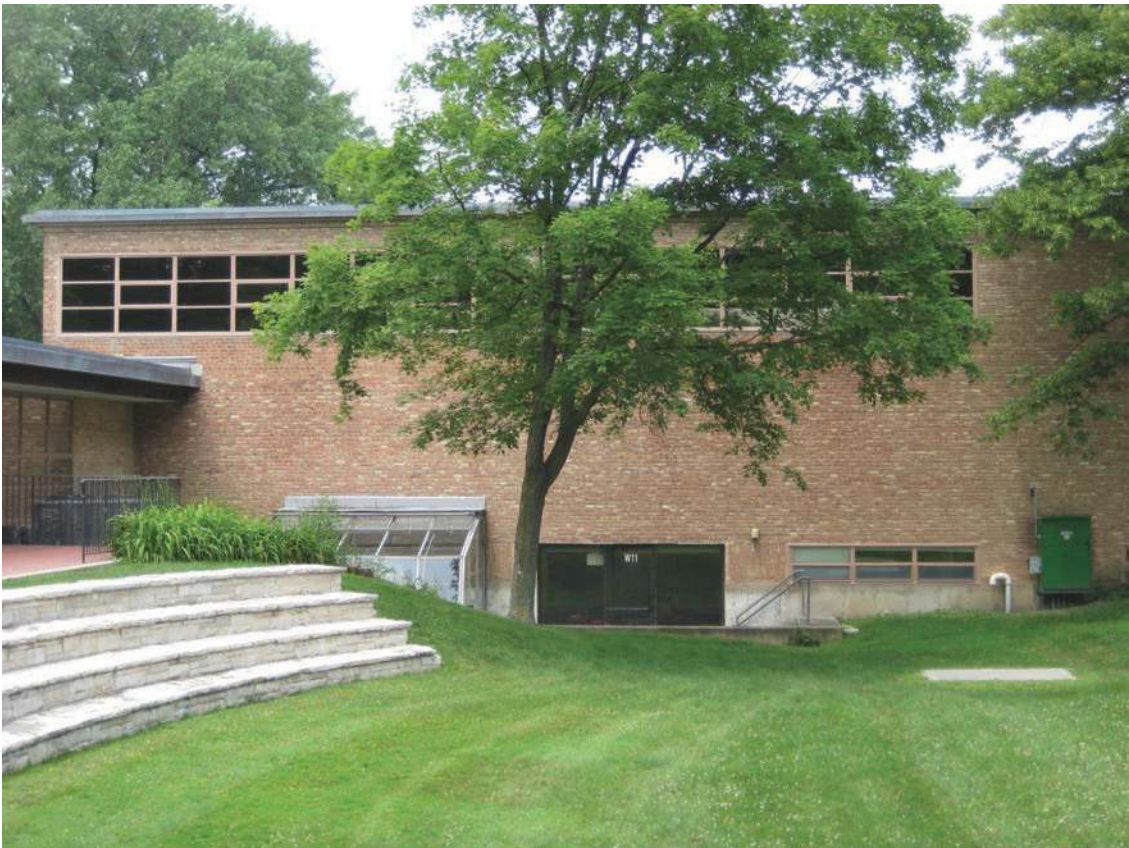
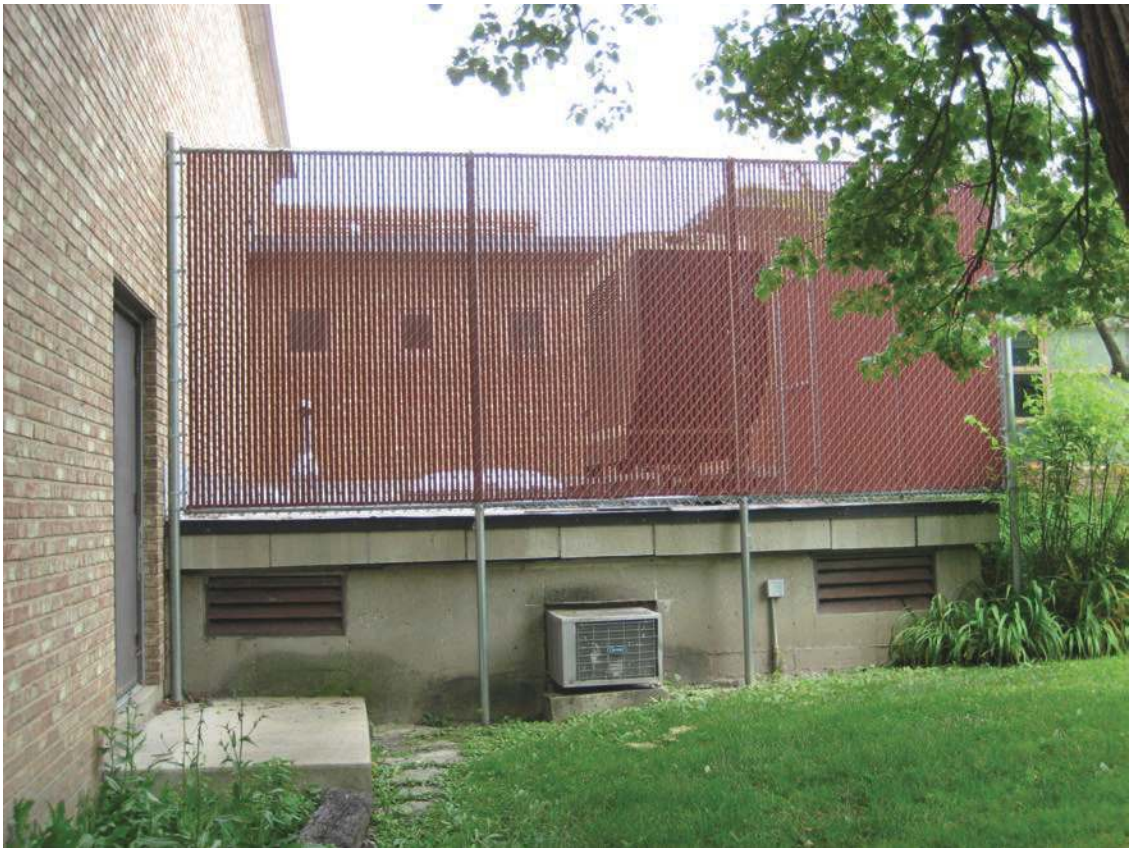
1954 addition and amphitheater, brick relief on south façade of 1940 central core

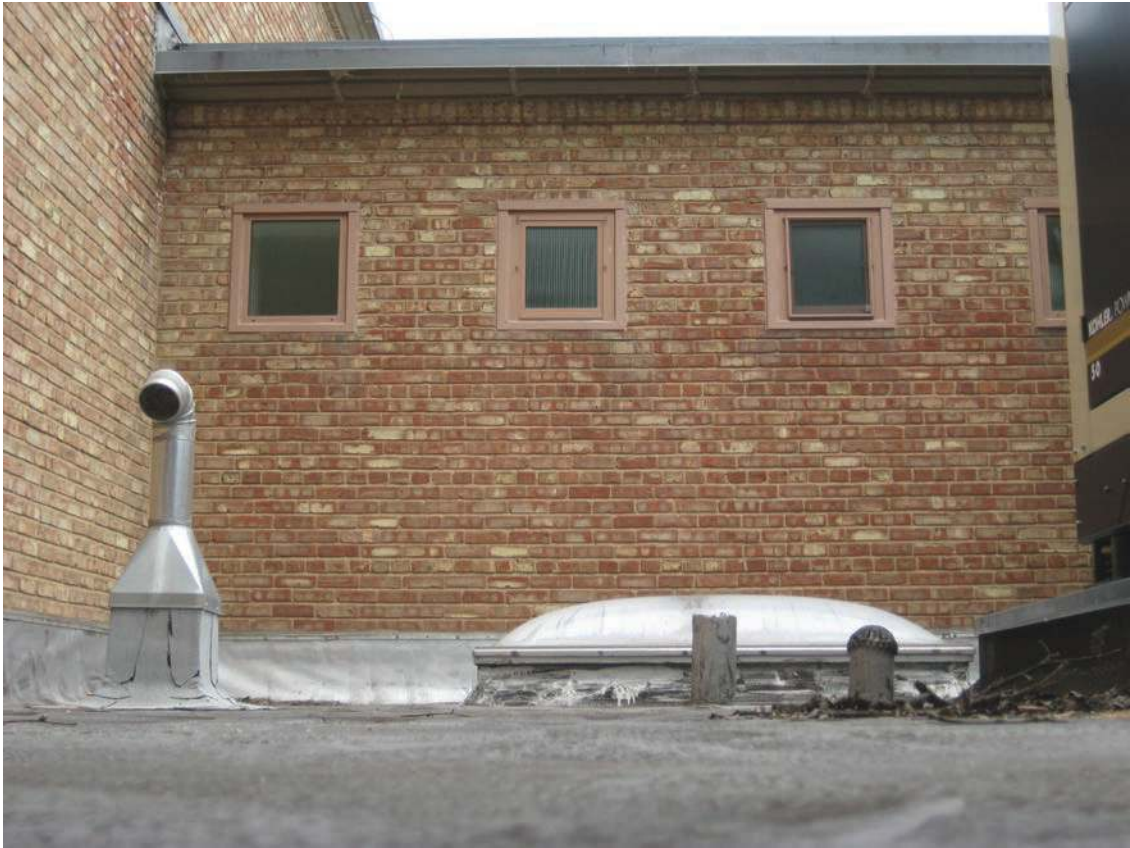
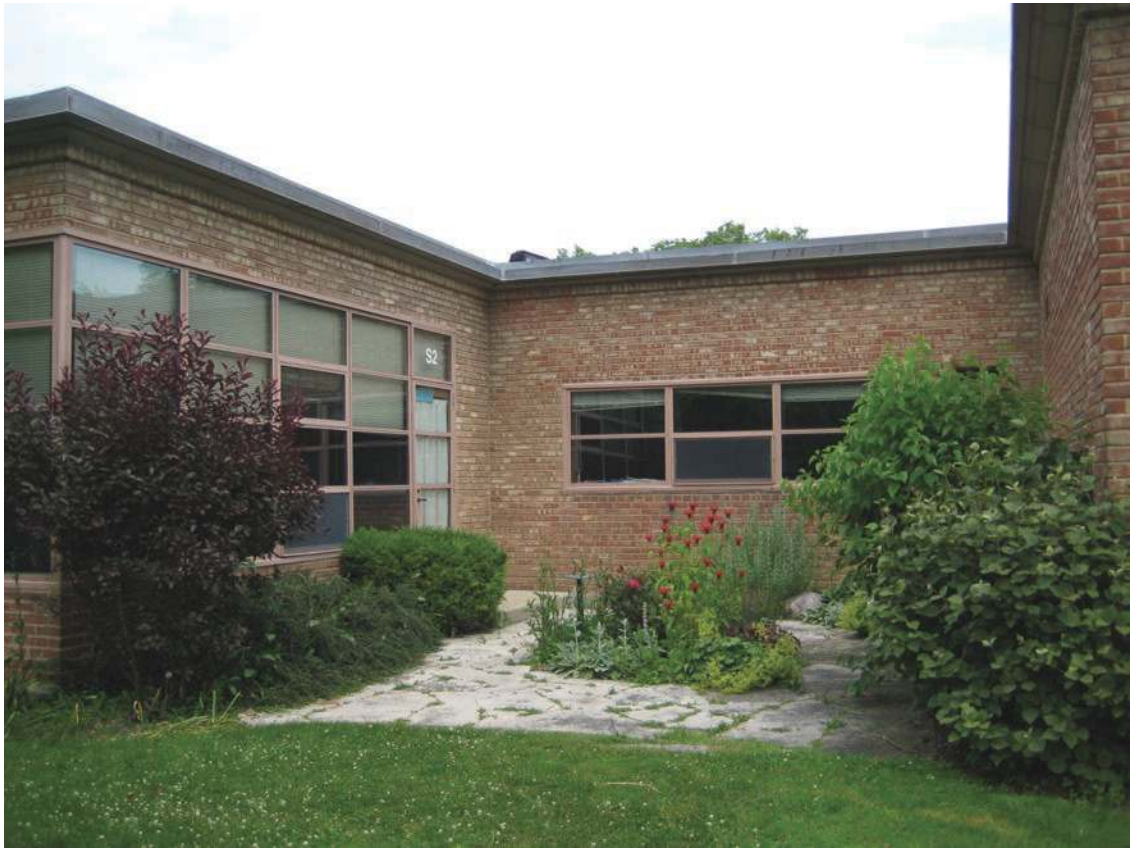
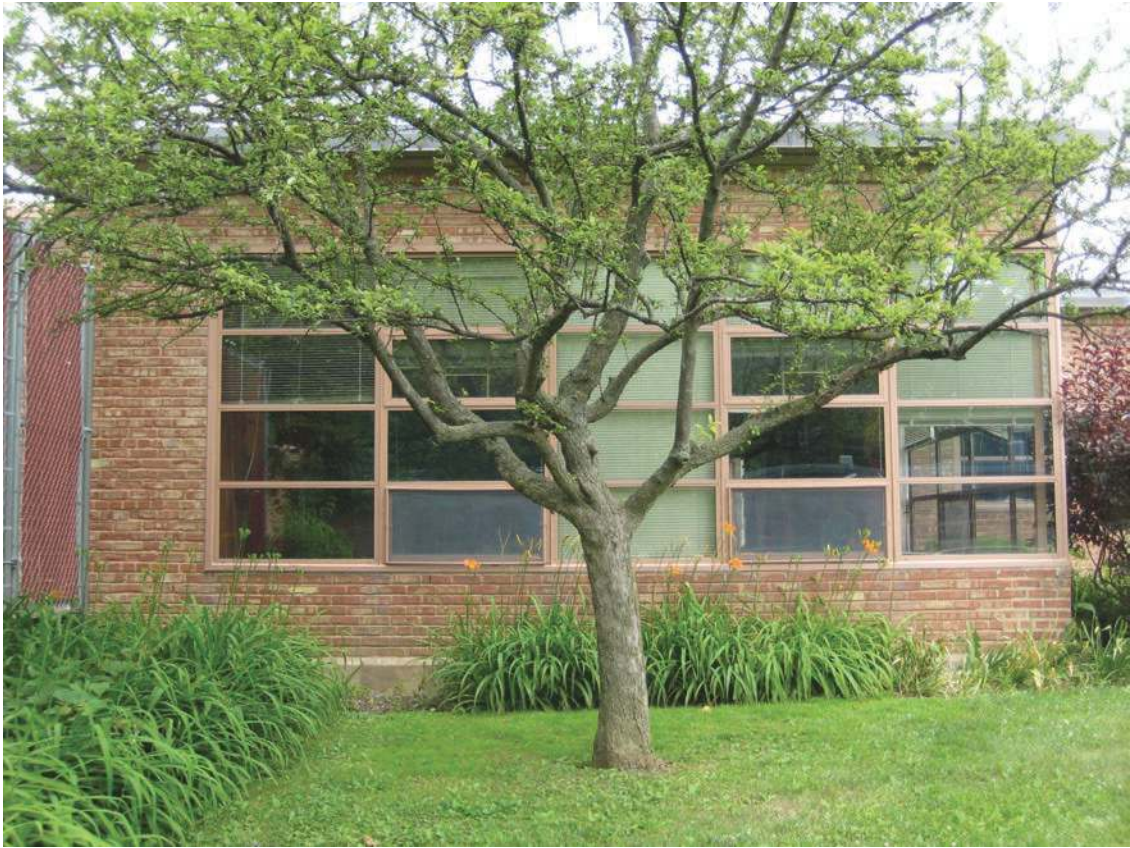
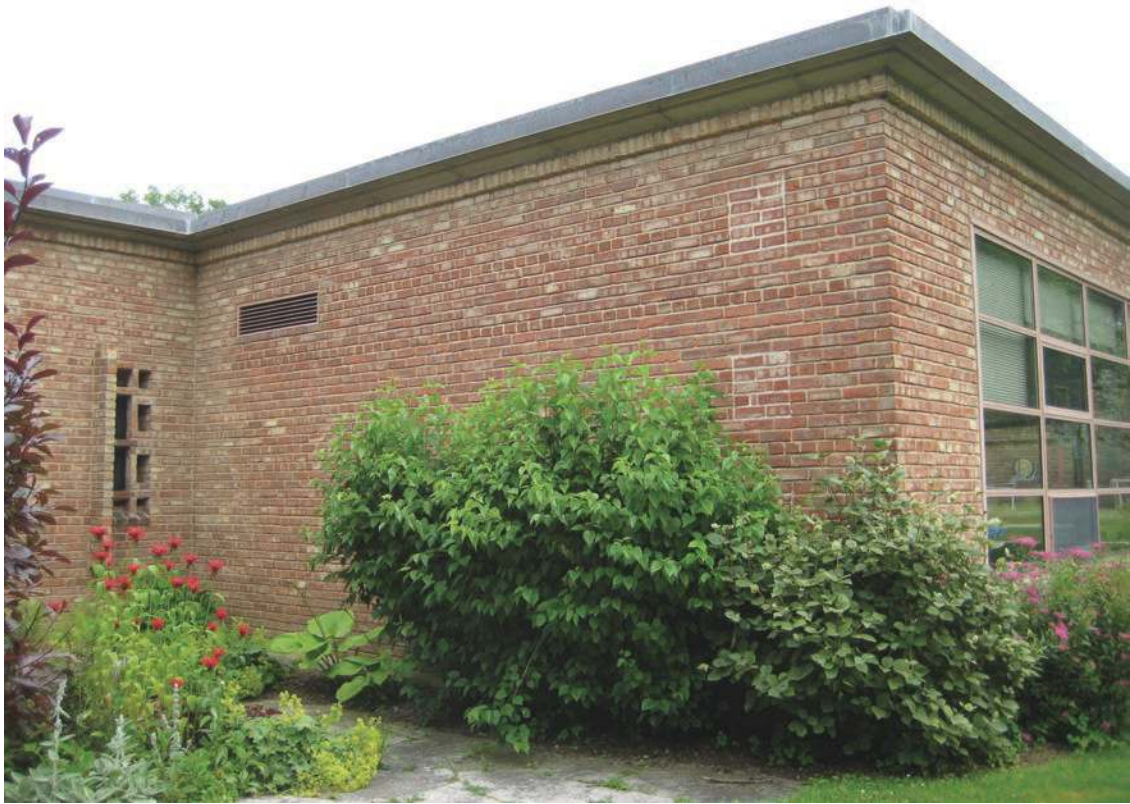
South facade of 1940 central core and view of mechanical area
