HISTORIC STRUCTURE REPORT

CROW ISLAND SCHOOL

WINNETKA,
ILLINOIS

2017

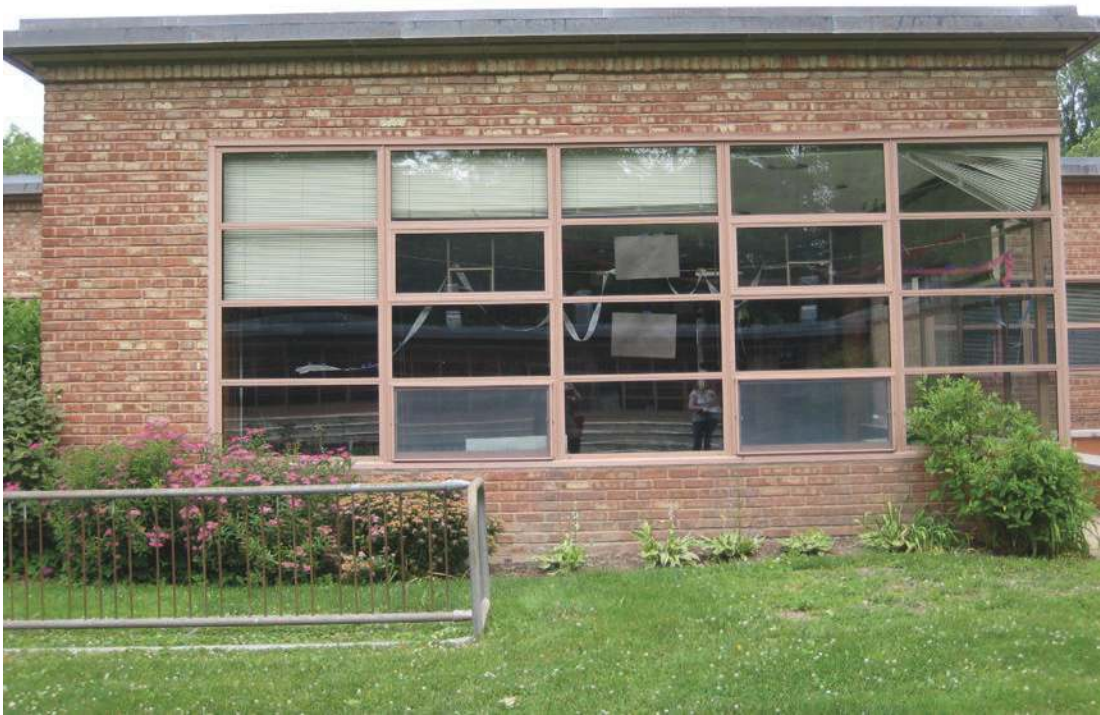
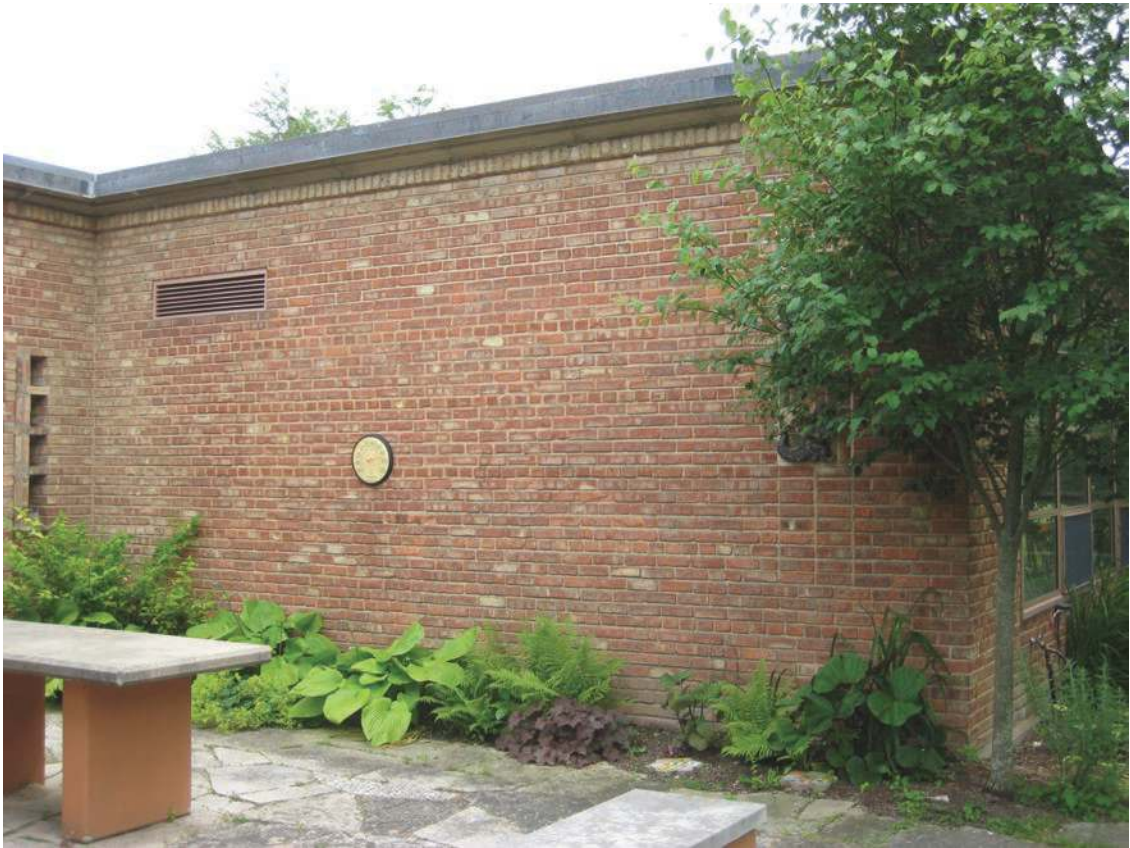
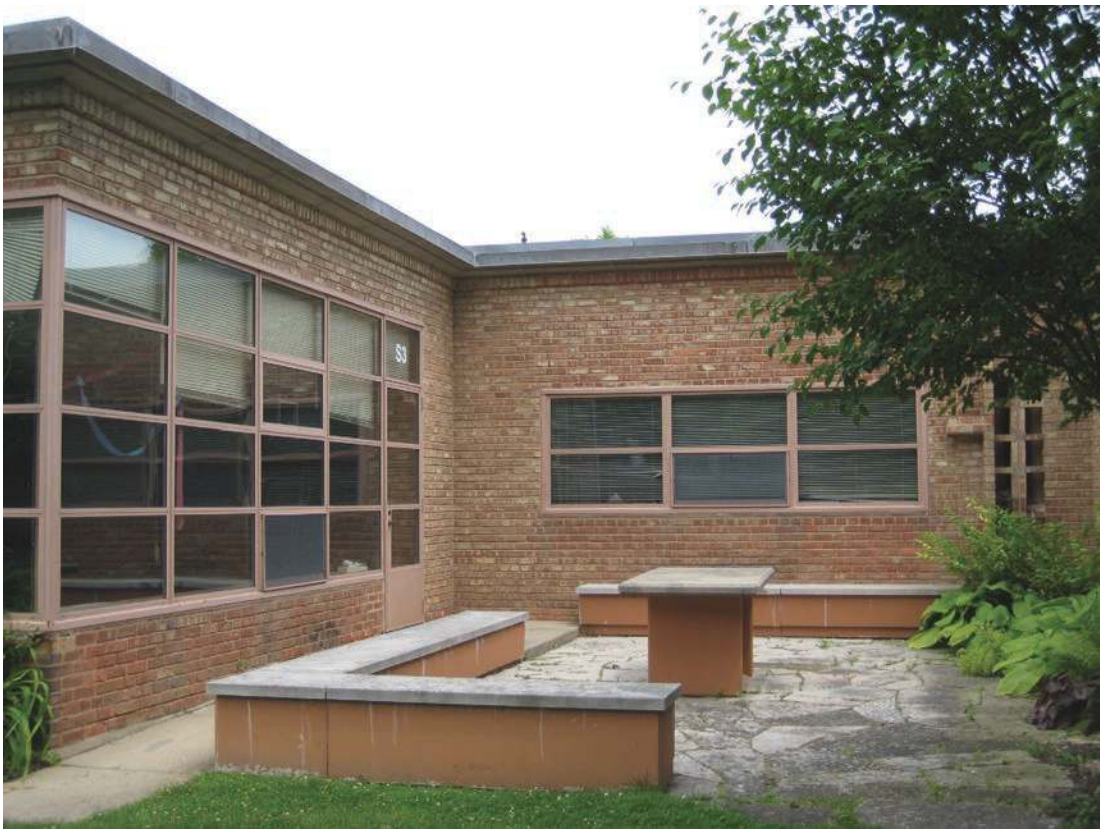
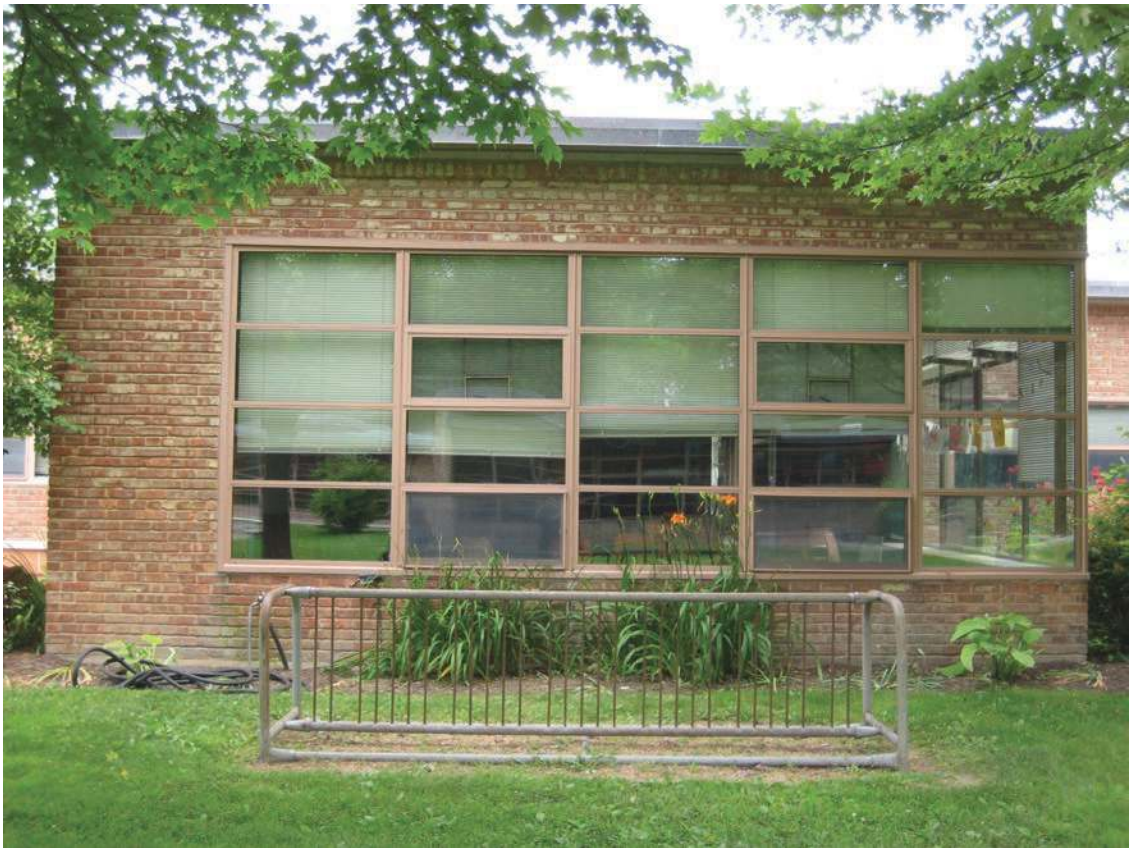
West façade of southeast wing and classroom courtyard

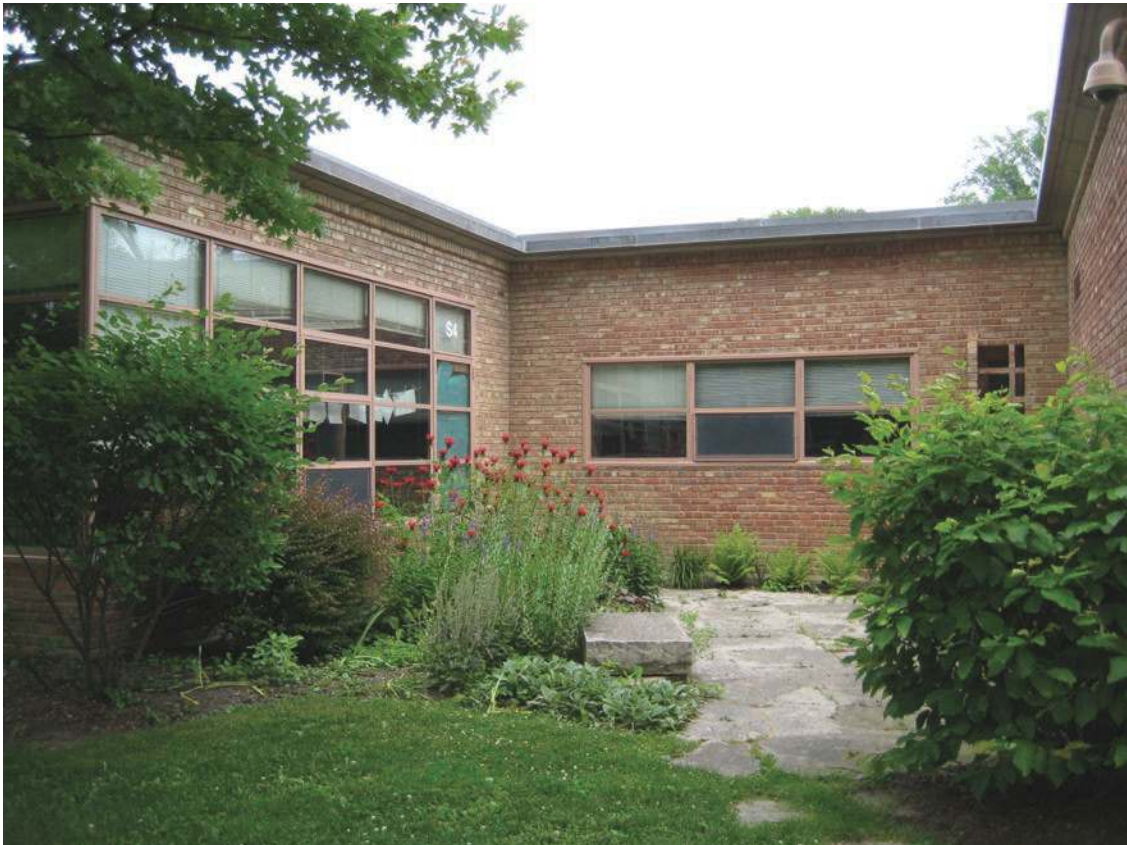
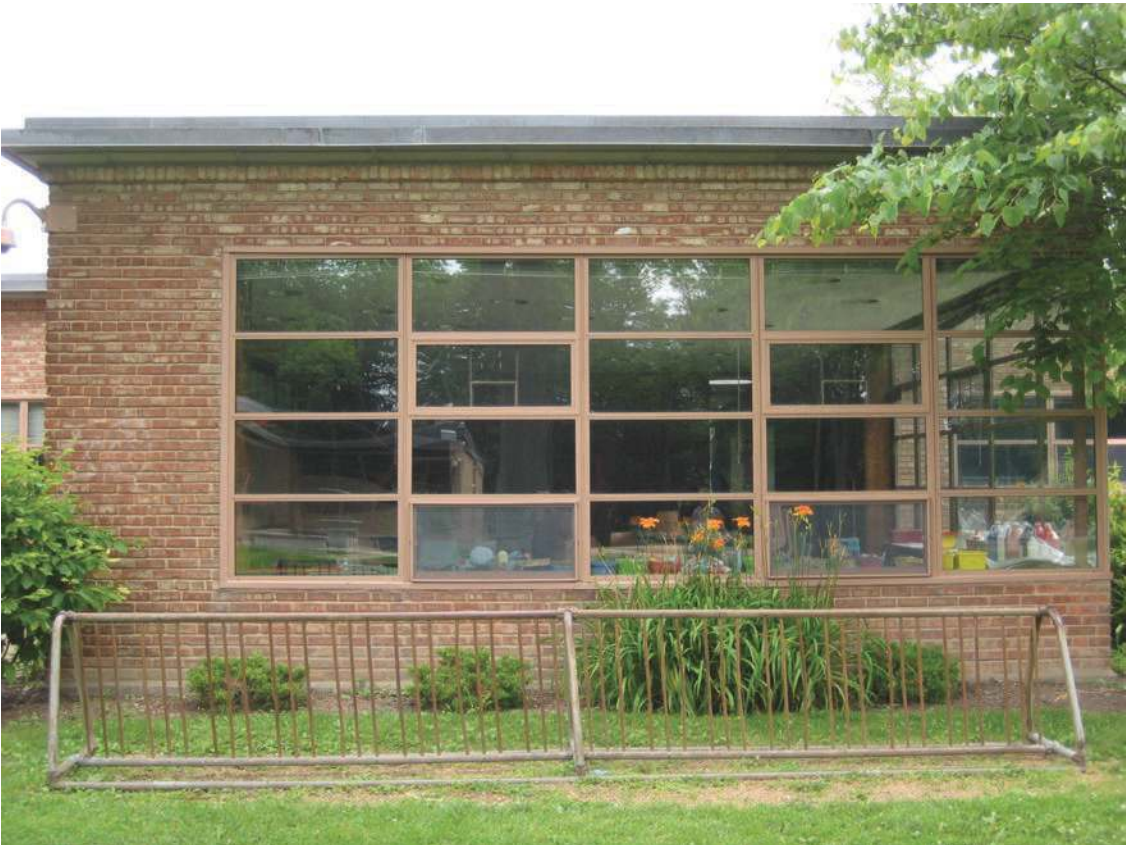
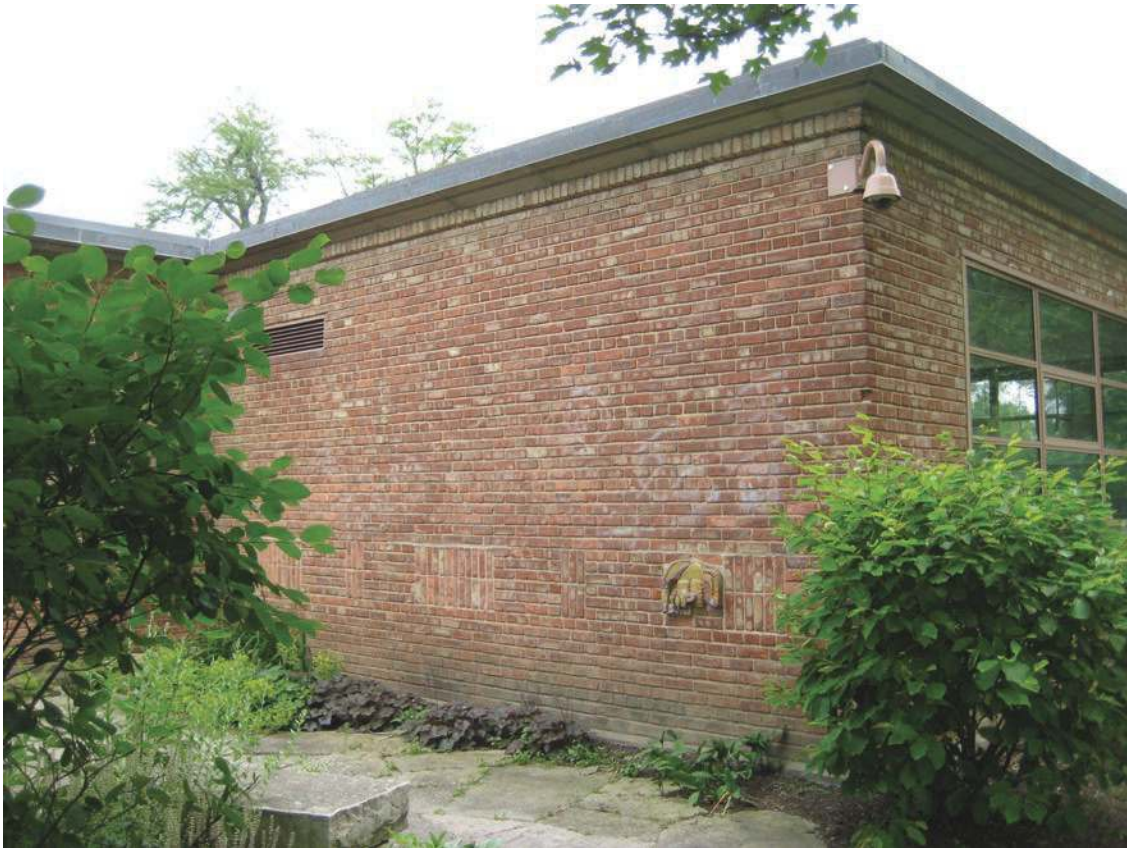
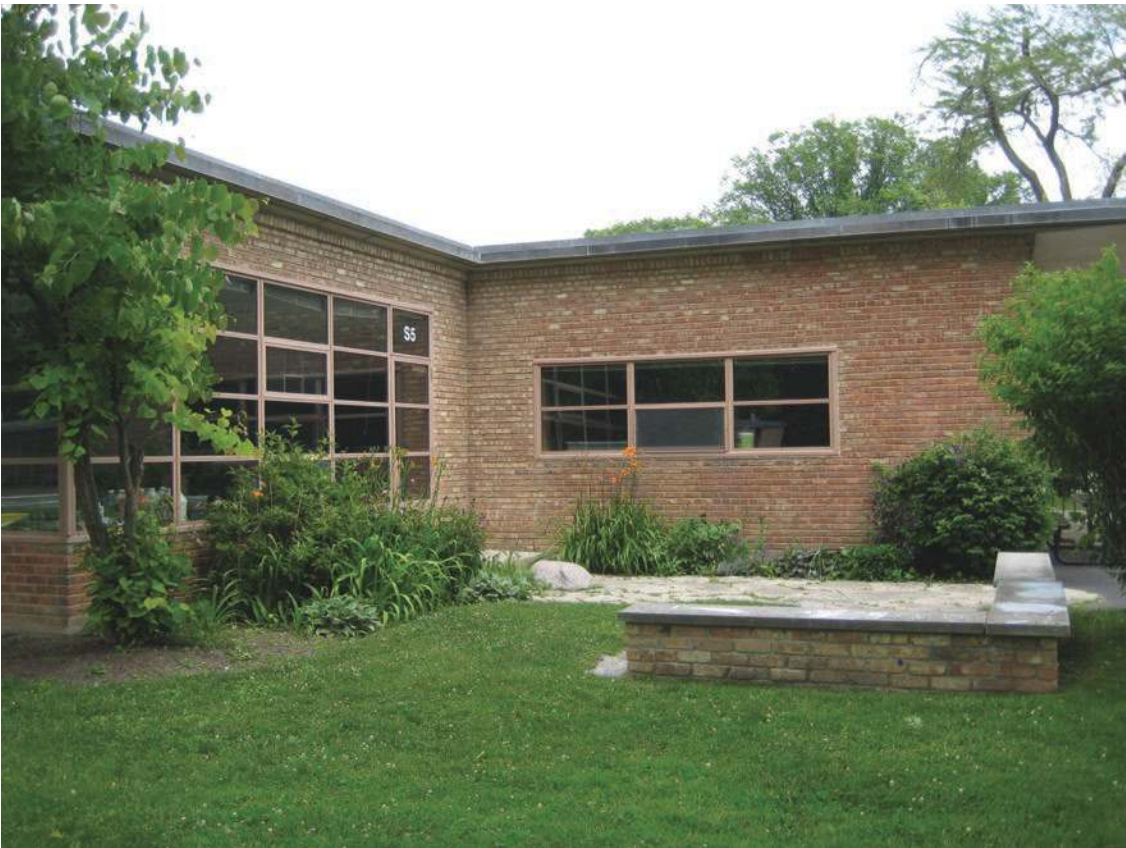
West façade of southeast wing and classroom courtyard

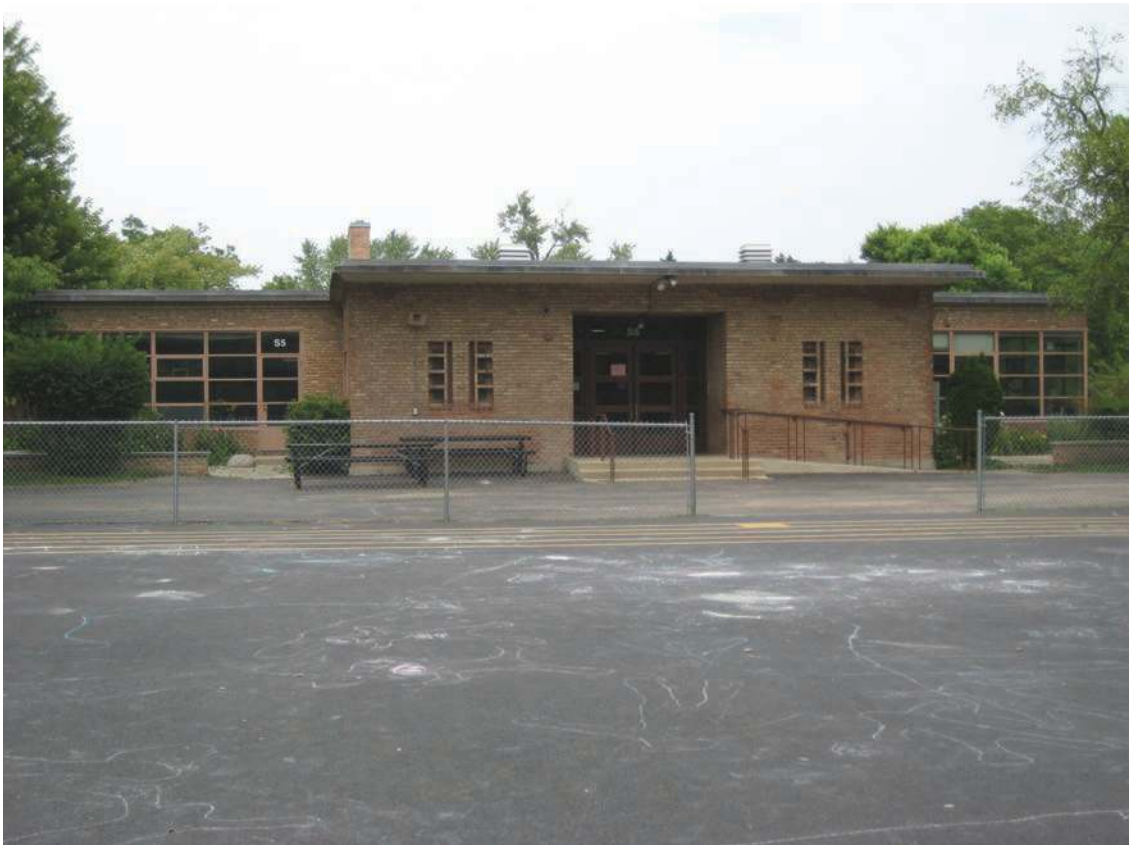
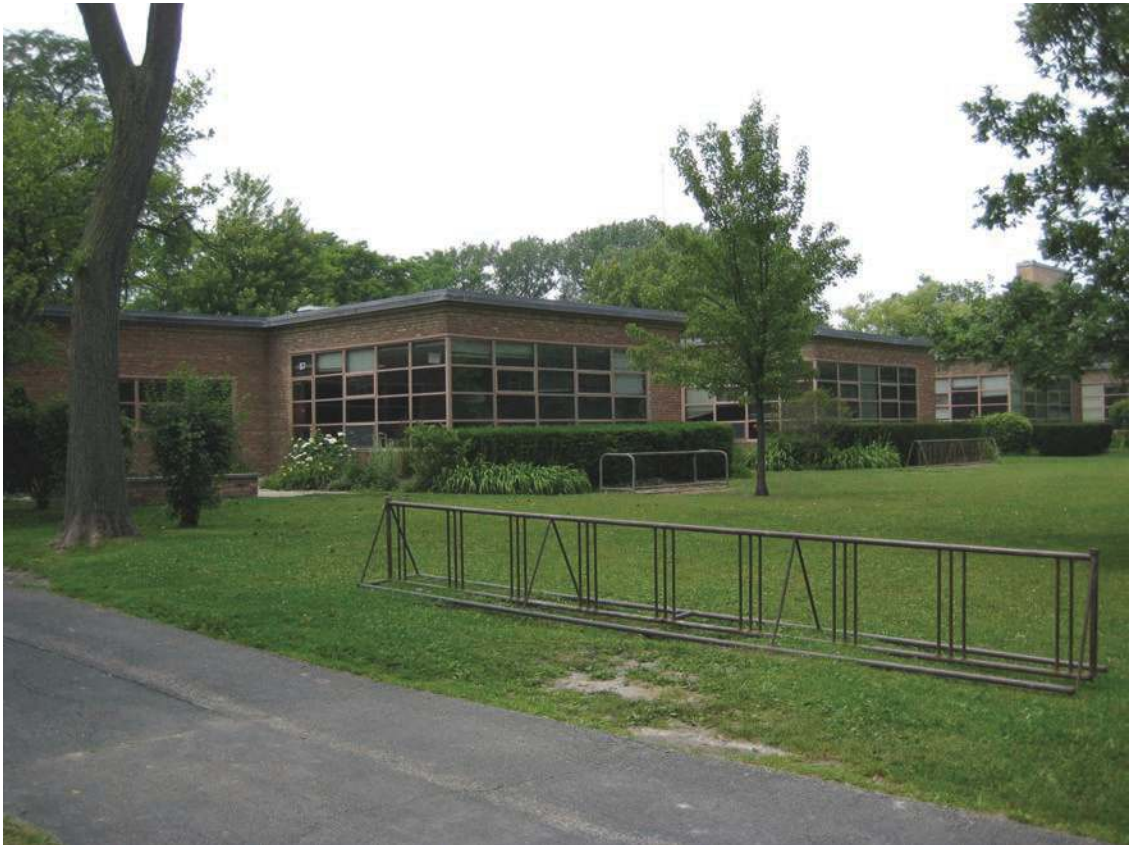
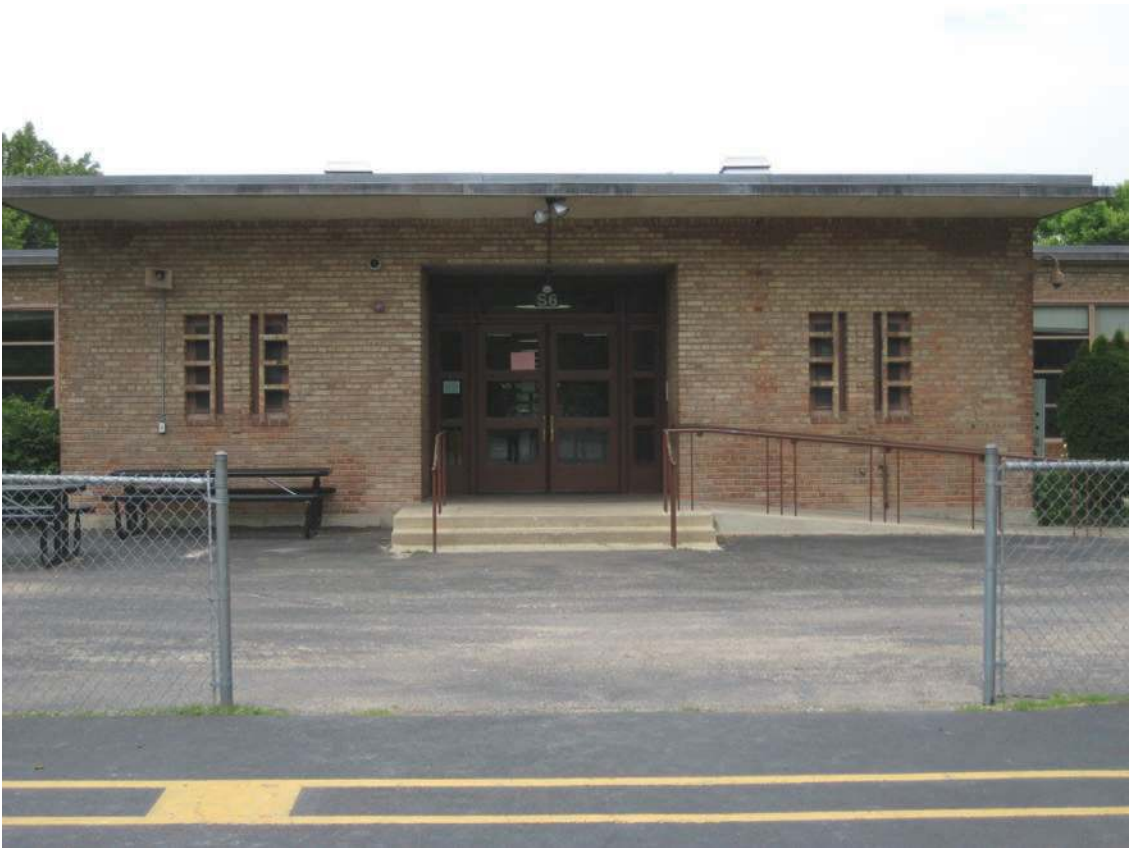
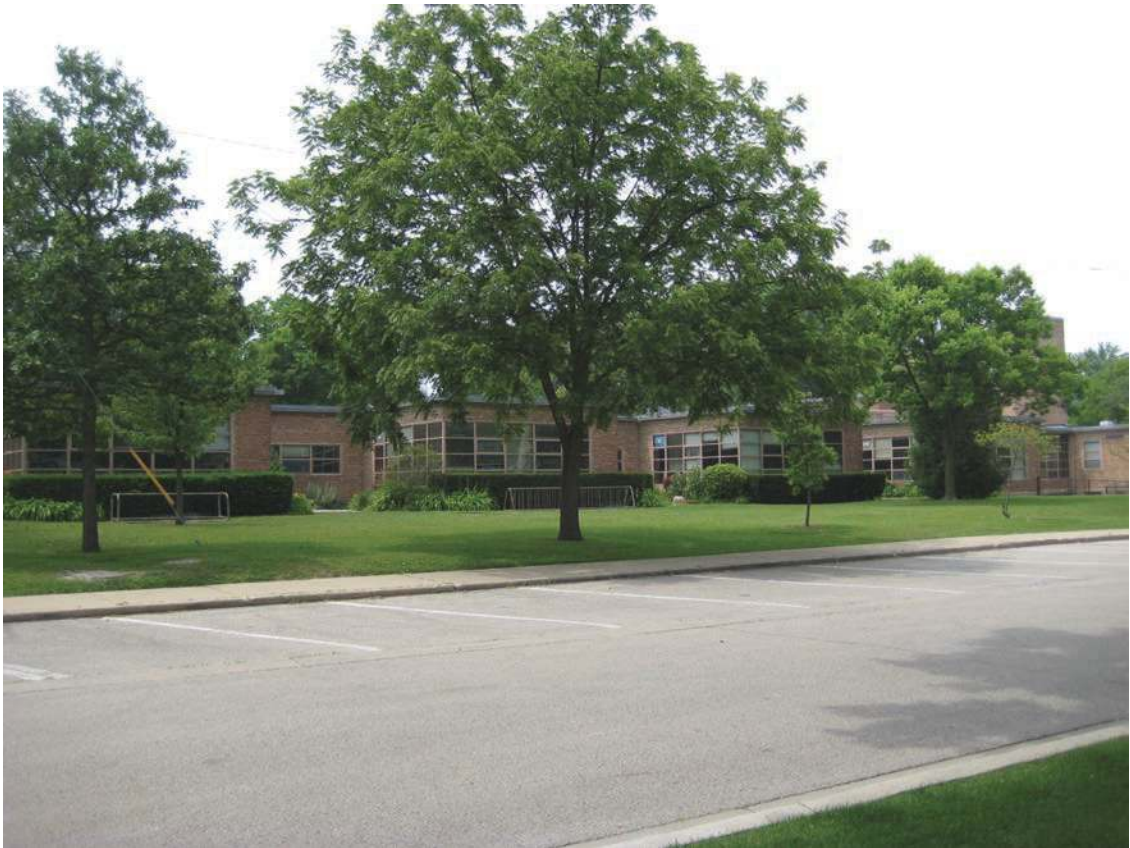
West façade of southeast wing and classroom courtyards

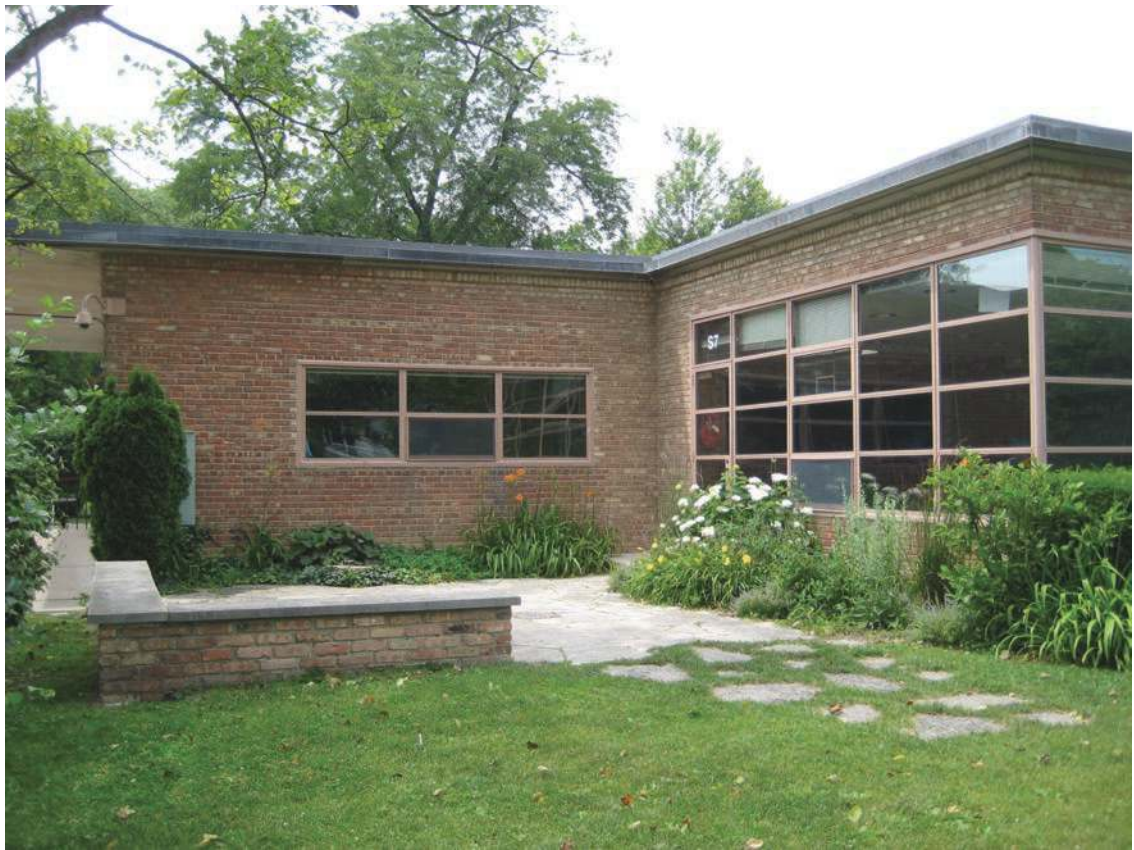
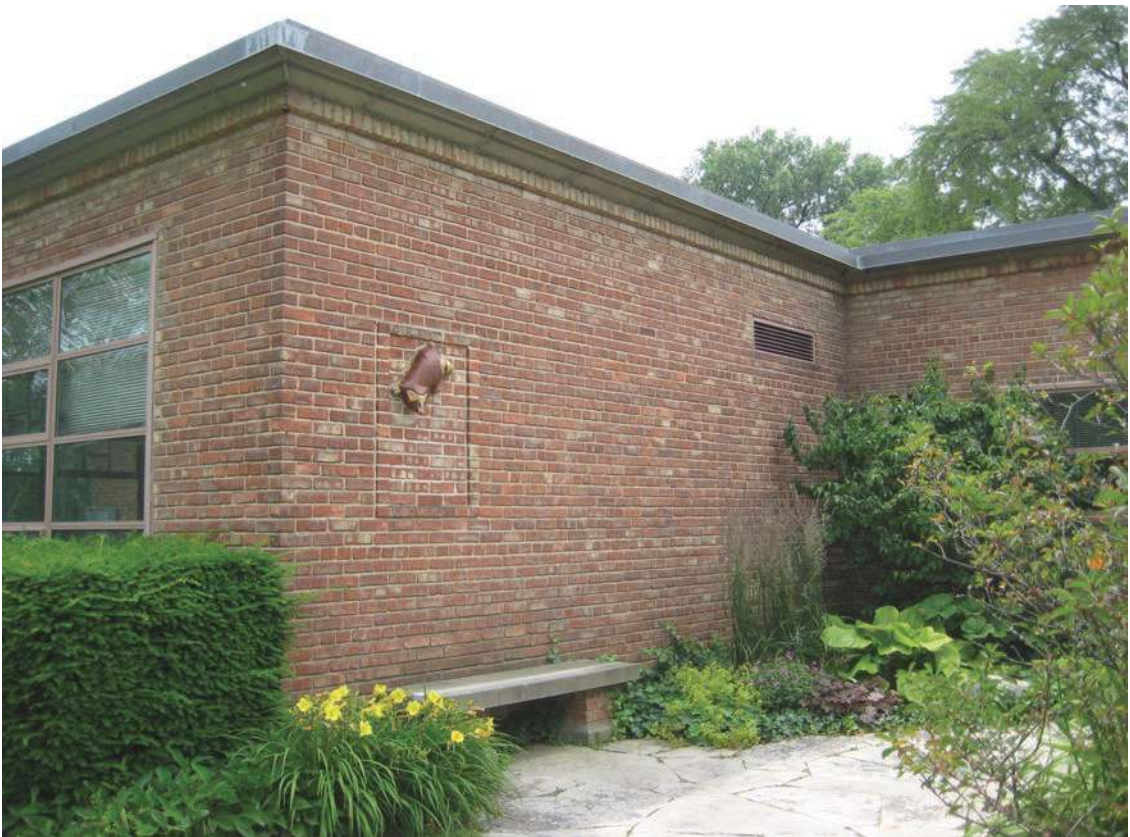
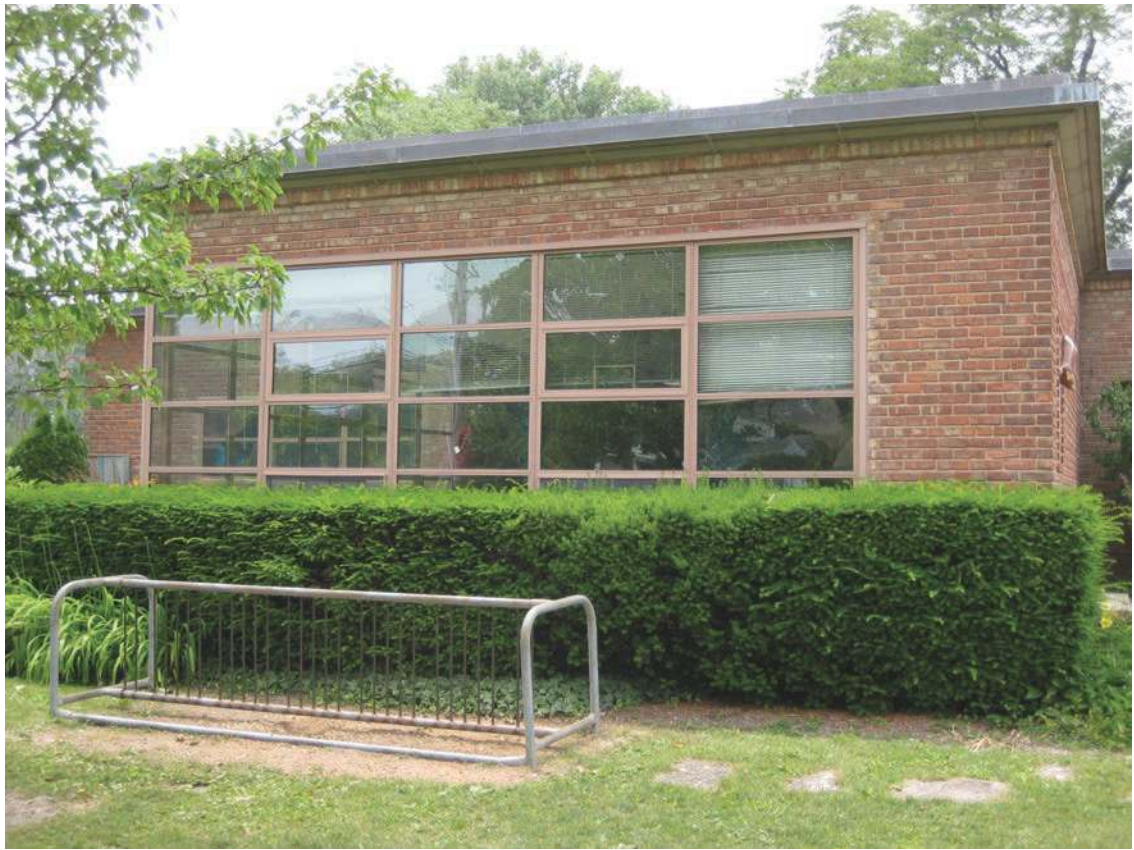
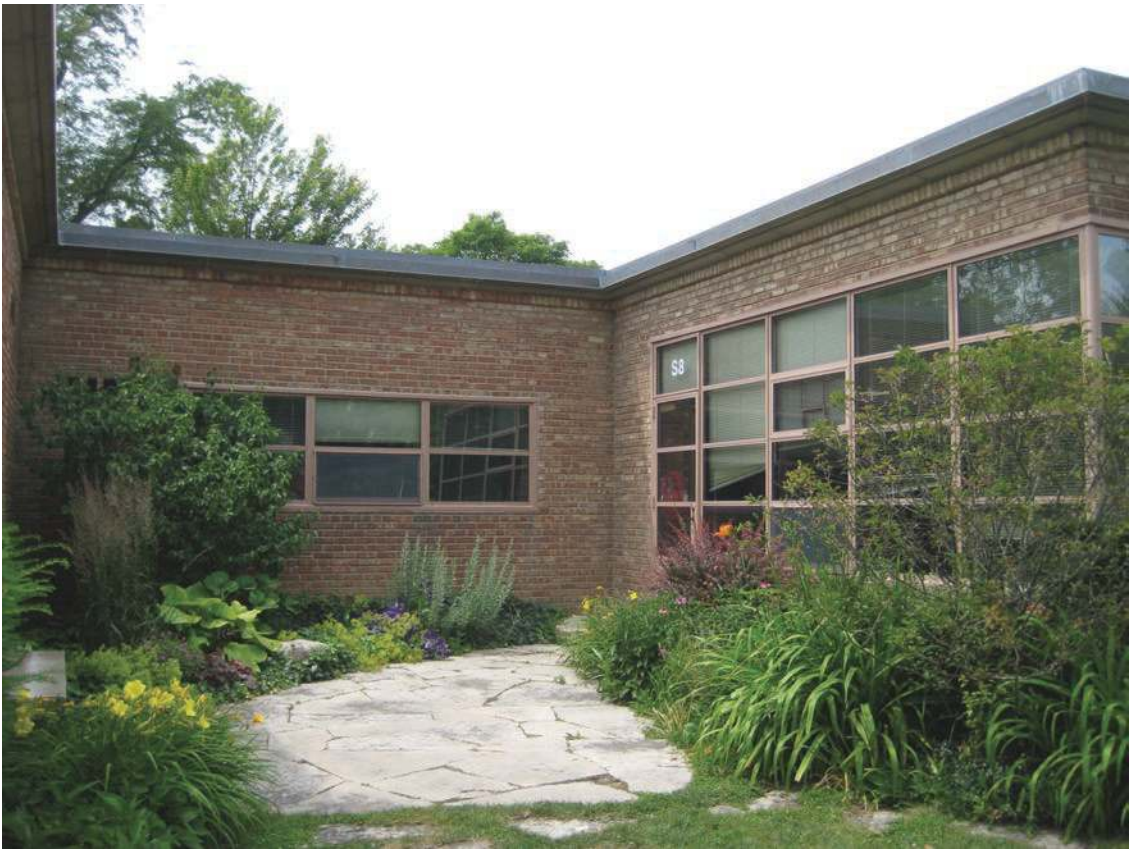
South façade of southeast wing and overall view of east façade classroom units and courtyards

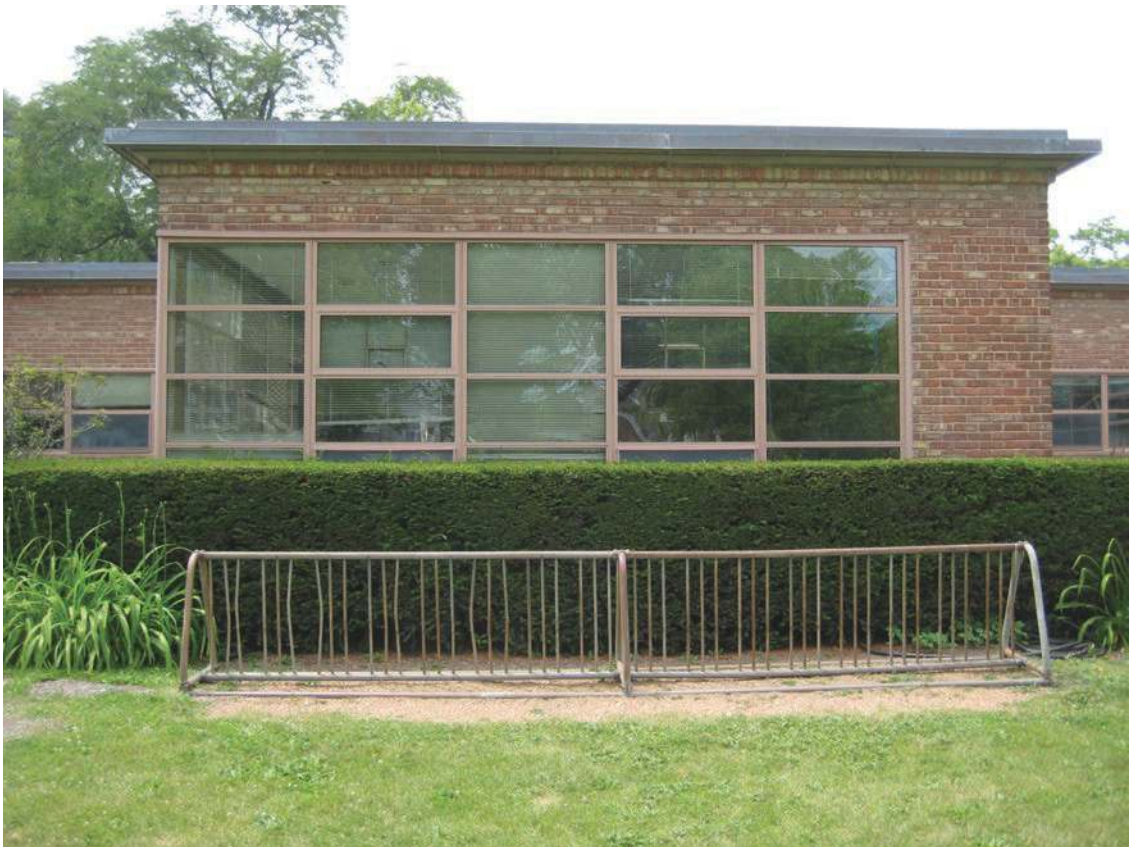
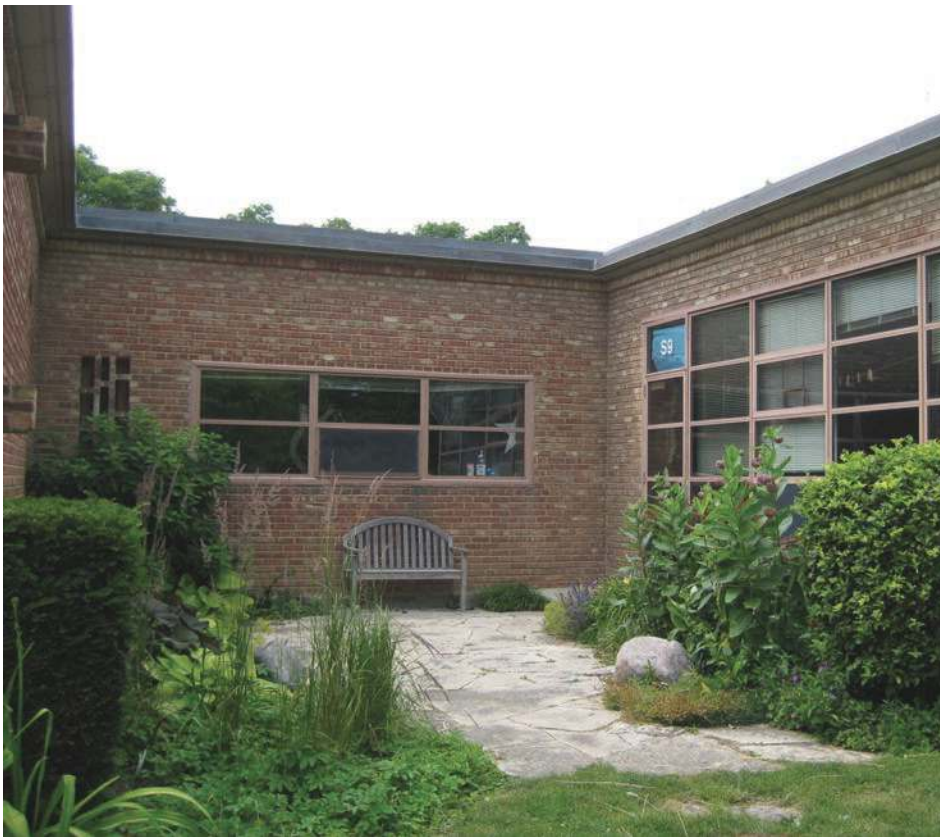
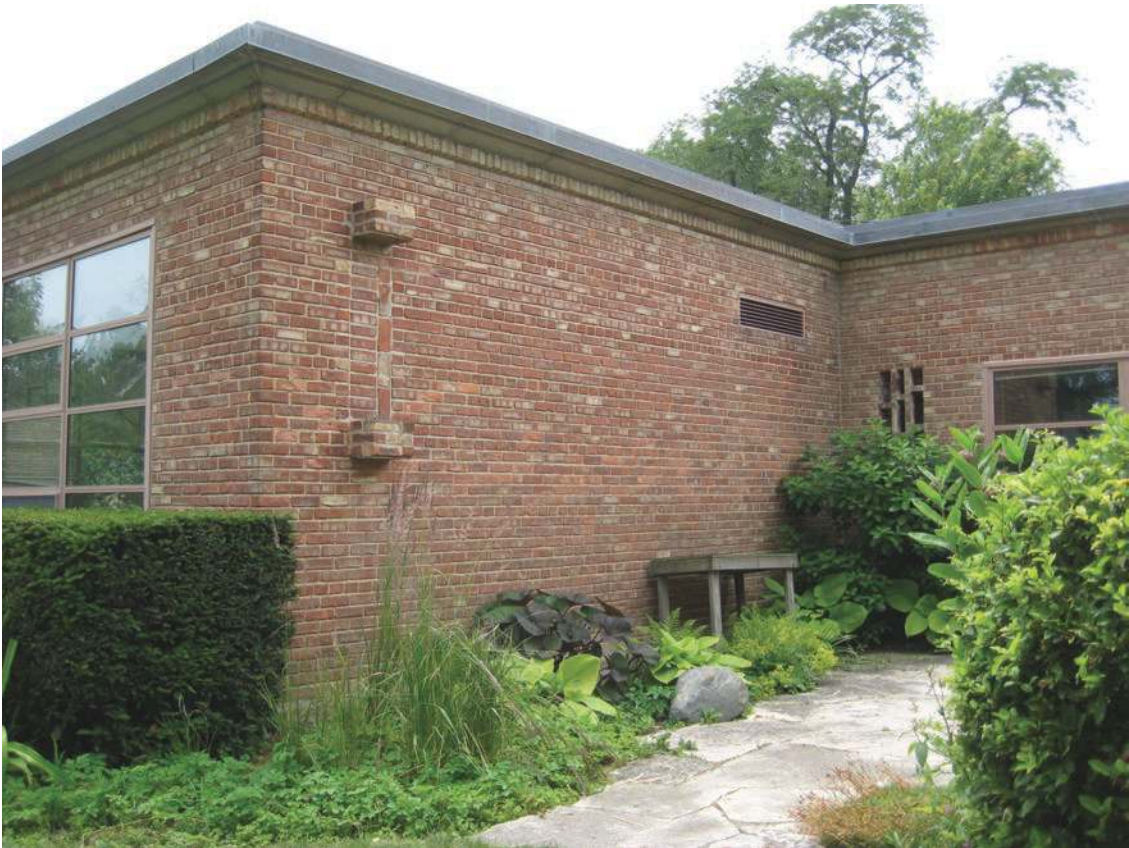
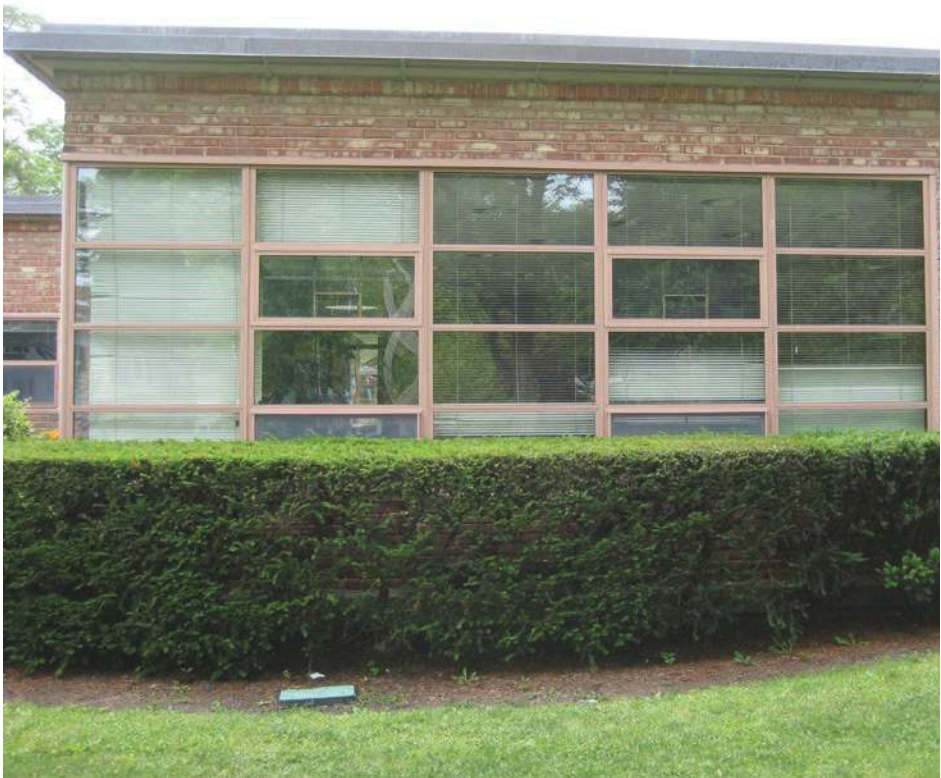
East façade of southeast wing and classroom courtyards

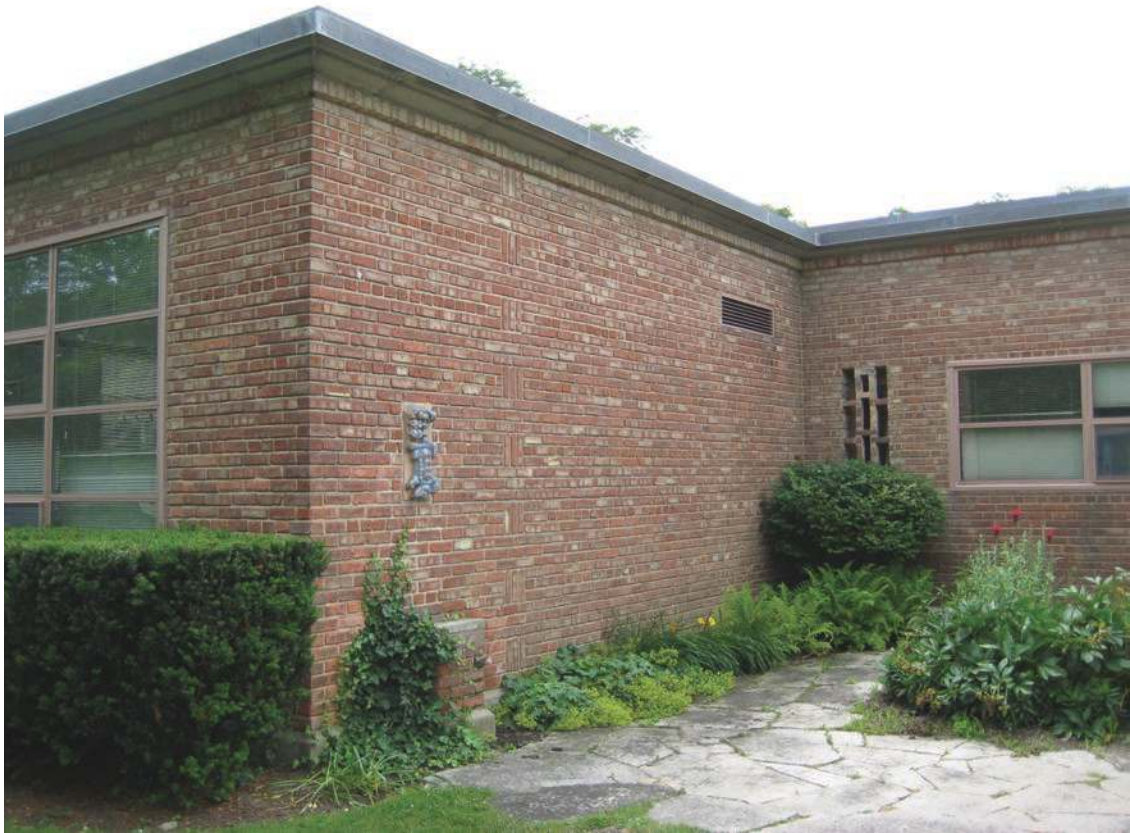
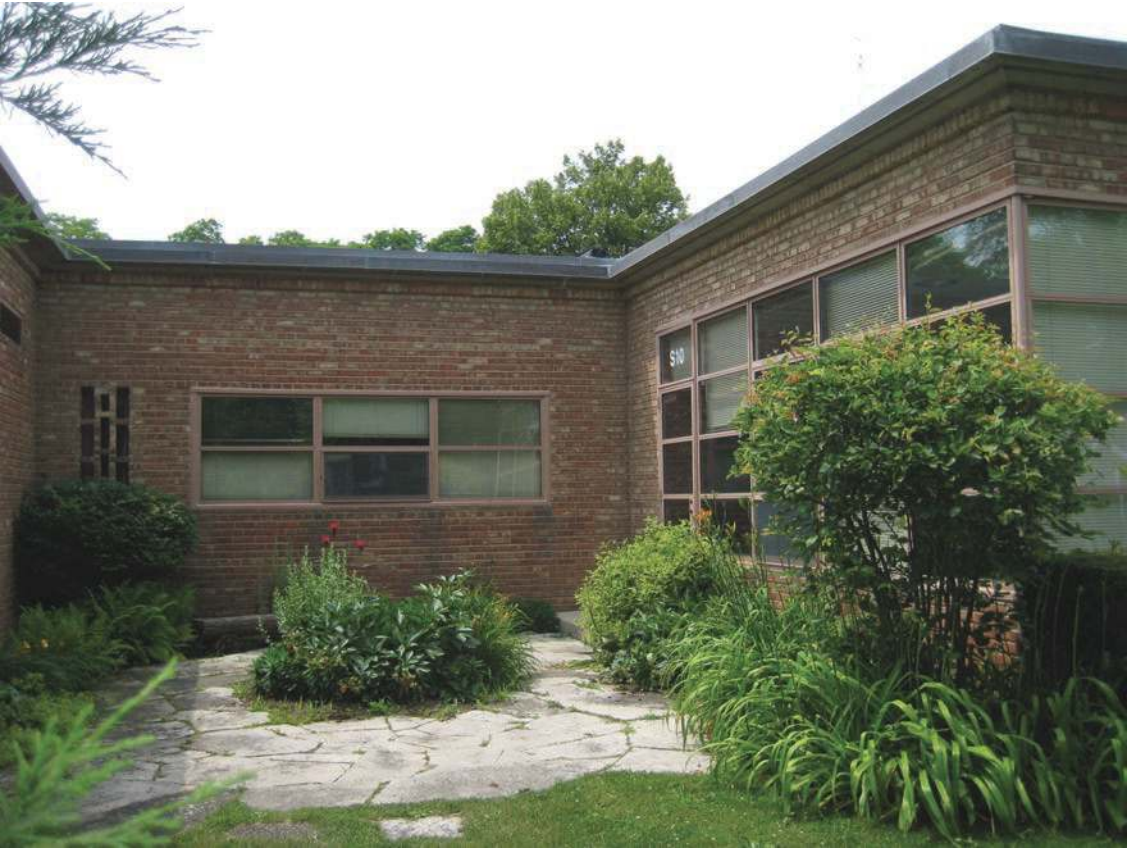
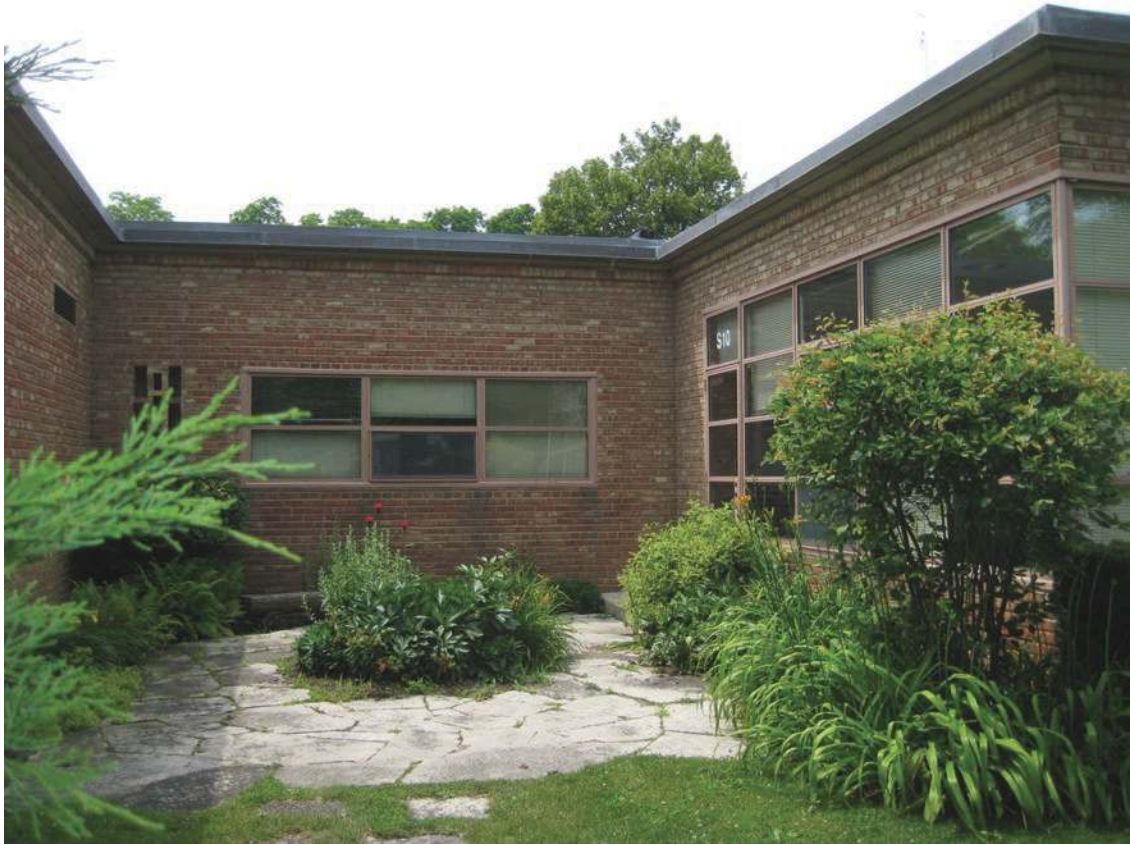
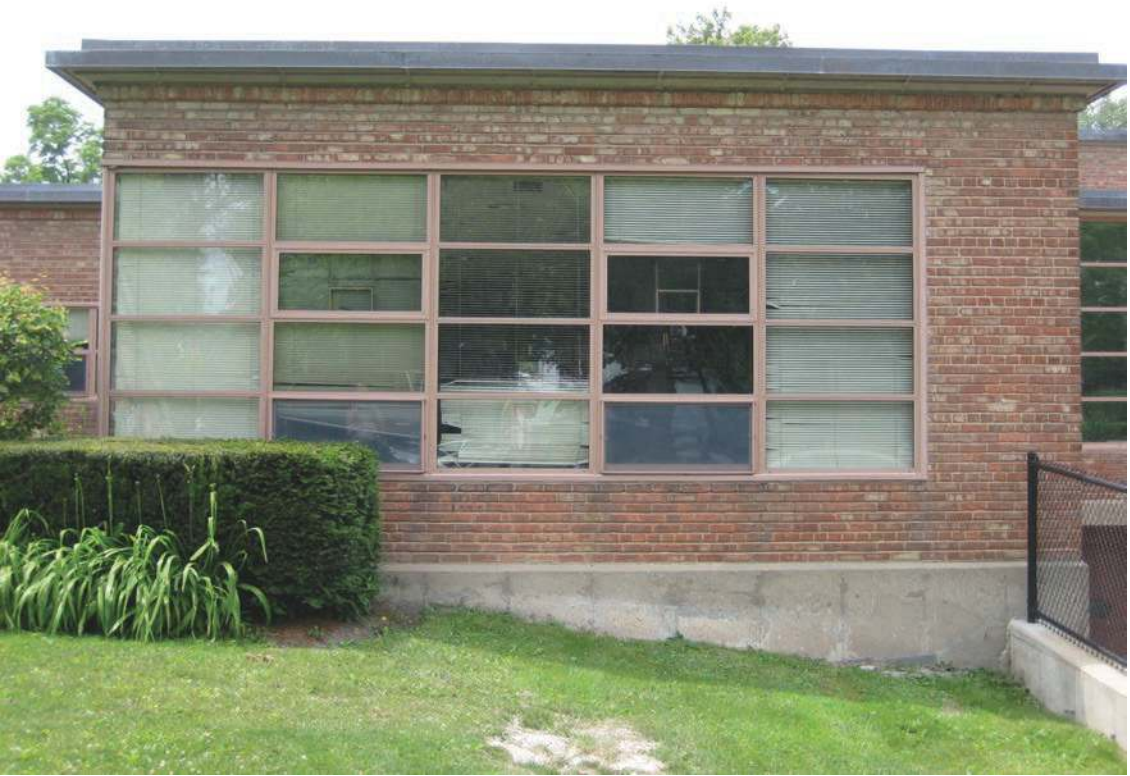
East façade of southeast wing and classroom courtyards
